*Historic Structures Report*

# **VAN LIEW-SUYDAM HOUSE**

Franklin Township, New Jersey

June 15, 2002

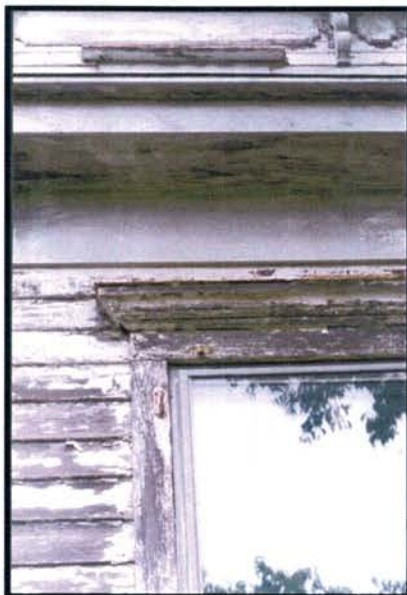
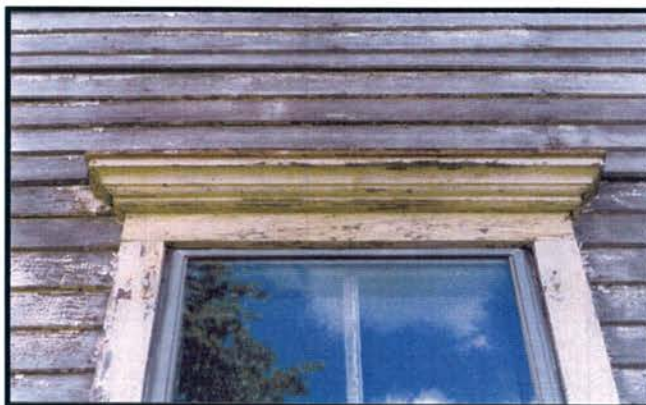
Two window details showing typical Victorian cornices above double hung units. Cornices are typically capped by a metal flashing. Most of these should be replaced with copper flashings.

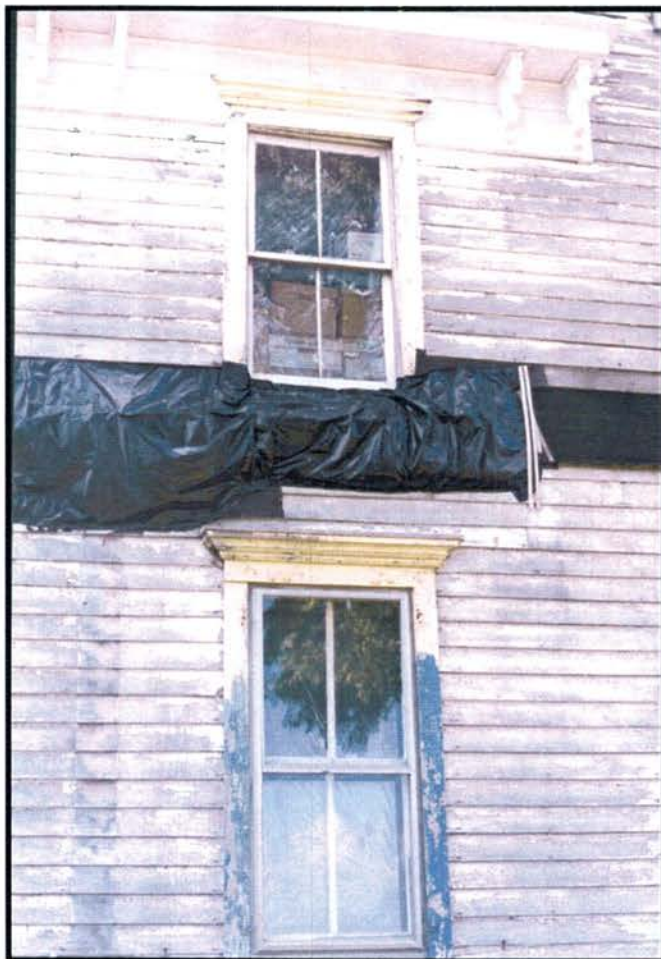
Two windows on west façade, behind the porch that was removed. The upper unit has rotted sills due to exposure to water from the porch roof. We recommend truncating the window to prevent further deterioration when the porch is restored.

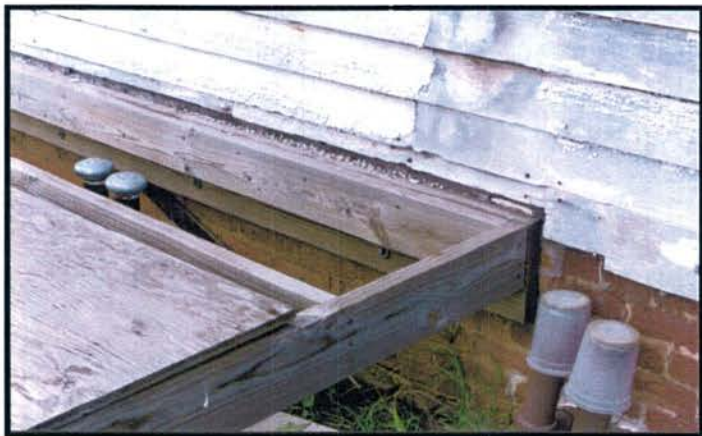
Above left: new plates and ledgers attached to the brick foundation wall to support the porch reconstruction. These members should be evaluated before re-use.

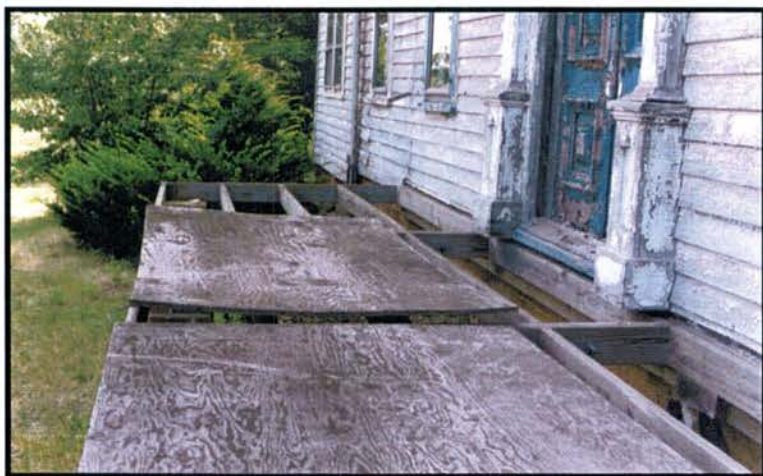
Below left: temporary plywood sheets on porch framing created by Meadows Foundation volunteers following the porch removal.

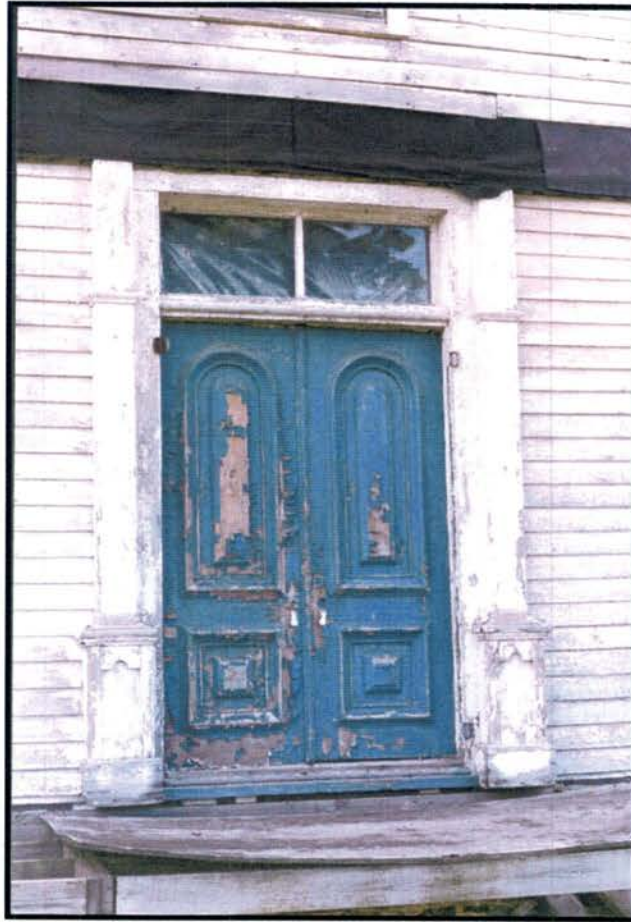
Arch paneled Victorian doors from the 1875 build. The doors are integral to the character of the façade and porch elements (note the pilasters flanking the frame). They are in good condition and should be conserved and repainted.

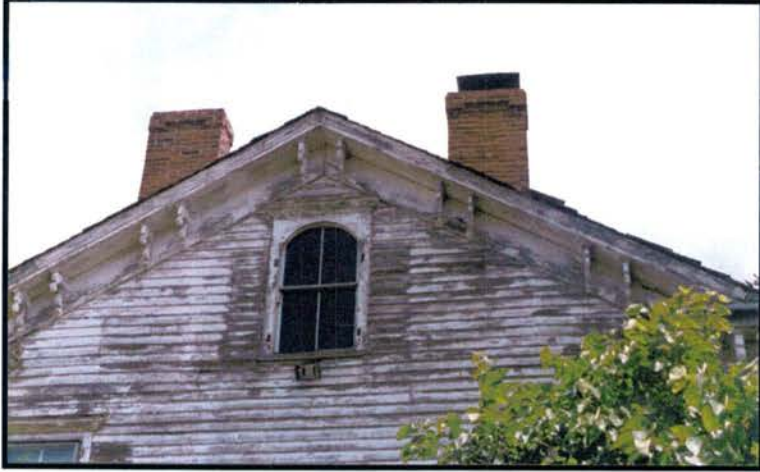
Peak of south gable shows brackets and arched attic window. Meadows Foundation volunteers made repairs to rotted cornice during the roofing campaign.

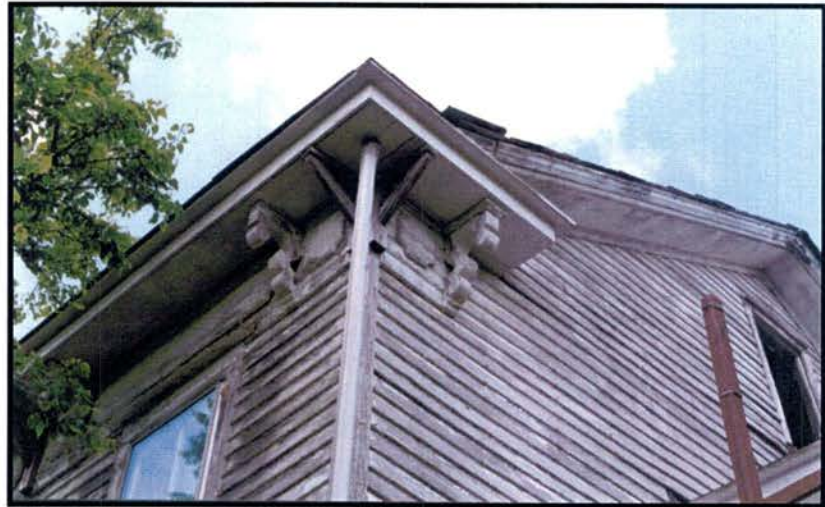
Detail of leader from projecting eave on the southeast corner of the main block. All leaders need repair or replacement, and should run to a new drainage system.

- Repair the porch and porch roof on the east side of the house, adjacent to the old dining room wing.
- Repair all damaged eaves, gutters, brackets or trim at the roof levels of the house. Inspect the roof for wear or damage and repair where necessary.

- Repair the gutter and leader system and install replacement components were required.
- Remove all existing storm/screen units and install new units in the first floor windows. These should replicate historical window sash and be made of wood.

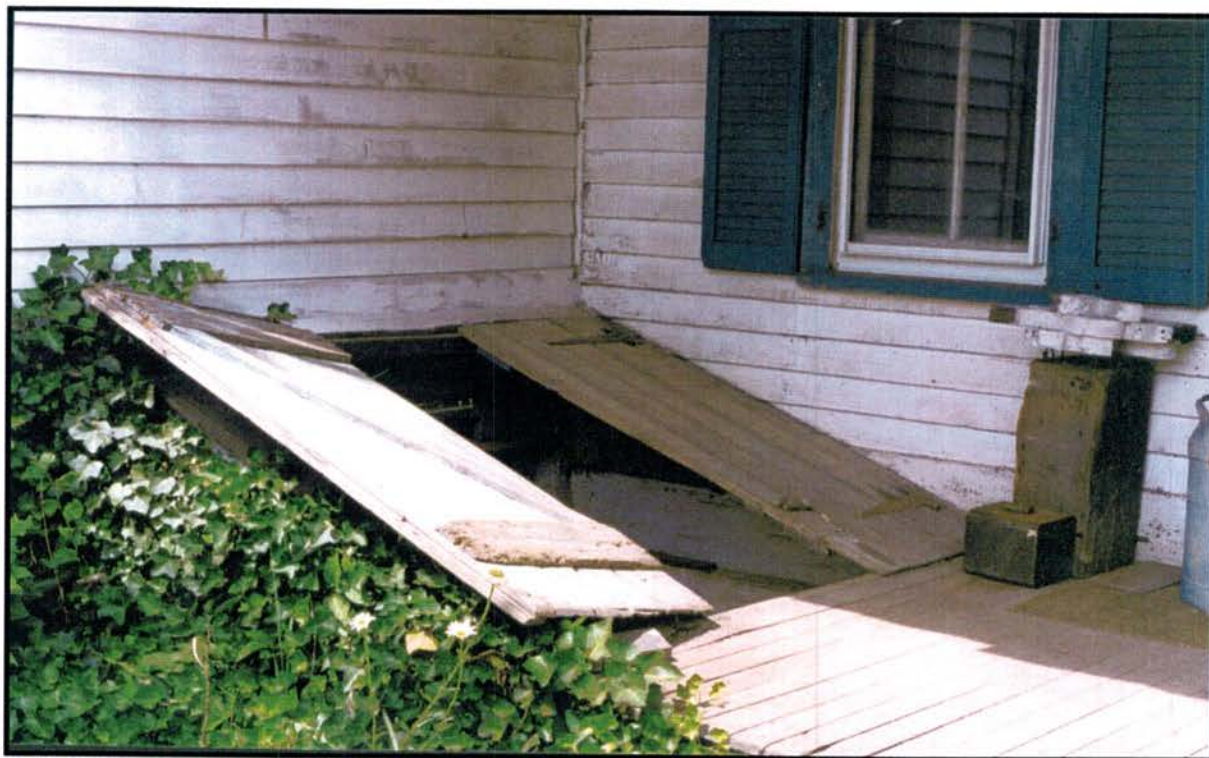
Hatch leading to cellar is on the southeast side of the house, adjacent to the smaller dining room wing. Both the doors and the plank flooring are severely deteriorated and should be restored with like materials. This is the only access to the cellar areas for service and should have a secure lock.

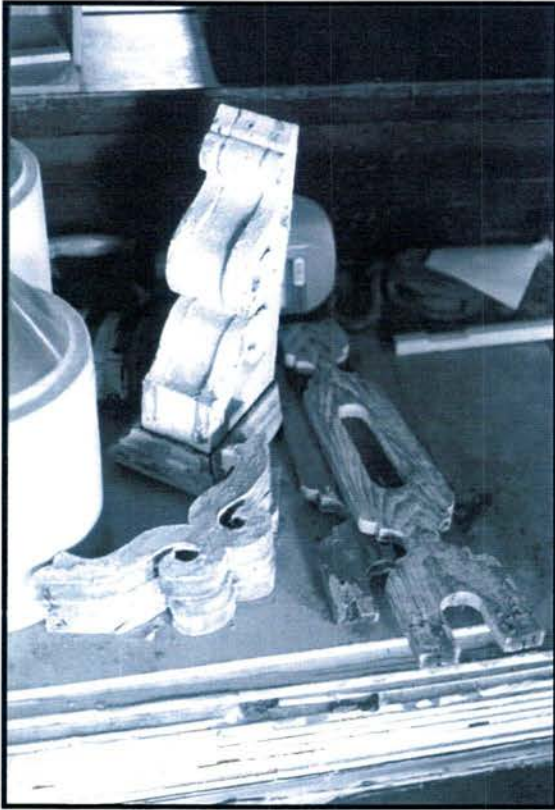
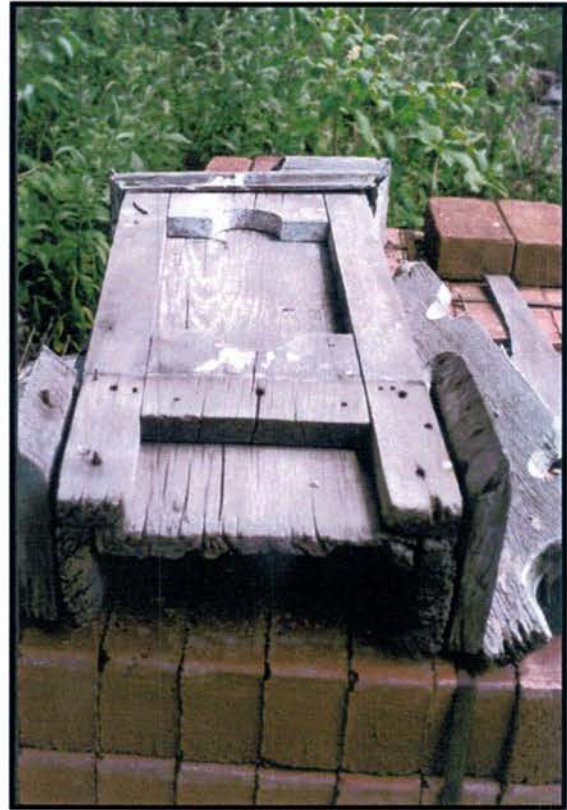
Salvaged components from the porch are stored both in the main parlor and outside the house, unprotected from the weather. When the porch is restored each piece will have to be evaluated to assess its condition and potential for re-use.

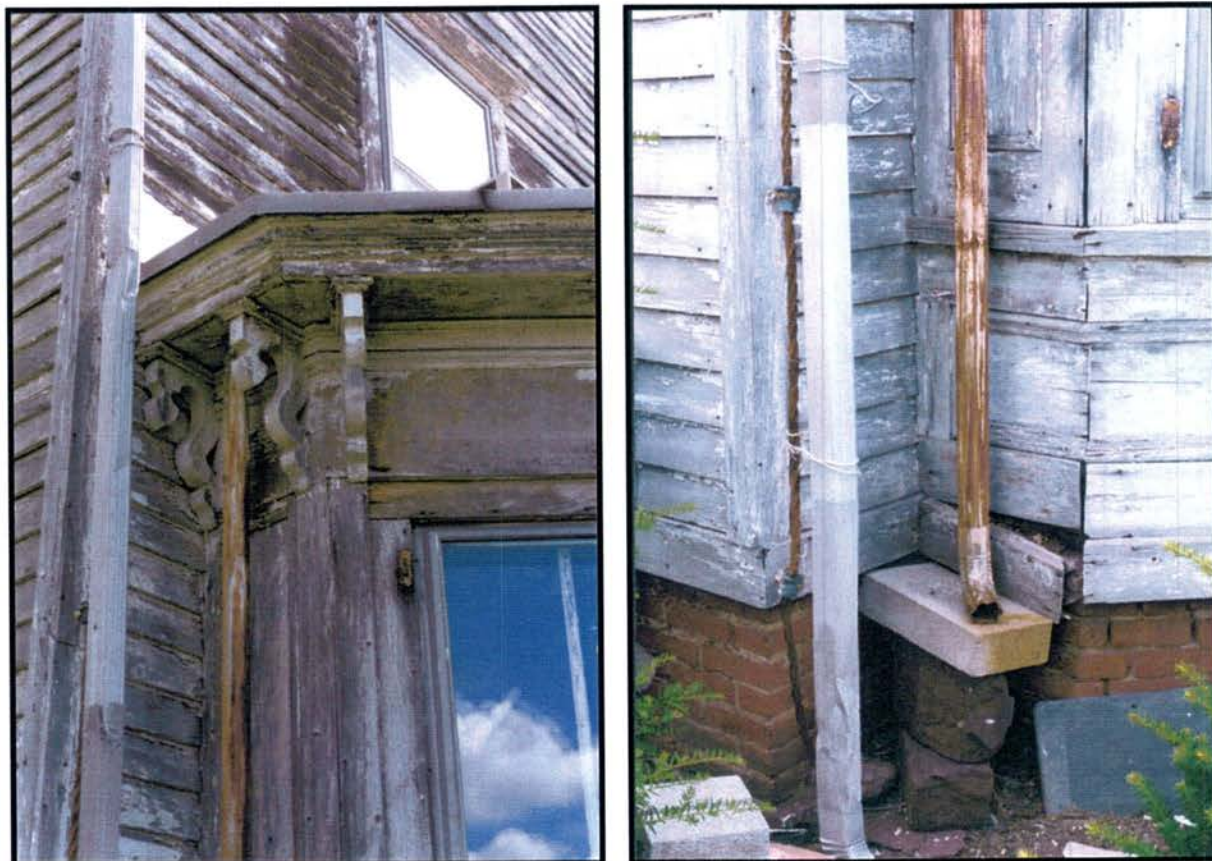
Details, above, of the oriel or bay window on the south side of the parlor show deterioration in the wood details, but fundamental soundness of the components.

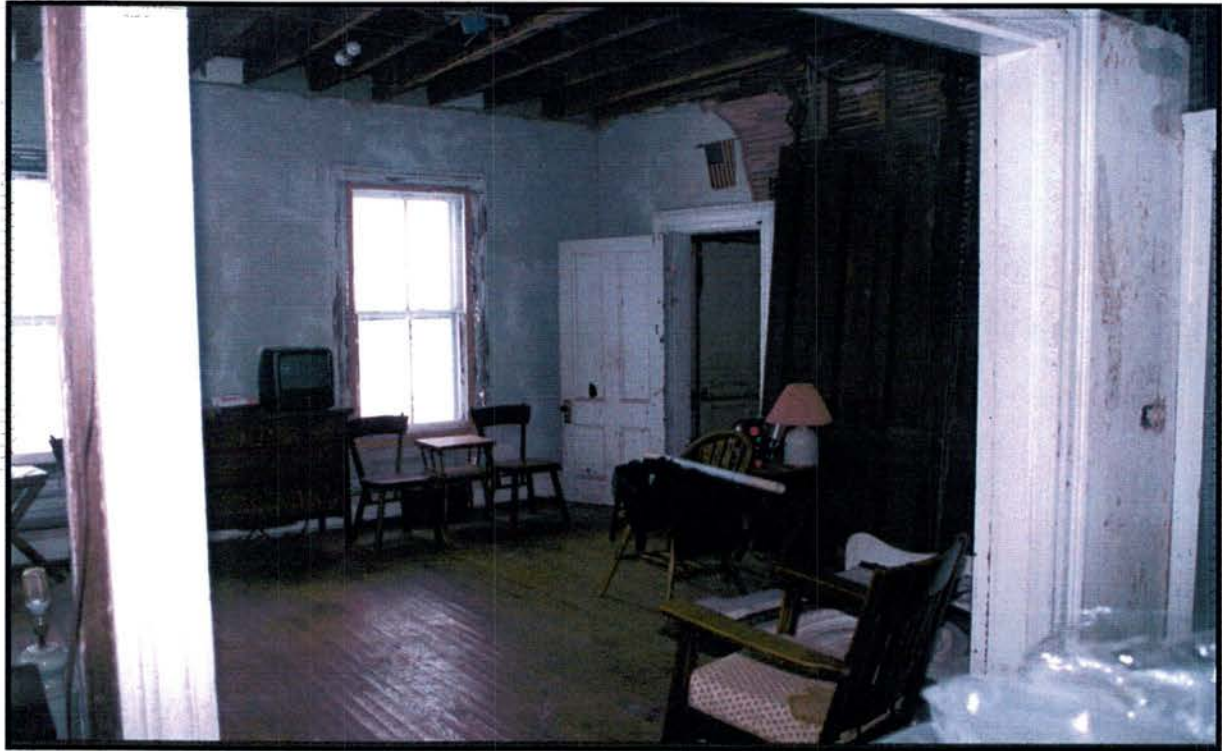
View of front parlor, 105, from rear parlor, 106, showing the open ceiling and partially stripped plaster walls.

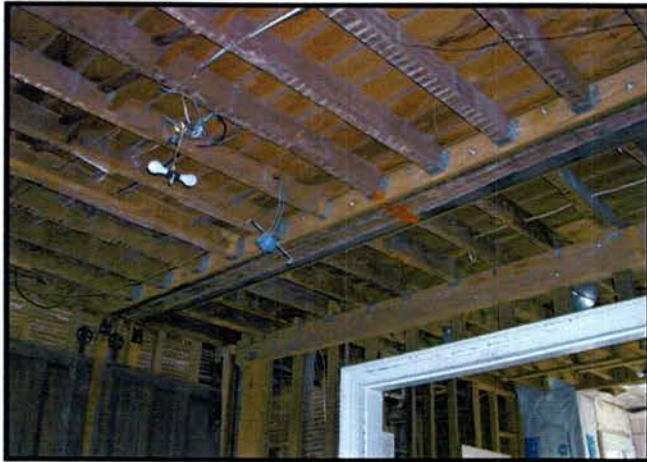
Left: ceiling framing in the front parlor, showing structural repairs made to existing floor joists and marks from old lath strips.

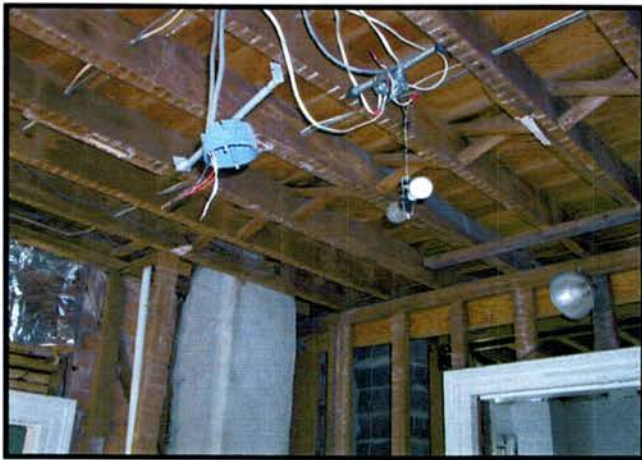
Left: ceiling in rear parlor, showing bridging and new electrical wiring as well as repairs to chimney and wall framing.

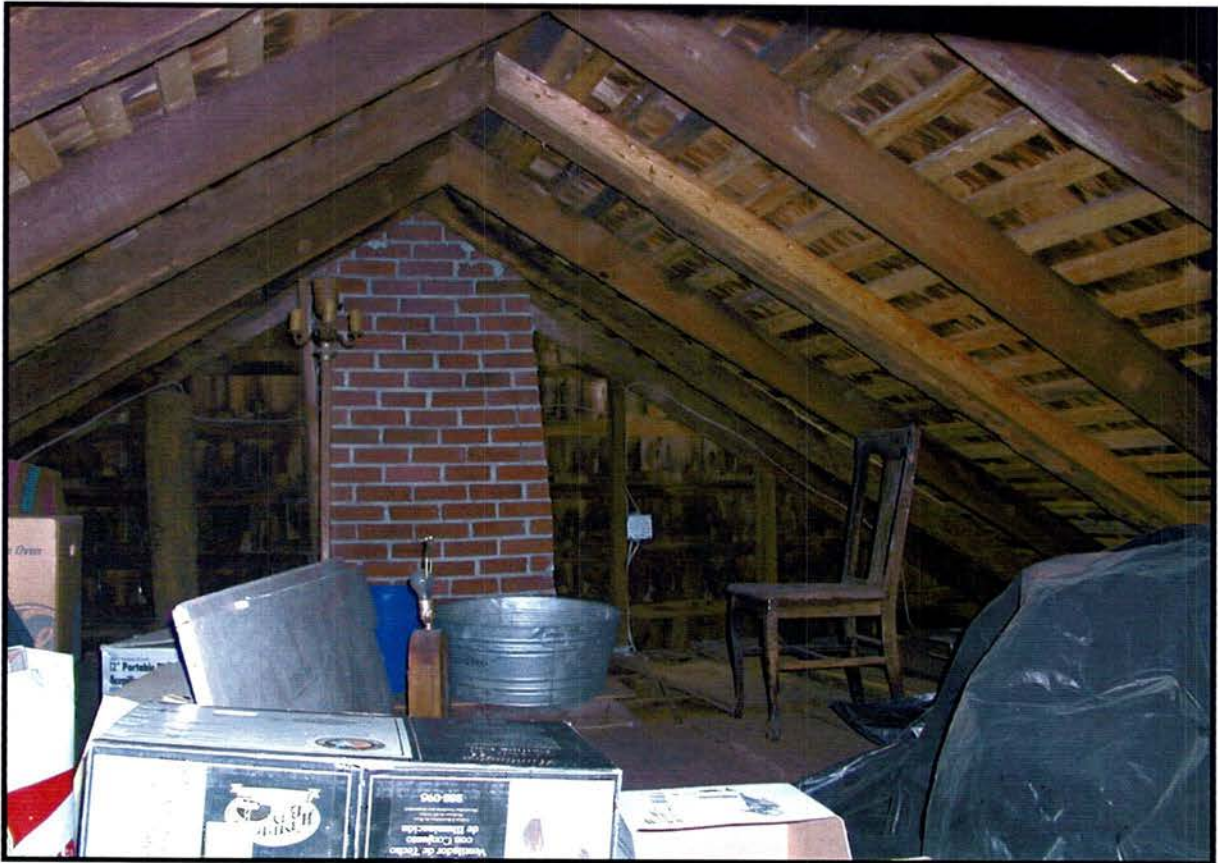
Attic of south (older) wing, showing sistered framing and re-used hand-hewn rafters. The chimney at the far end of the space was recently rebuilt.

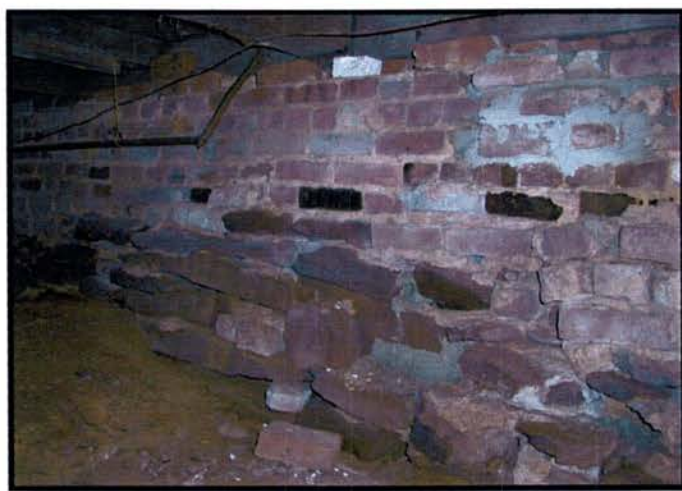
Below left: sandstone and brick foundation wall in crawl space. The wall shows evidence of at least two building campaigns. The earlier build employed only stone, laid with a soft lime mortar.

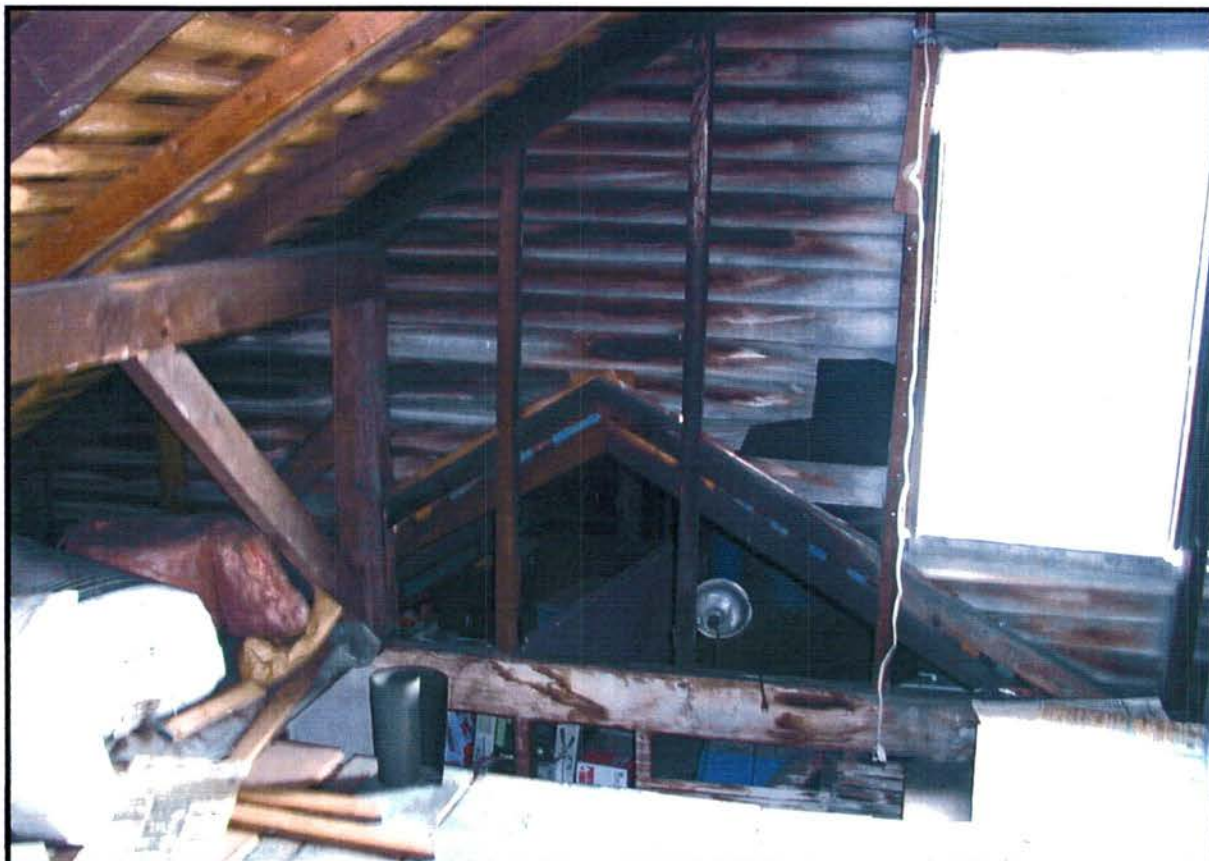
South wing attic, looking north toward roof join between the two builds. No evidence was found of a lower roofline at this juncture, but the current roof framing is exposed.
