Historic Structures Report
Wyckoff-Garretson House

Franklin Township, New Jersey

Volume II: Illustrations & Appendices

Mark Alan Hewitt, AIA
Architect

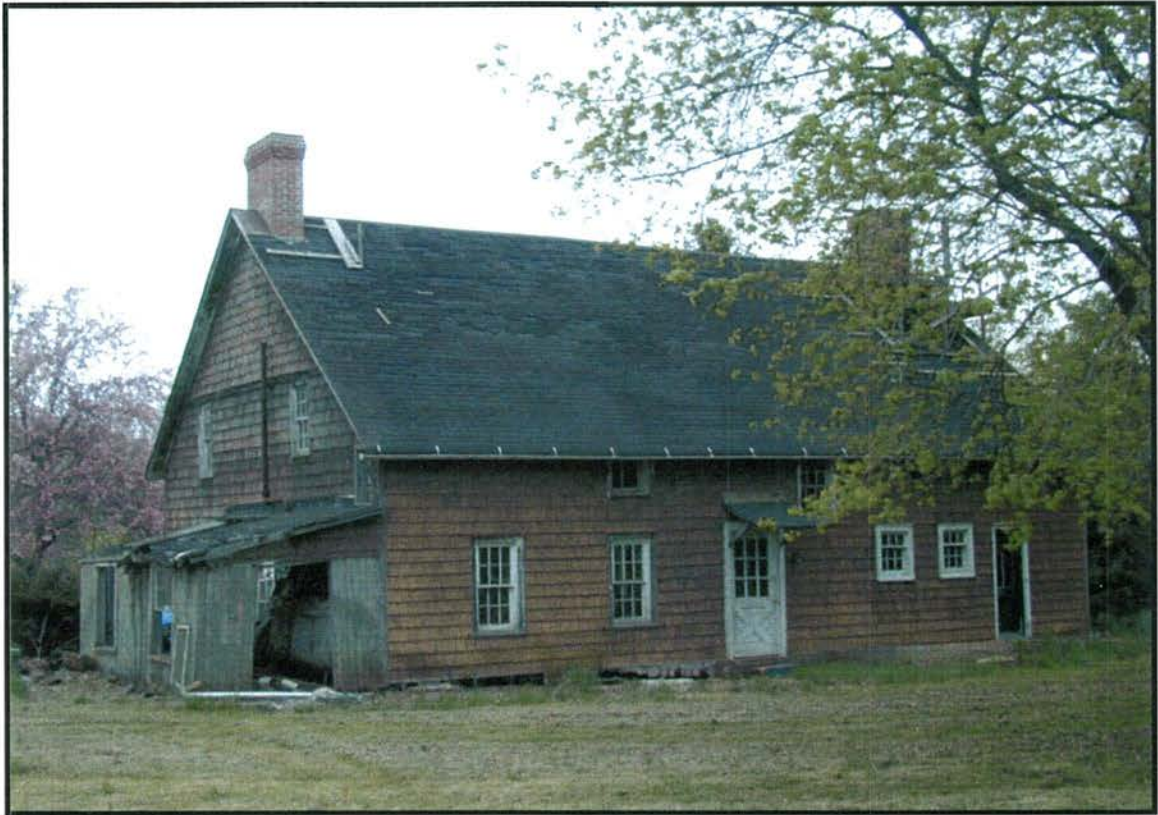
House from the northwest, showing lean-to addition that was removed during the study period.

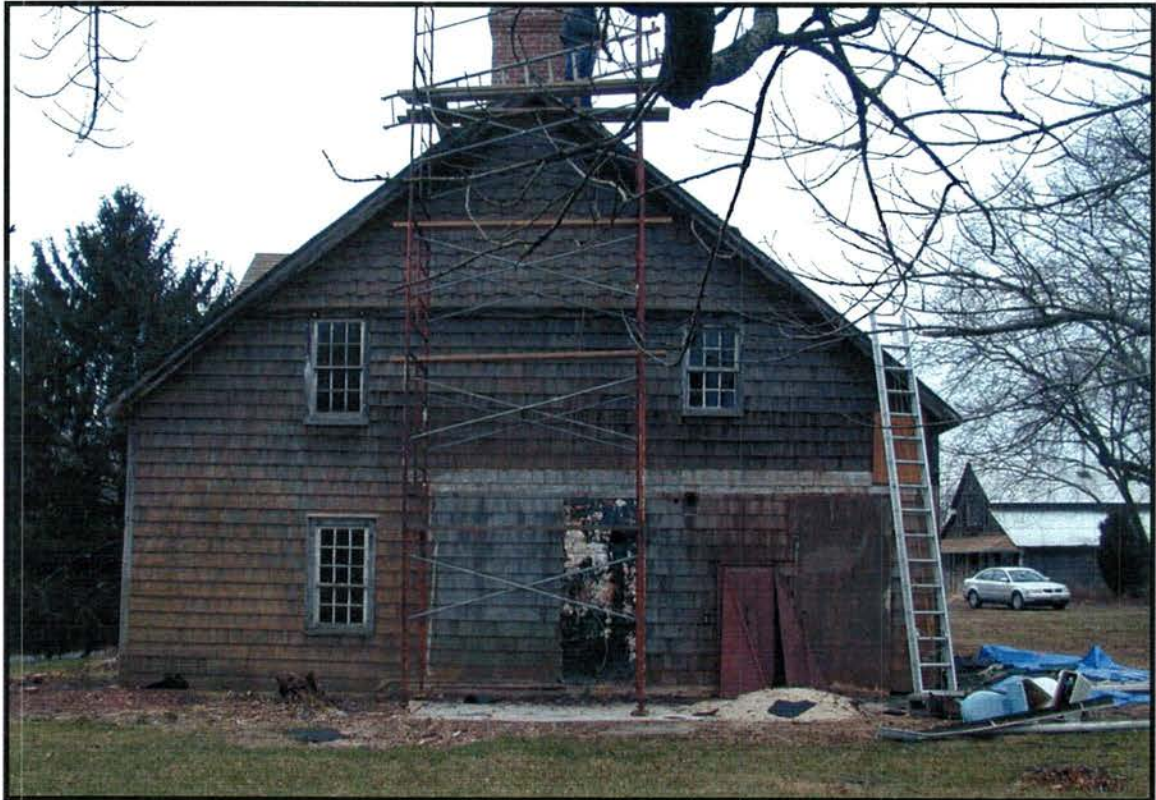
Similar view of north facade in late fall 2000, without the lean-to. Note the exposed chimney at the lower right, and former door.

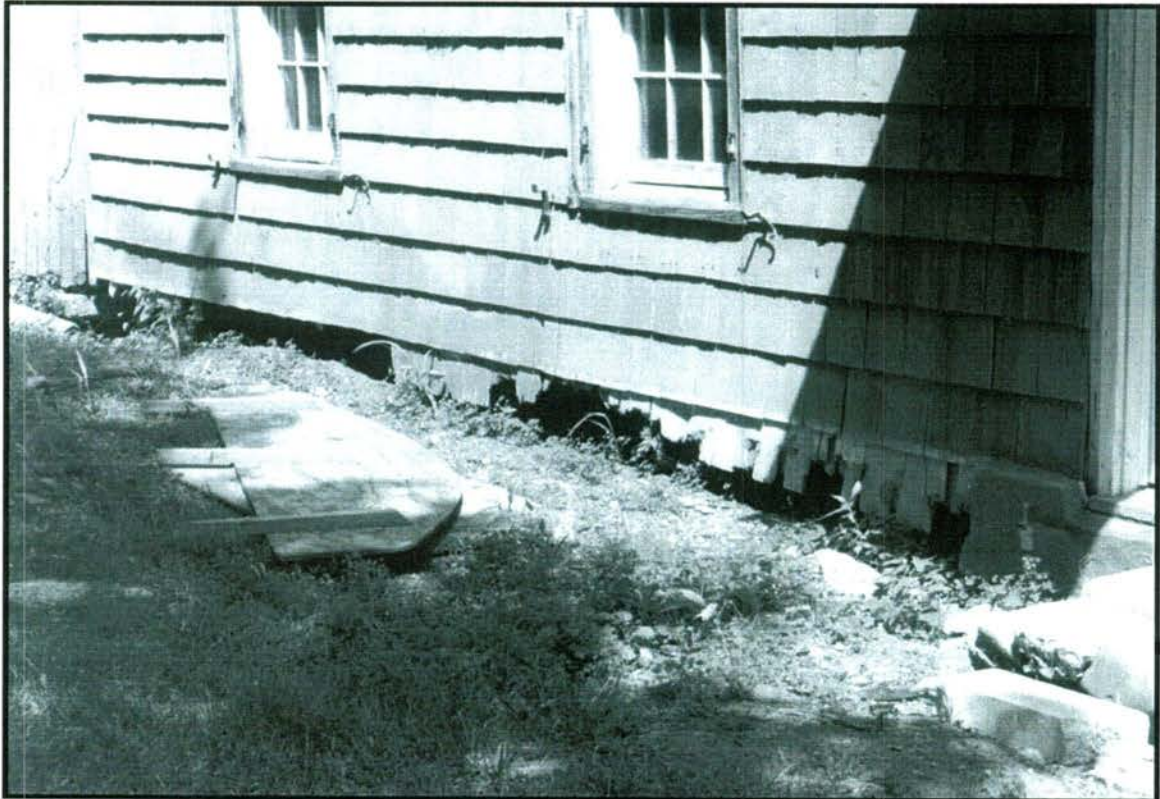
Close-up view of missing sill, foundation wall damage, and rotted shingles at base of west wall.

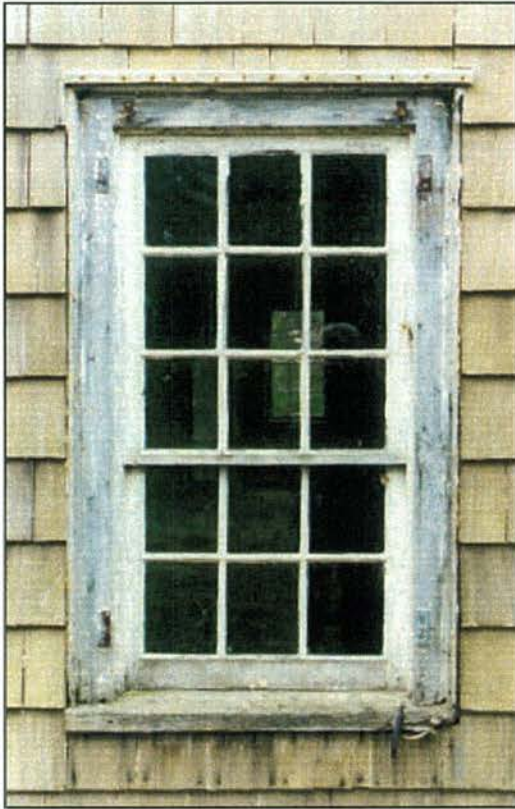
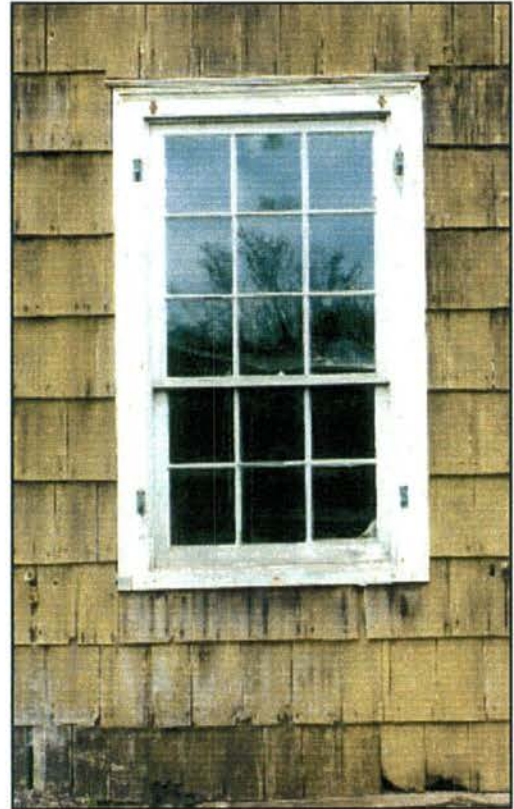
9 over 6 windows on the east facade. Modern galvanized shutter pintles and other hardware are mixed with earlier work. The windows are in fair condition and may be conserved.

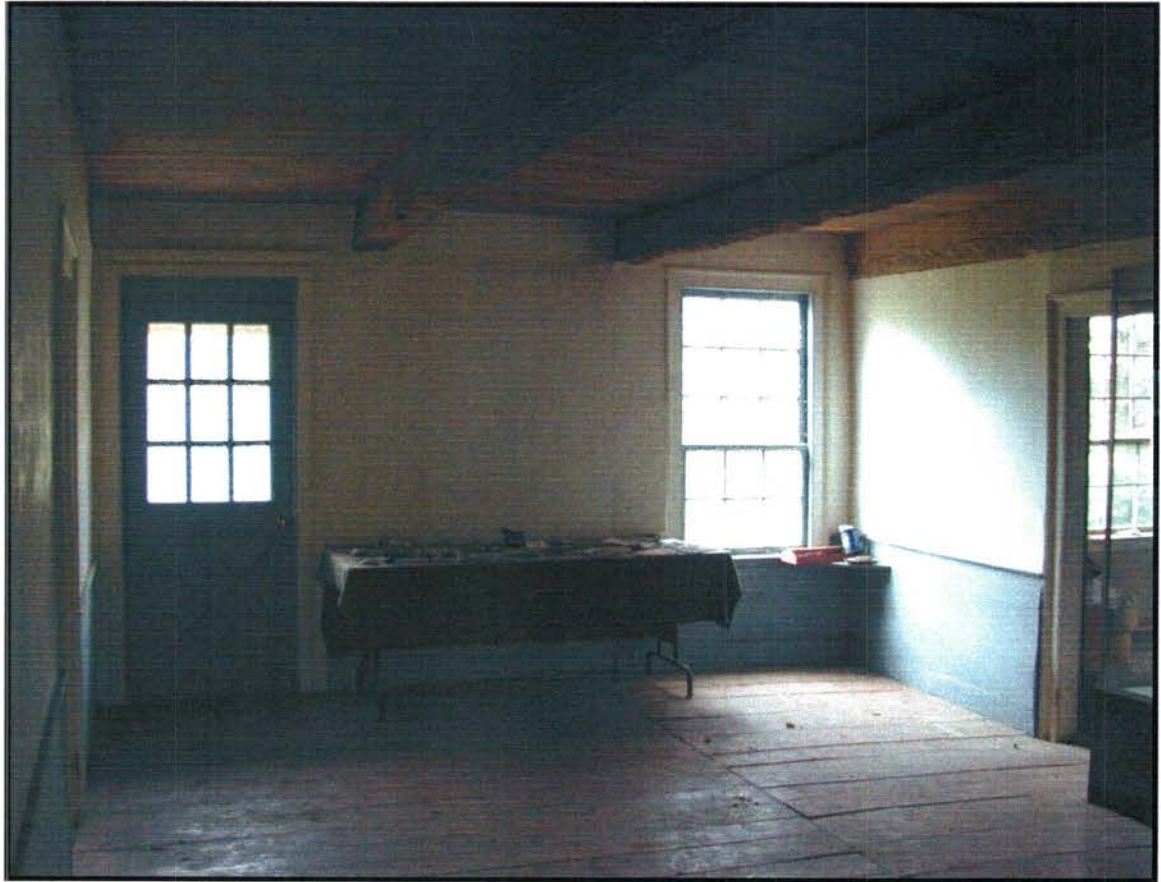
Room 104, Hall, looking east. The anchor beams were reduced in depth when a plaster ceiling was added. Note the break in the floor boards.

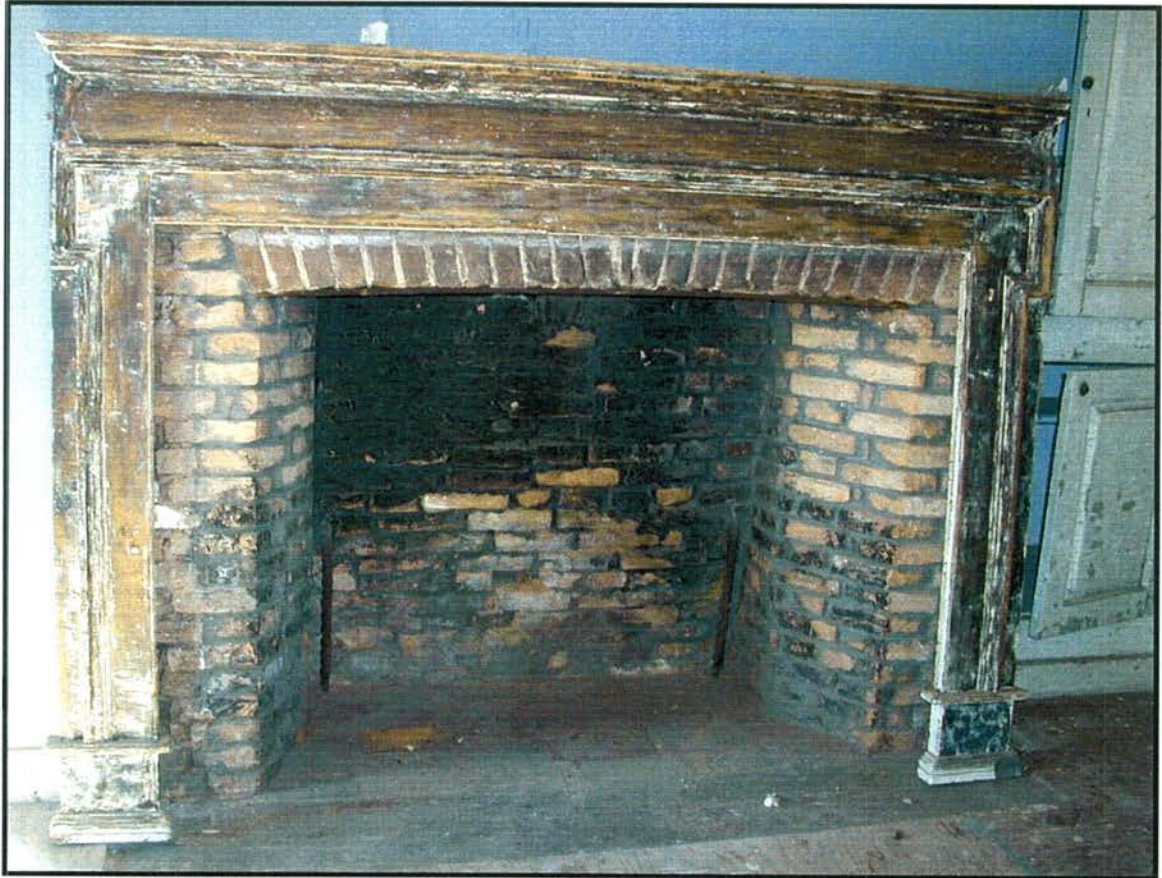
Room 103, fireplace opening and mantelpiece following the removal of sheetrock. The plaster line revealed that the mantel dates from construction of the English fireplace, c. 1750. The firebox post-dates the original build.

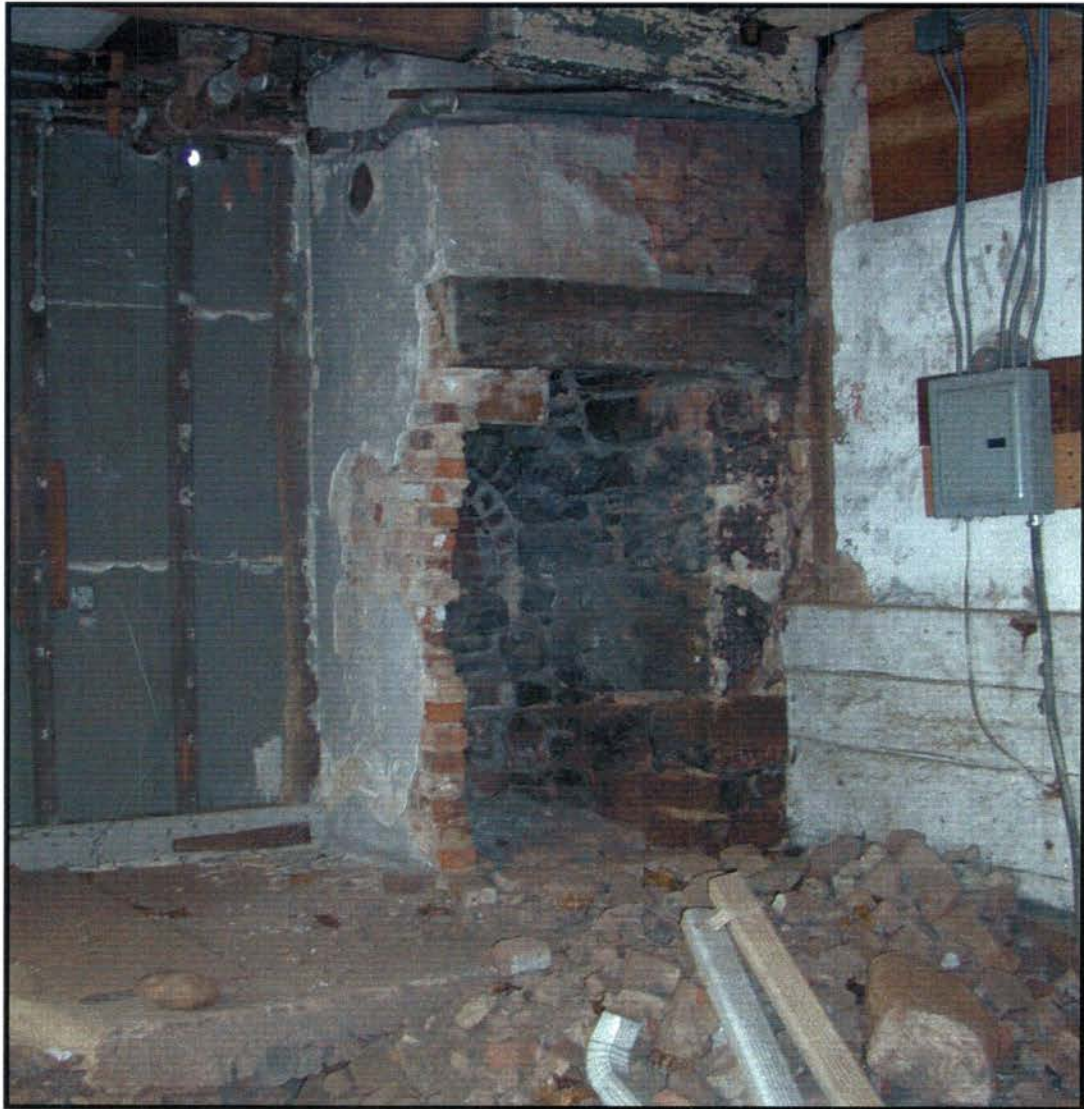
Room 102, former kitchen, looking north toward truncated cooking fireplace. The floor in this room was removed for foundation repairs ten years ago.

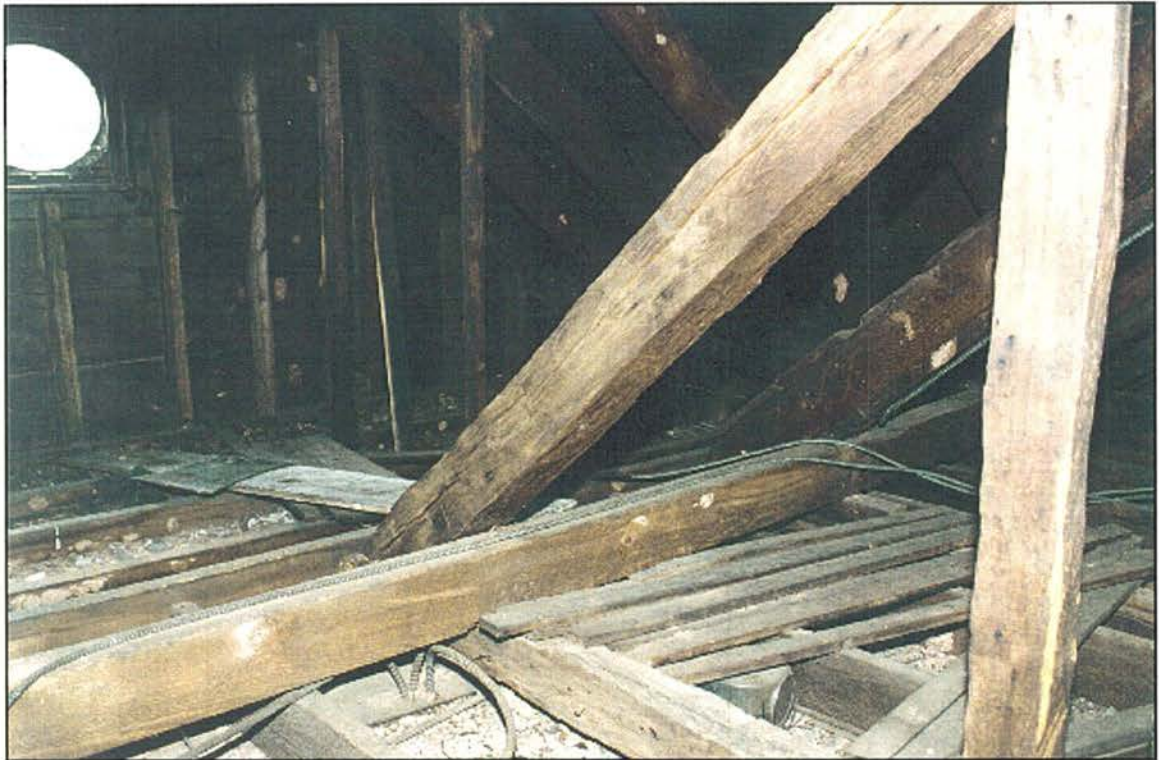
Room 301, attic, looking toward the modern dormer. The old rafter in bent number II remains in place in the foreground. The other framing is conventional lumber, in good condition. This dormer may be removed easily and the older framing re-established, since even the plate remains.

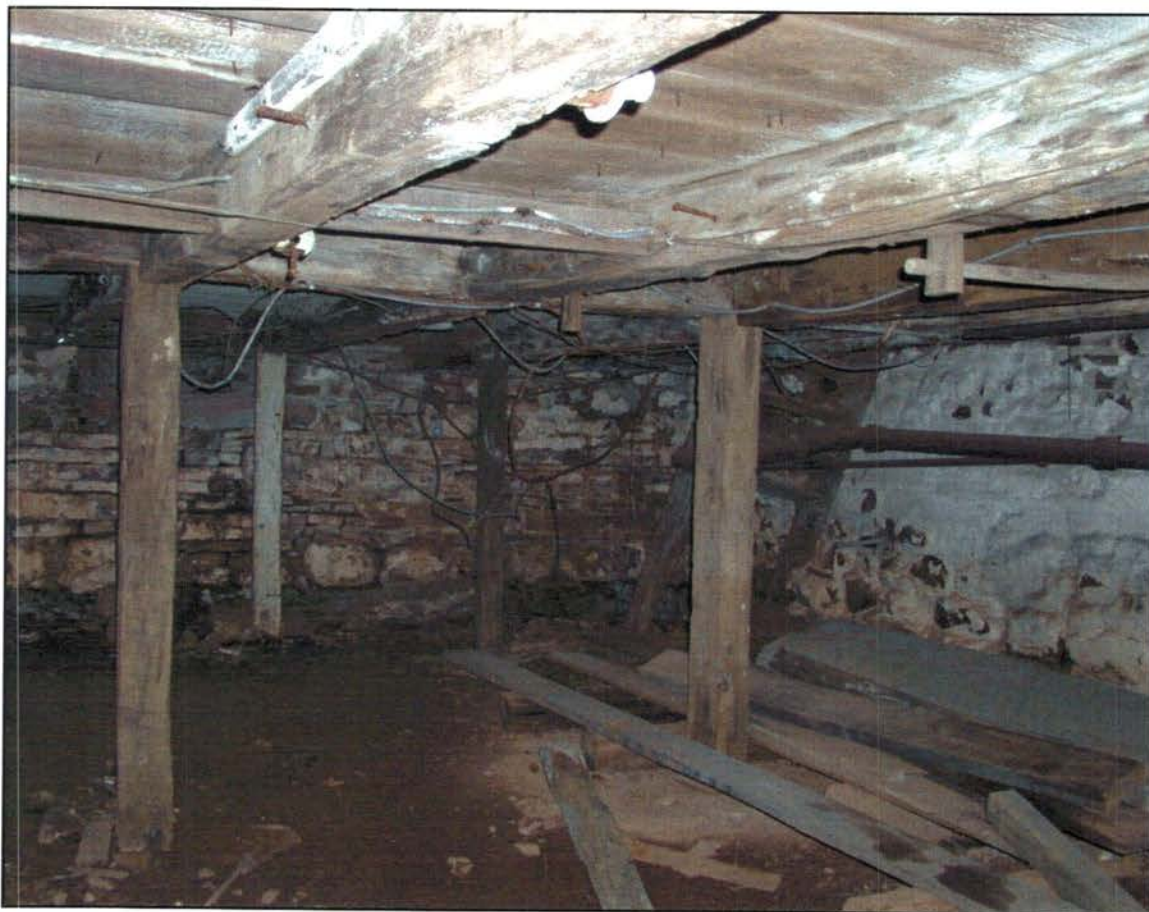
Cellar looking north toward join between first and second build. The walls show signs of whitewash, and are built directly on the shale bedrock. Posts have been added over the years to reinforce the floor above.

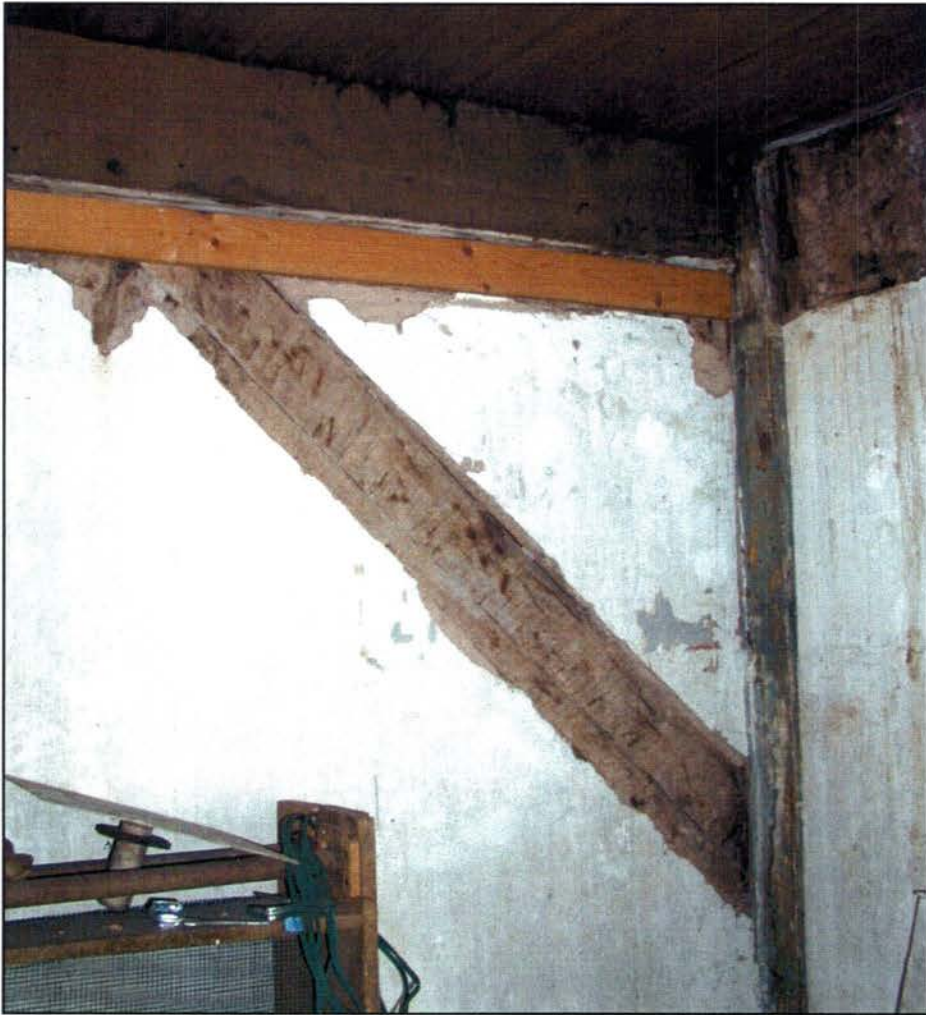
Room 100, view of corner post and diagonal brace at southwest corner. The upper board is a recent addition and will be removed.

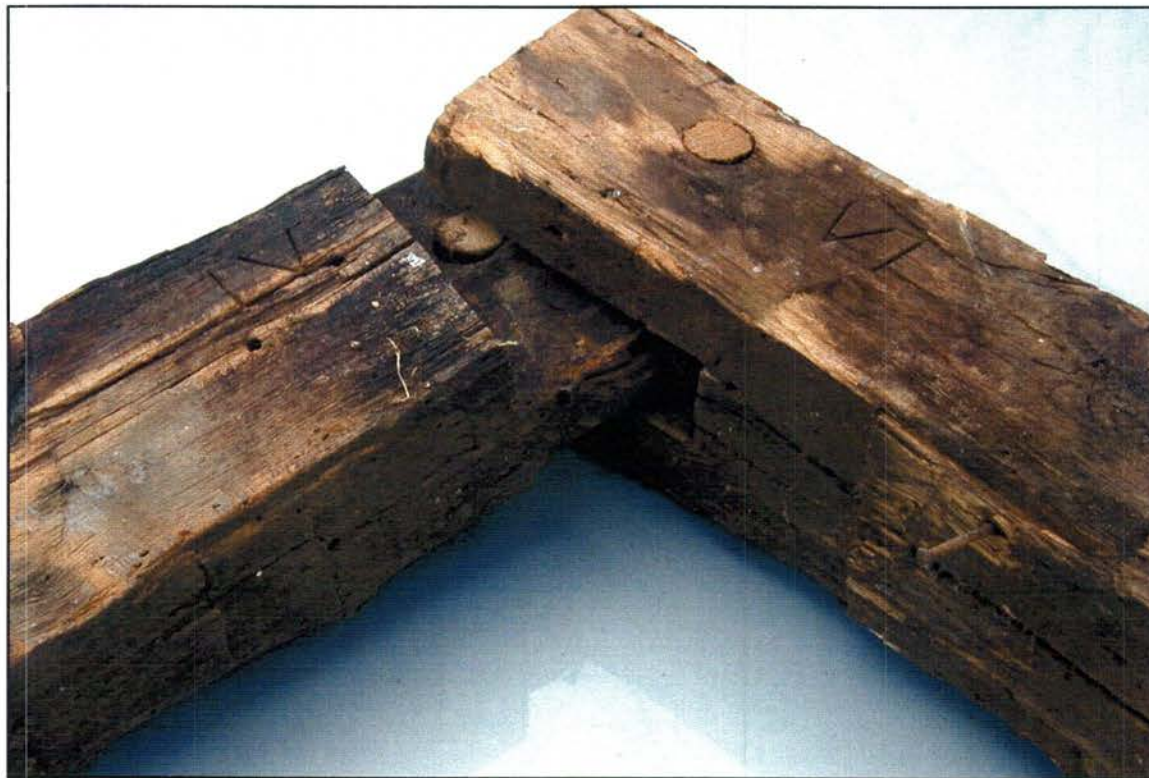
Detail of the apex of the rafters at bent number VI in the new, or Garretson build, following repairs to the joint by Island Housewrights. The Dutch carpenter here uses a scarf joint, rather than the more common half lap or bridle.

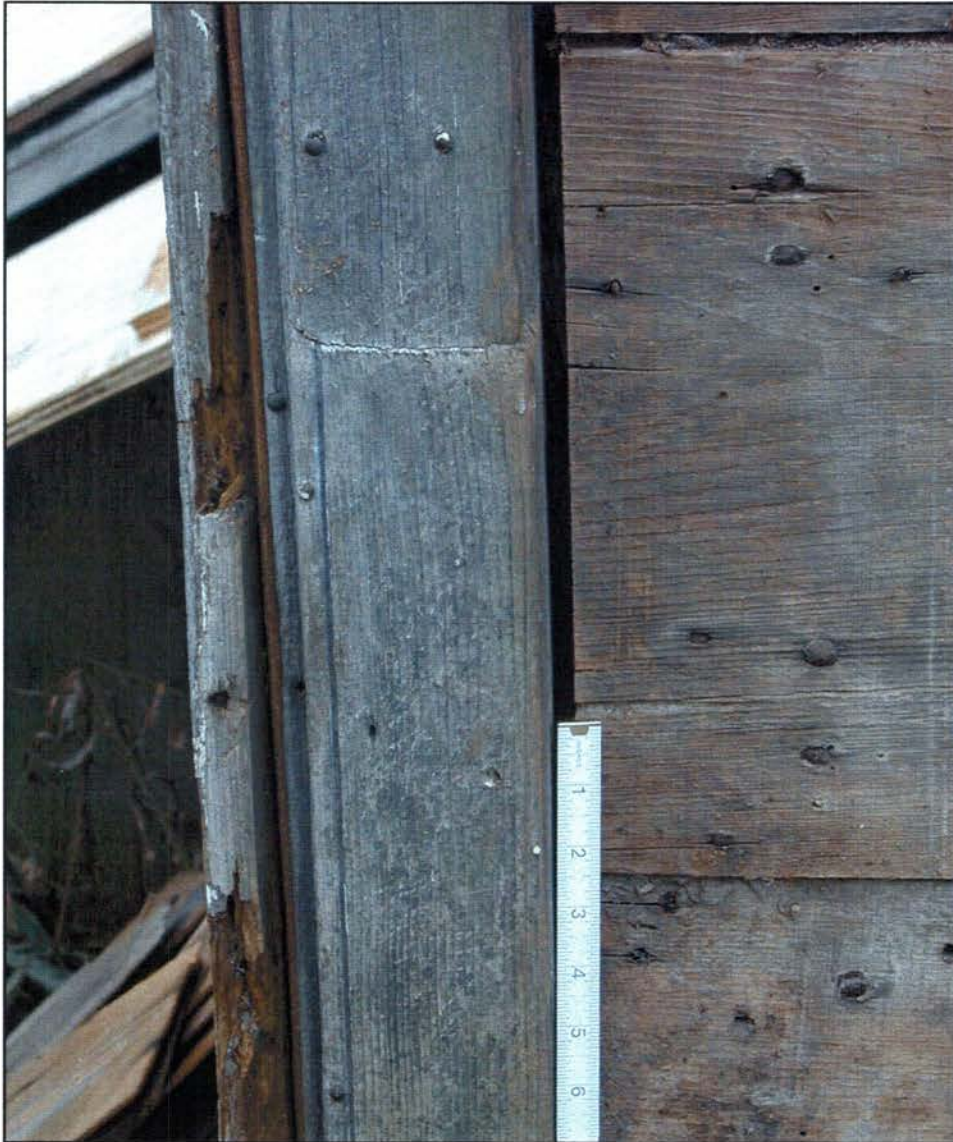
Detail photo showing the outside southeast-corner of the house. To the right are the shiplap boards of the original cladding. To the left is evidence of two kinds of shingles--larger handsplit types and the more recent 7" exposure.
