Historic Structures Report for **Symen Van Wickle House**

1289 Easton Avenue, Franklin Township, New Jersey

April 2019

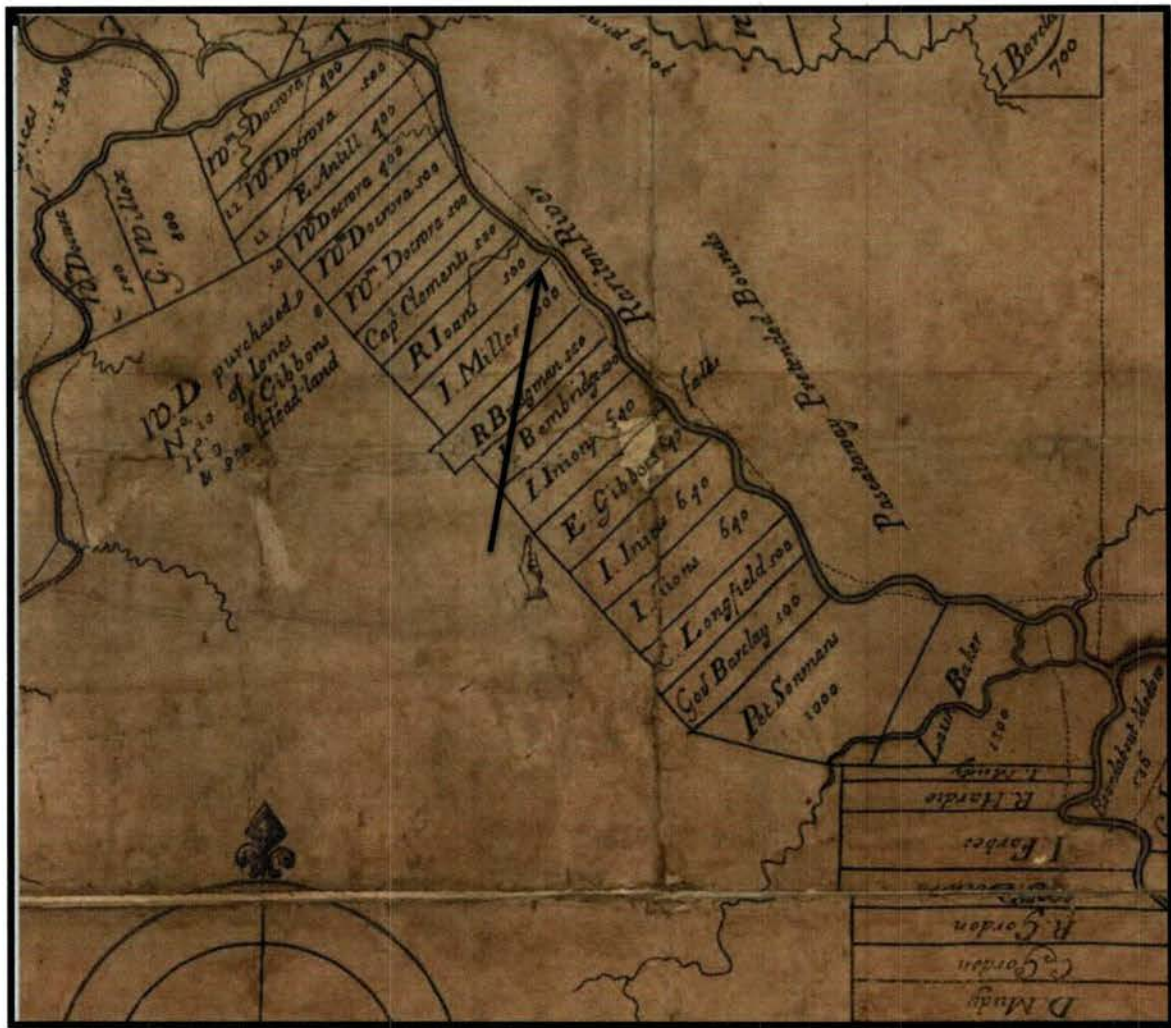
Figure 1. The 1685 map made by John Reid records the subdivision of land throughout the Raritan River region, giving each lot's acreage and owner's name, as is evident in this detail of lots fronting along the river. The abutting lots of "J Miller" and "R Jones," (subsequently known, respectively, as Lots 6 and 7), encompass the Van Duyn and Van Winkle farms. Present-day DeMott Lane approximately follows the boundary between the two.

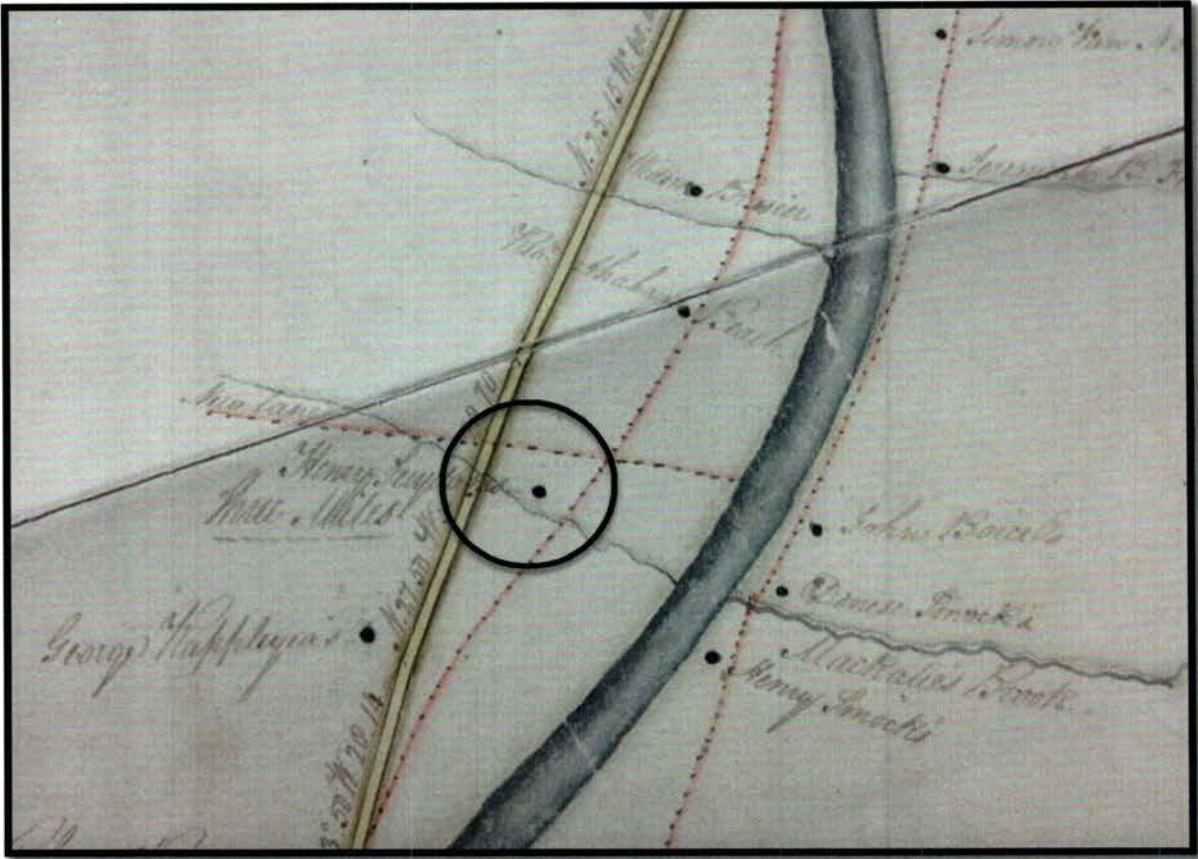
Figure 3. This detail of the 1807 survey map of the New Jersey (Easton) Turnpike depicts the dwellings of “Henry Suydam” and the “Rev. Abraham Beach”, as well as the old road along the river, abandoned by the construction of the Delaware and Raritan Canal in the 1830s subsequently replaced by the canal, and the “new lane” (DeMott Lane) survey in 1803.

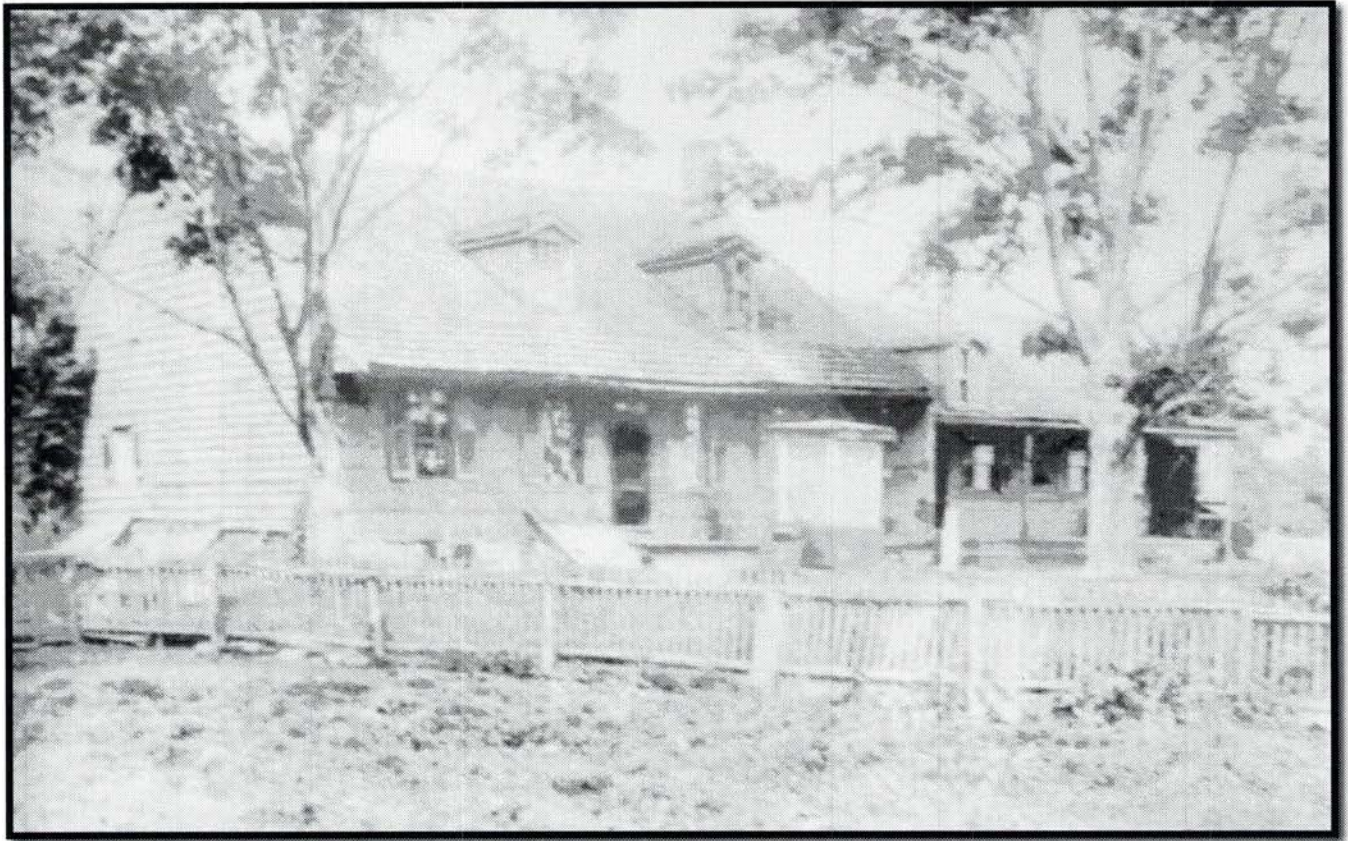
Figure 6. Van Wickle (Van Duyn) House, northwest view. This undated, but presumably late 19th or early 20th century photograph records the dwelling's appearance before the Colonial Revival renovations undertaken in the 1930s. The "fish-scale" shingles are clearly visible on the east front under the wide overhang, and the roof appears to be covered with wood shingles. A picket fence delineates the south side of the dwelling's dooryard, which feature a well curb with lattice-work enclosure.

the dormers visible in the c. 1900 photograph (Figure 6). The house was remodeled in the 1930s, at which time the west or rear façade became the front entrance, a large living room created from the main block's two east rooms and a stone terrace constructed along the main block's east front. The terrace features a stone inscribed with the date 1703, a mistaken commemoration of the acquisition of the subject property by Evert Van Wickle in that year. A sun porch/green house was added on the south end of the main block during the 1950s, and sometime during the second half of the 20th century, the upper story of the main block was converted into an apartment.

wood shingles); the gable dormers (two on each side) evidently date to the later 19th century (Figure 6).

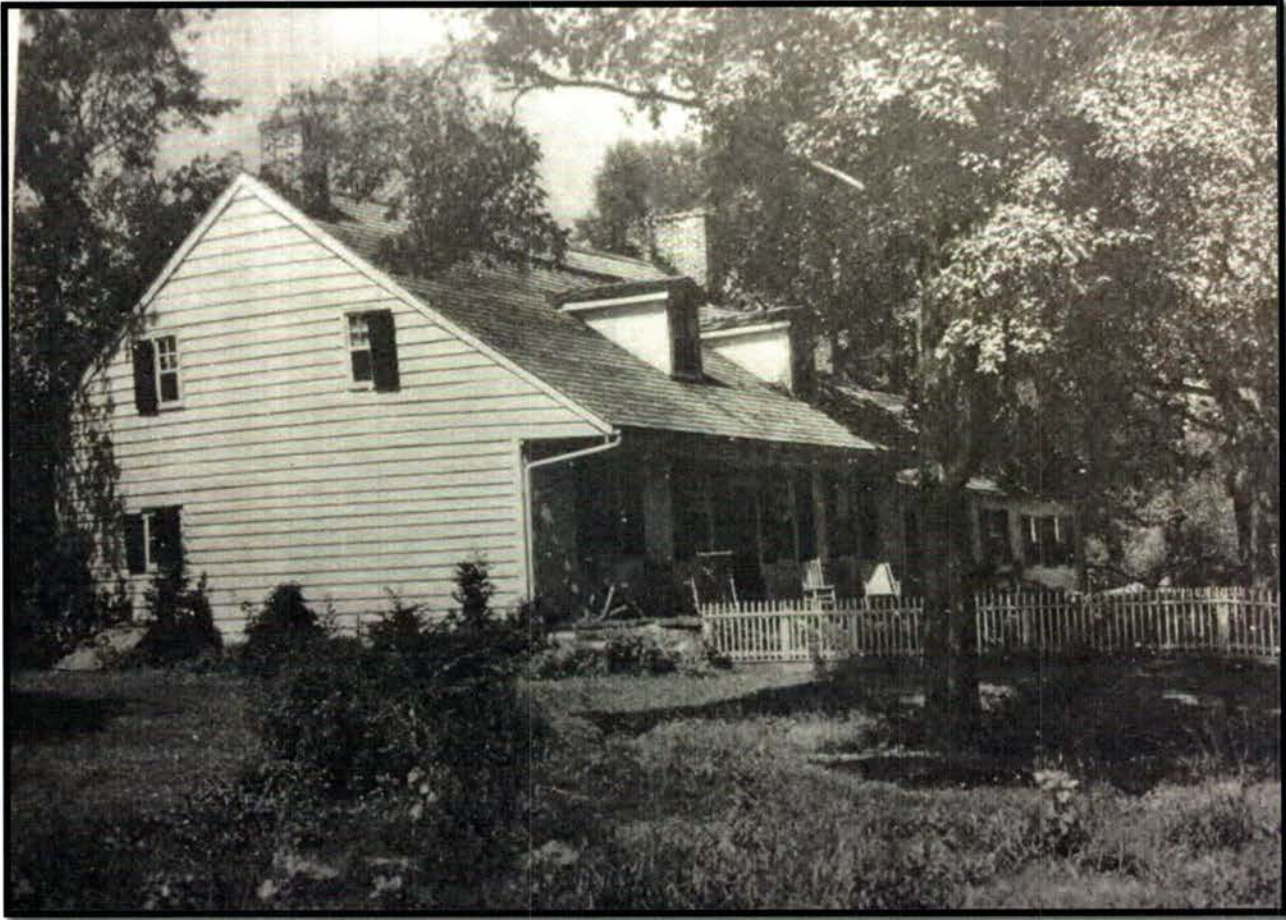
Figure 7. Van Wickle (Van Duyn) House, northwest view. This early 1930s photograph documents the dwelling's appearance after the renovations designed by architect George B. Howell, as part of which a terrace was added across the east façade and former back door on the west façade became the main entry.

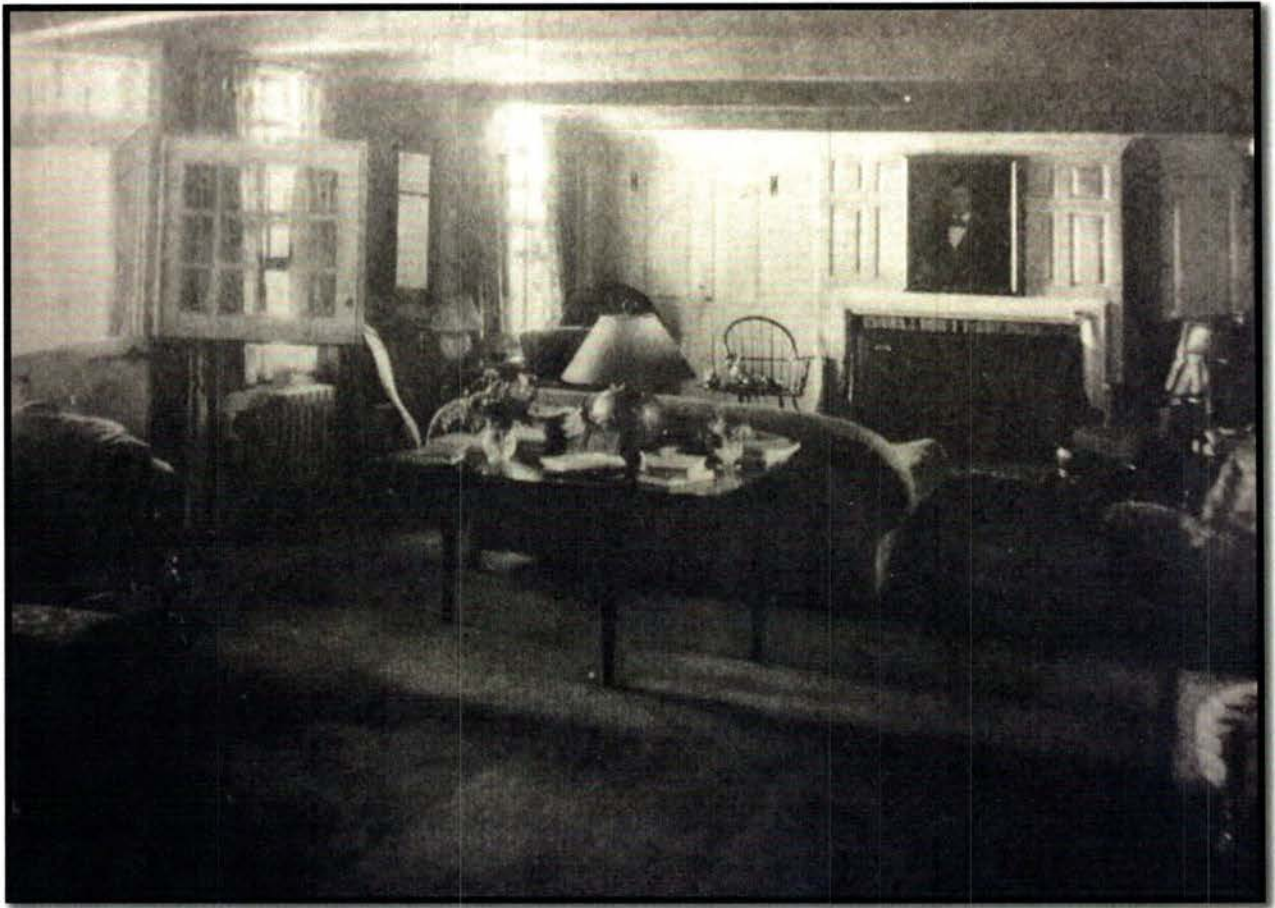
Figure 8. Van Wickle (Van Duyn) House, living room (Room 103), southeast view. In the 1930s renovations, the partitions dividing the east rooms and central hall were removed, creating one large living room across the south front.

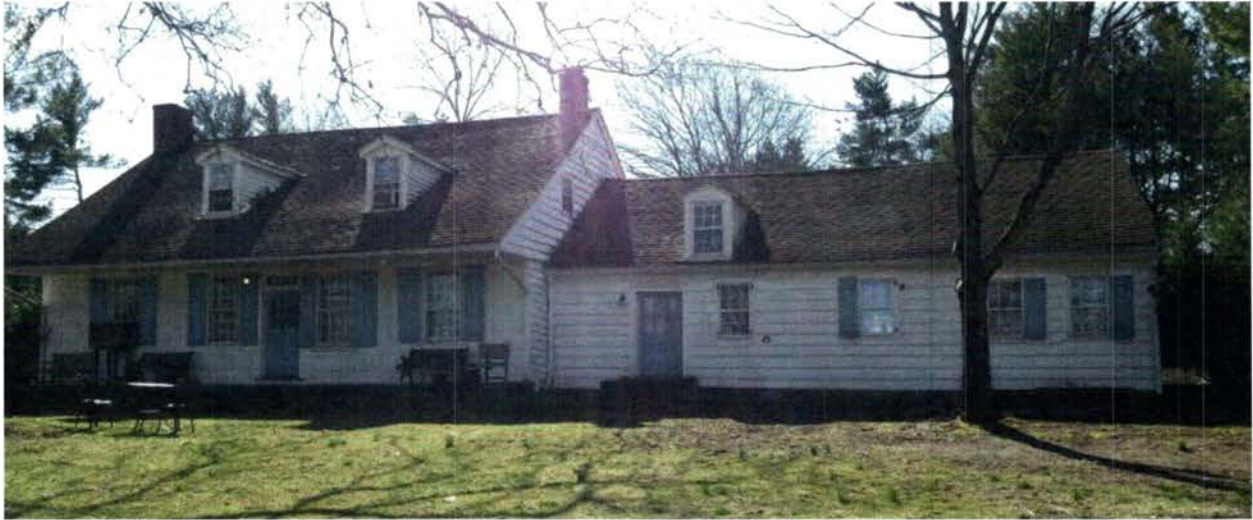
Photo 01: Main elevation with Builds A1, A2, B and C shown from left to right, as viewed looking west (from the Delaware & Raritan Canal and the Raritan River).

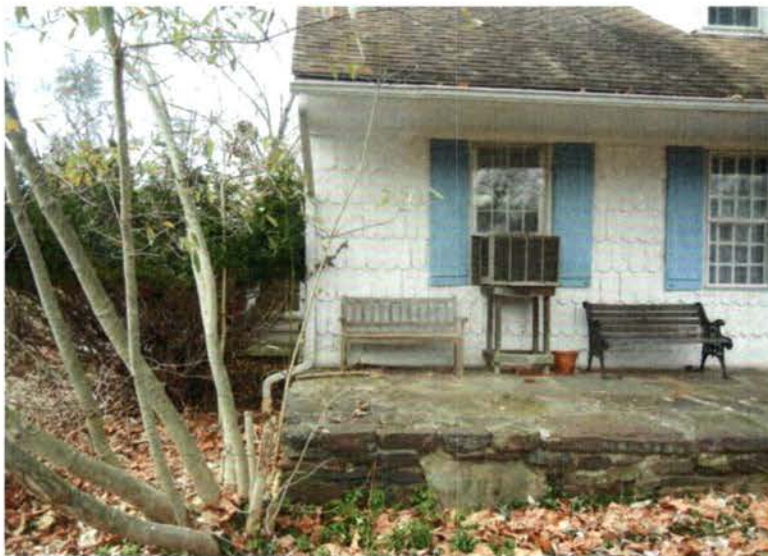
Photo 02: East elevation of Build A1 and detail of southeast corner of house terrace with the date stone indicating 1703.

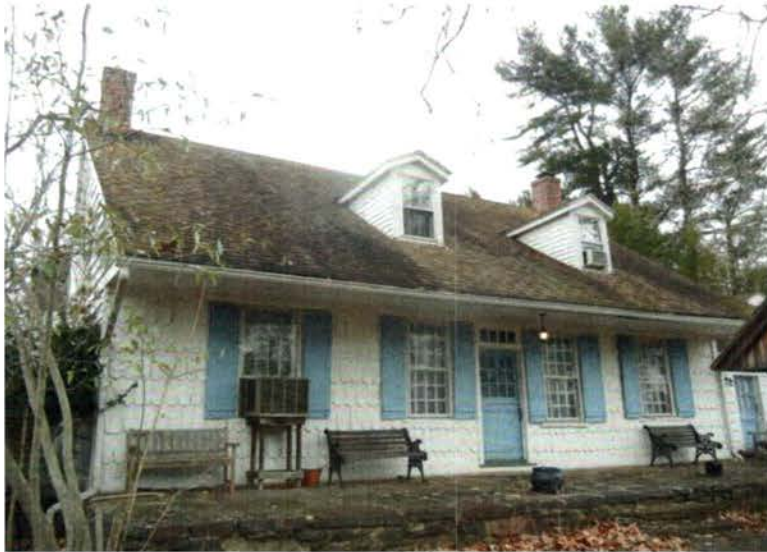
Photo 03: East elevation of the main block (Builds A1 and A2) with its distinctive round butt shingles and overhanging roof.

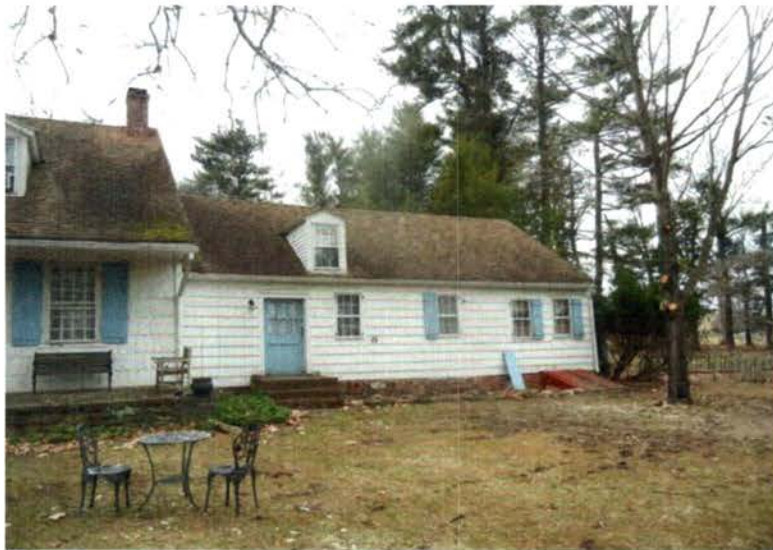
Photo 04: East elevation of Builds B and C. The shutters (here and above), the brick stoop and the metal areaway basement entrance door postdate the HABS drawings of the 1930s.

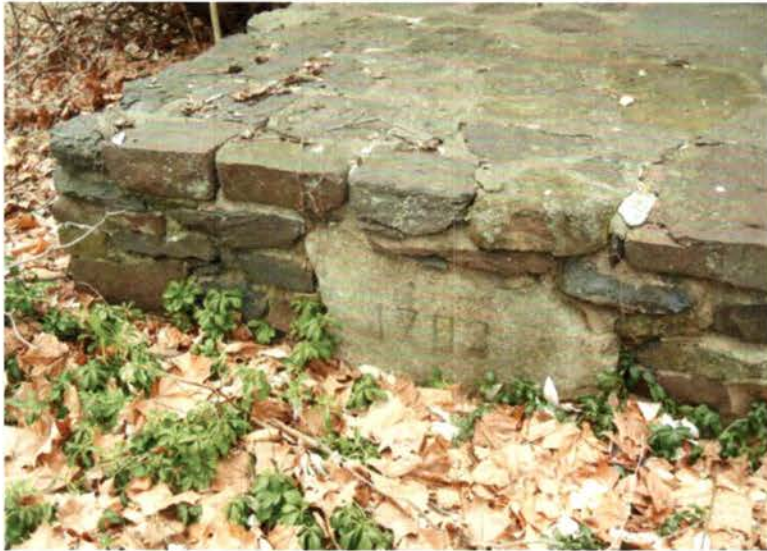
Photo 05: East elevation and detail of the 1703 date stone, part of the 1930s terrace.

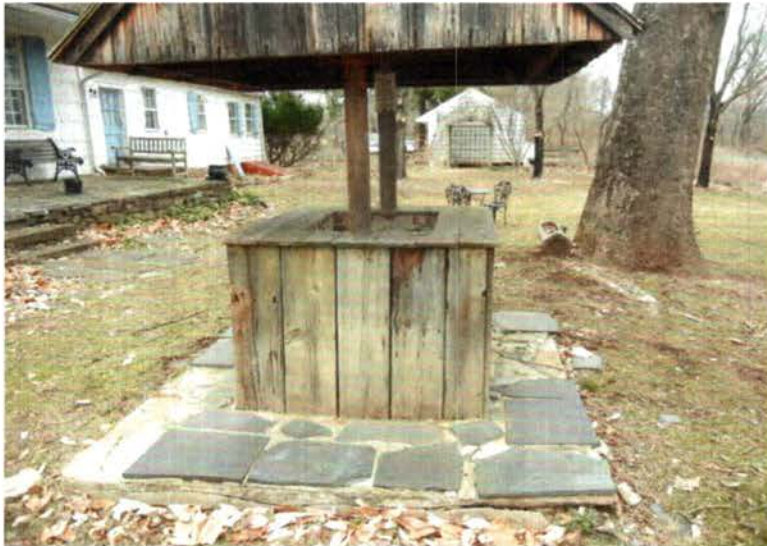
Photo 06: Existing wellhead, a 20th century construction, to the east of the house.

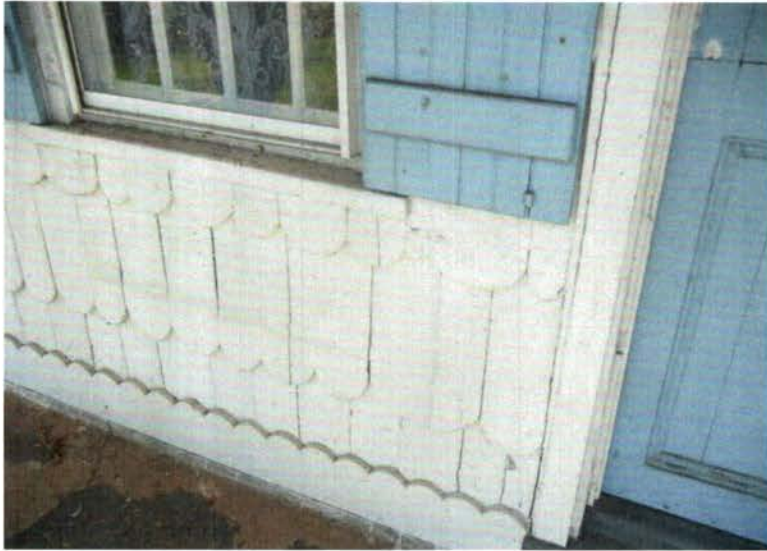
Photo 07: Detail view of east elevation of Build A1 at terrace where the round butt shingles terminate. The scalloped board is not original and partially conceals the bottom row of original shingles.

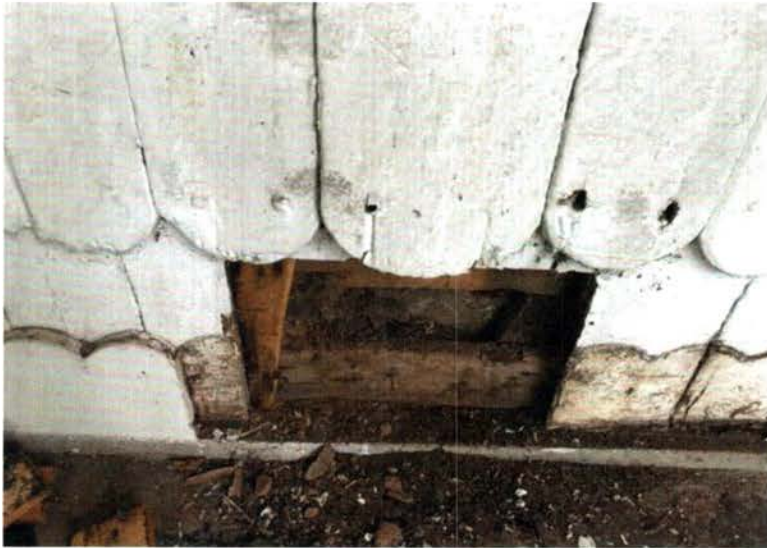
Photo 08: A probe location at the elevation of Build A reveals repairs that likely date back many decades. The heavy timber sill that would have located here was replaced by poured-in place concrete.

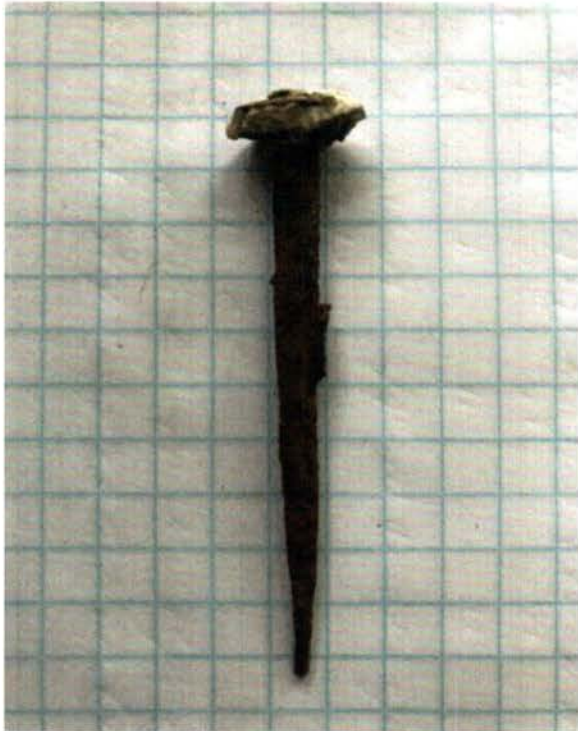
Photo 09: Hand wrought nail used to secure original round butt shingles to the east elevation of Build A, approximately 2-1/2" long.

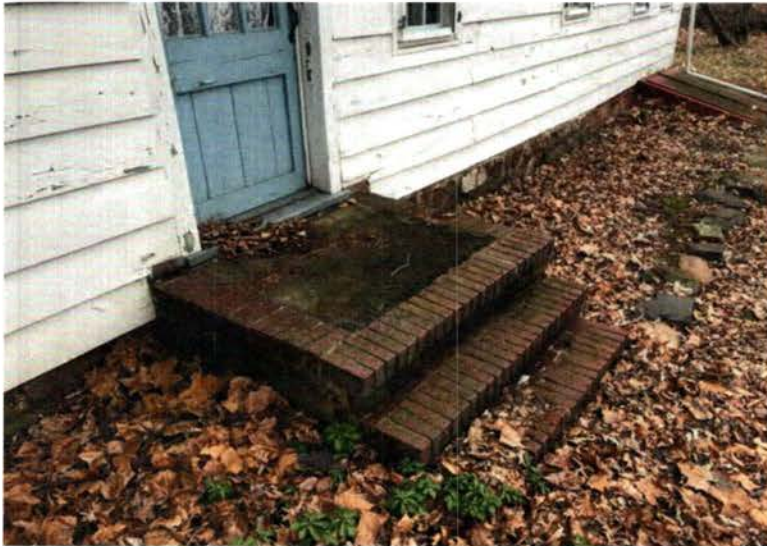
Photo 10: Brick and concrete stoop to the Dining Room door (Room 107), a change that postdates the HABS drawings, at the east elevation of Build B.

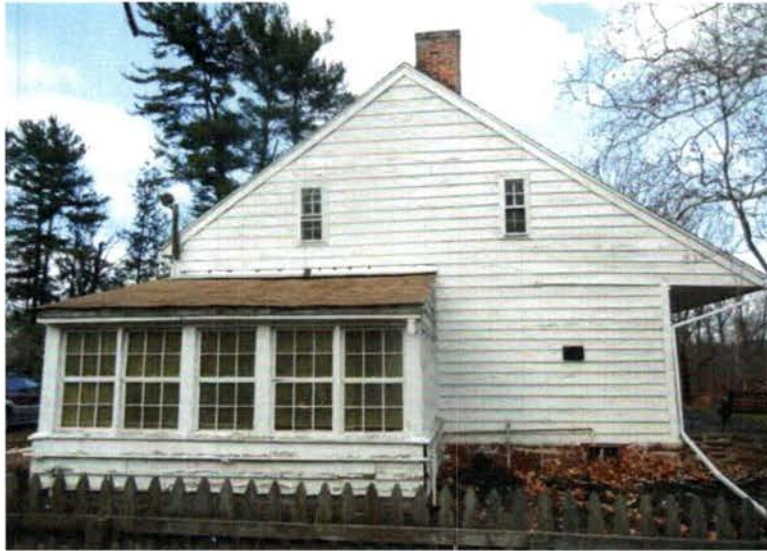
Photo 11: Overall view of the south elevation. The protruding "hothouse" addition was built in the mid-20th century.

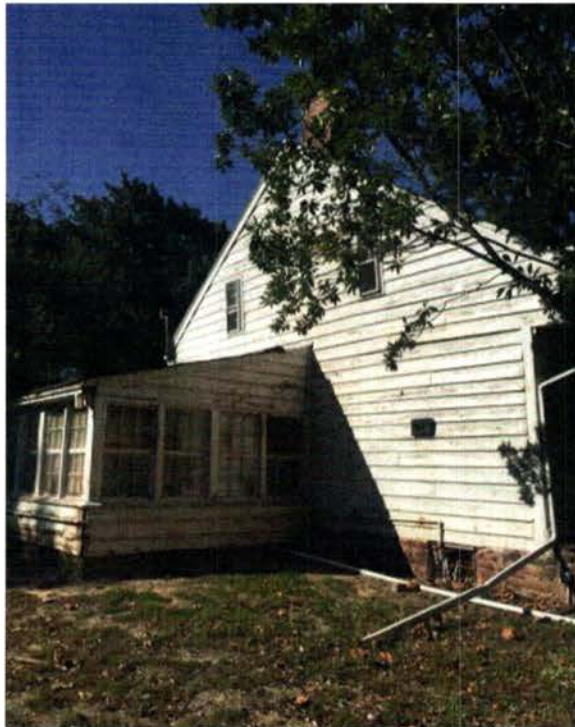
Photo 12: View of the south elevation looking northwest. The window in the stone foundation, currently blocked, is only one of two windows that provide the cellar and crawlspaces with natural ventilation.

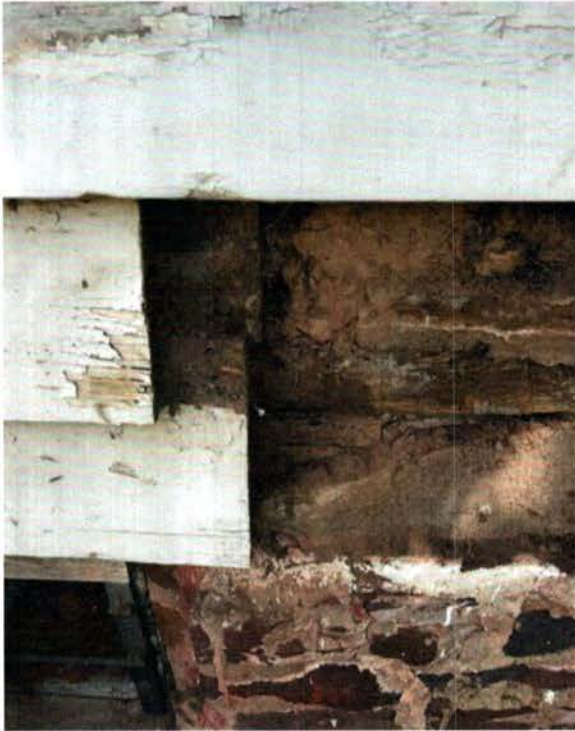
Photo 13: A probe location at the lower right corner of the south elevation (near terrace).

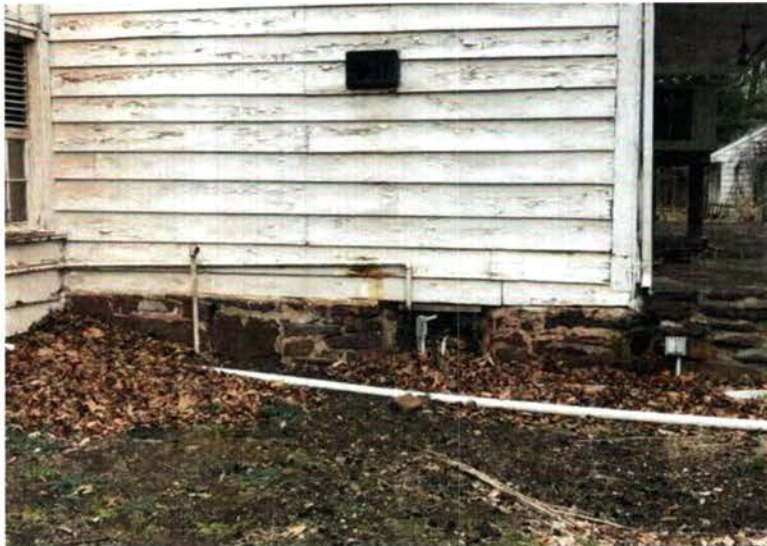
Photo 14: Same location at the south elevation where it meets the flagstone terrace prior to the probe. The black rectangle mounted on the clapboard is the thru-wall side vent of the boiler in Mechanical Closet (Room 103A).

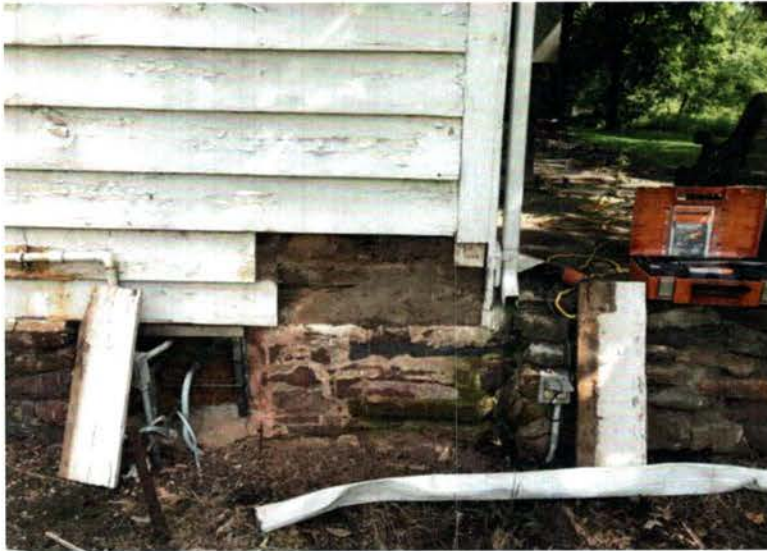
Photo 15: Like the location at the terrace, this probe at the south elevation reveals repairs that likely date back many decades. The heavy timber sill has been partially replaced with poured-in place concrete.

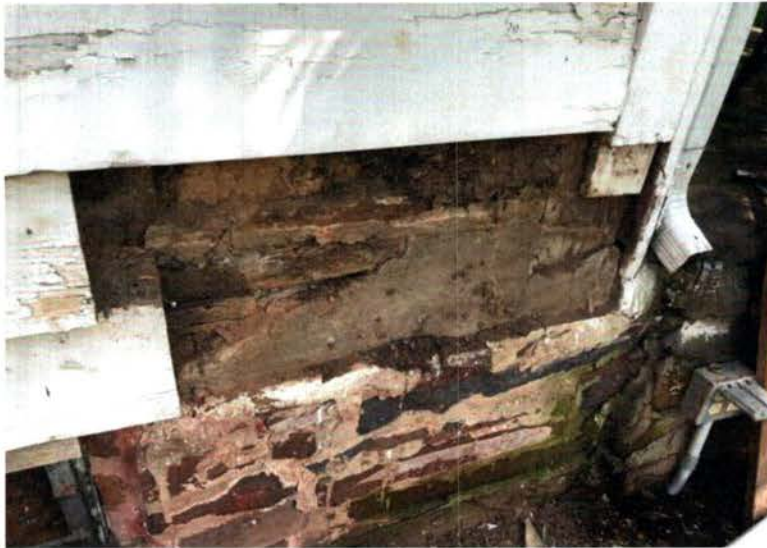
Photo 16: The intermediate stud at the left of the probe opening still has its Roman numeral markings.

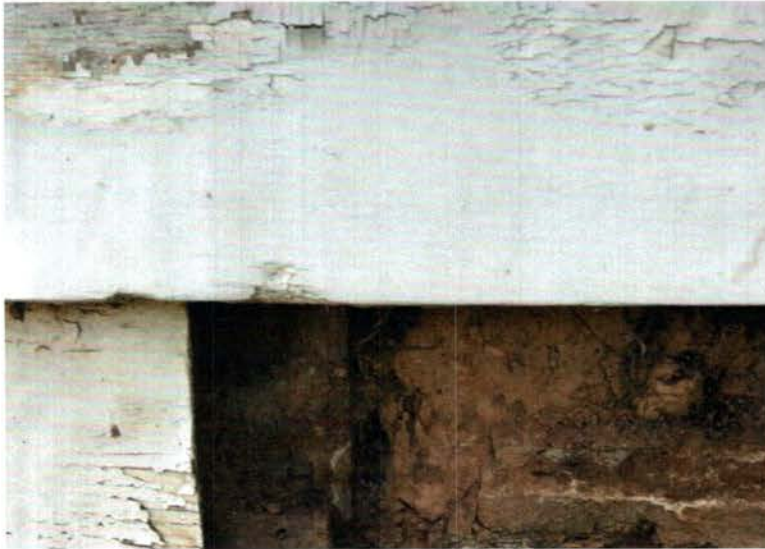
Photo 17: The clapboard siding on the lower portion of the south elevation, like much of the building's exterior, is not original.

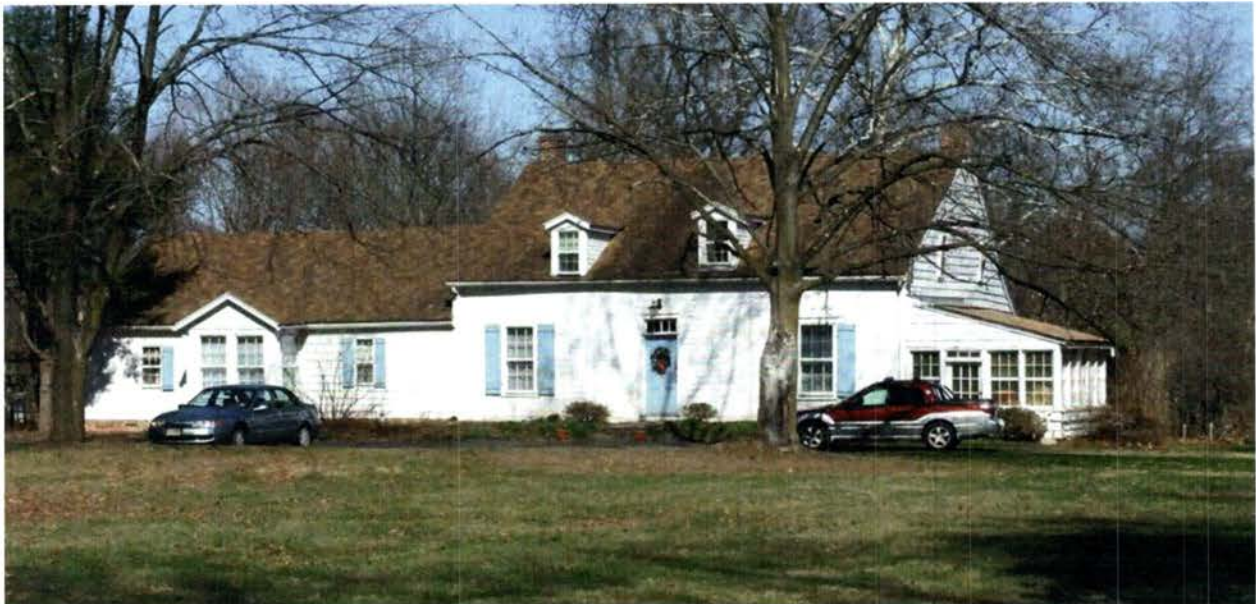
Photo 18: Overall view of the house's west elevation, looking east in the direction of the Delaware & Raritan Canal and Raritan River, with Builds C, B, A2, A1 and D shown from left to right. The current main entrance, Door A, is at the center of the main block and would be adapted to provide ADA/Barrier-Free access. Build D, the hothouse, would be demolished.

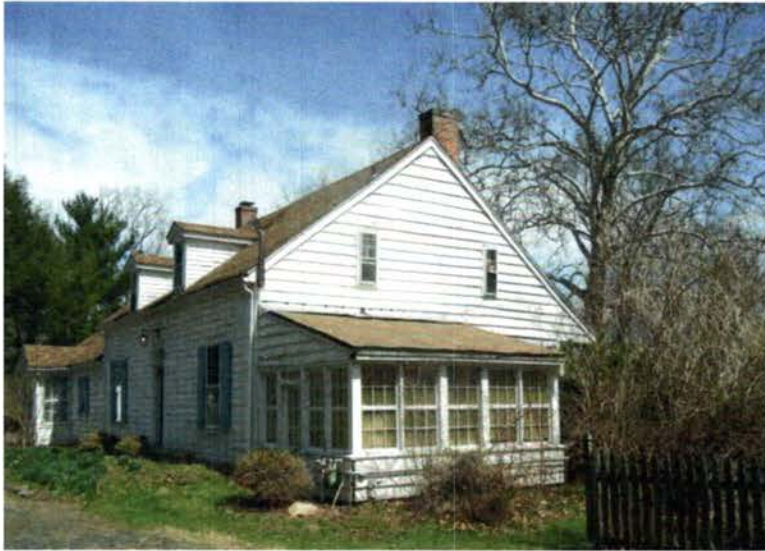
Photo 19: Overall view of the south and west elevations. The hothouse addition on the south elevation and the projecting bay window on the west elevation are later additions.

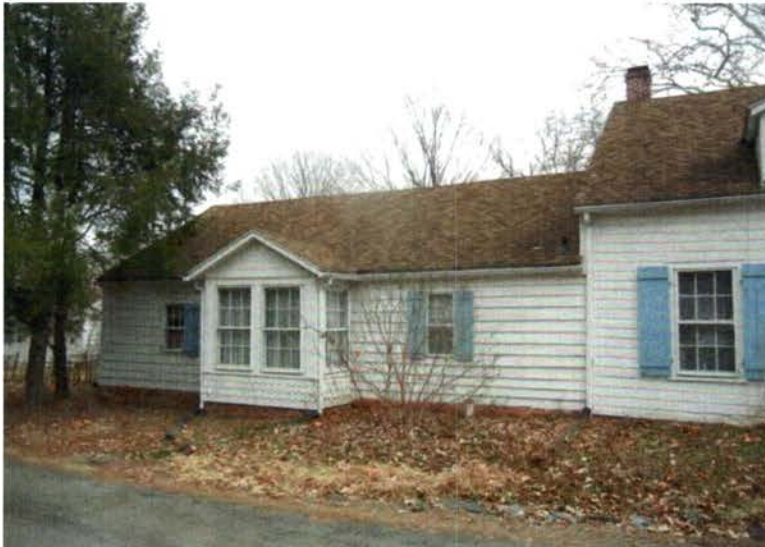
Photo 20: Partial west elevation with Build C (left), Build B (center with later projecting bay window) and (northern portion of) Build A2.

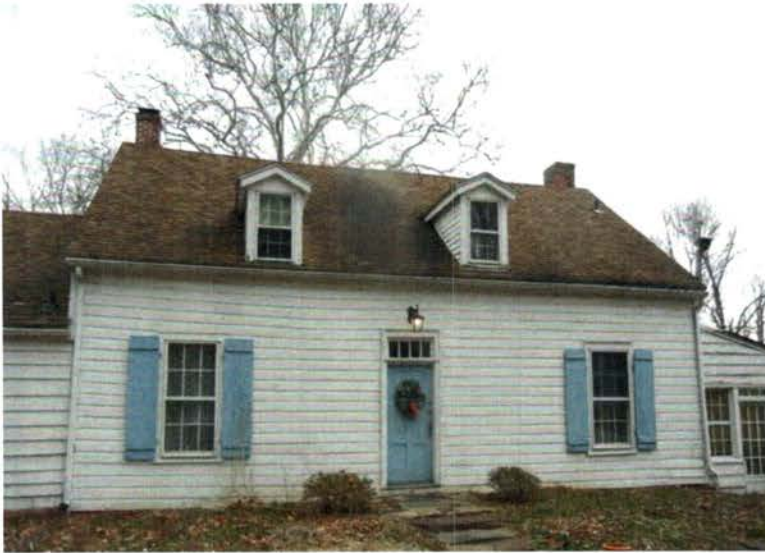
Photo 21: West elevation of the main block, Builds A1 and A2, is covered in German shiplap siding, likely a 20th century alteration. The main entrance shown here and its flagstone stoop would remain but be adapted to provide barrier-free access. The darkened roof area between the dormers is the region where reinforcement of the roof frame appears most needed.

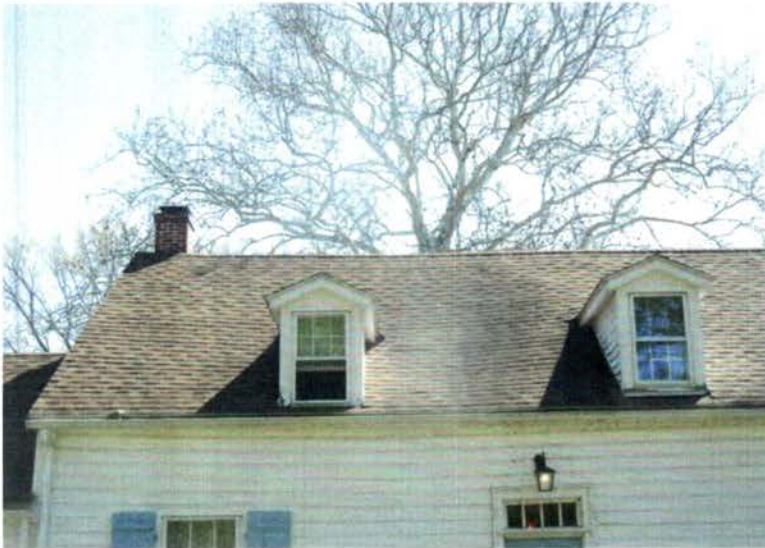
Photo 24: West elevation's Build A2 (left) and A1 (portion right). As noted in Photo #21, the darkened roof area between the dormers is the region where reinforcement of the roof frame appears most needed. Moreover, the problem appears to translate to the siding below (later selected for a probe).

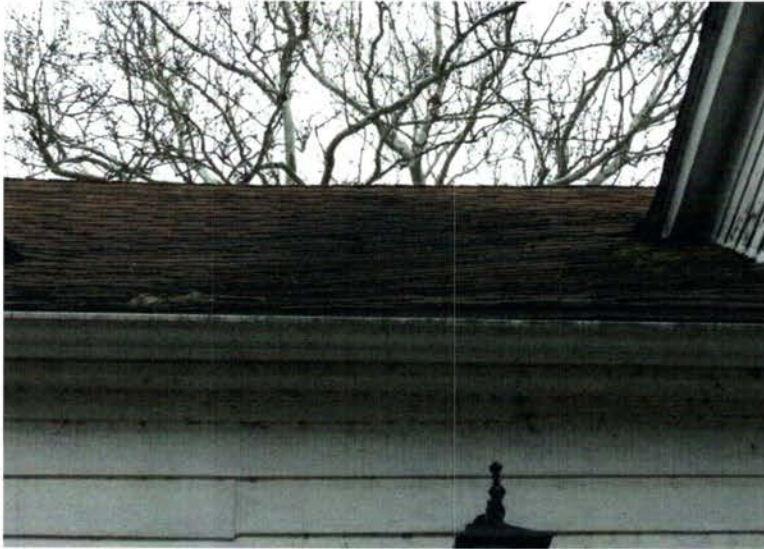
Photo 25: West elevation and a closer view from previous image.

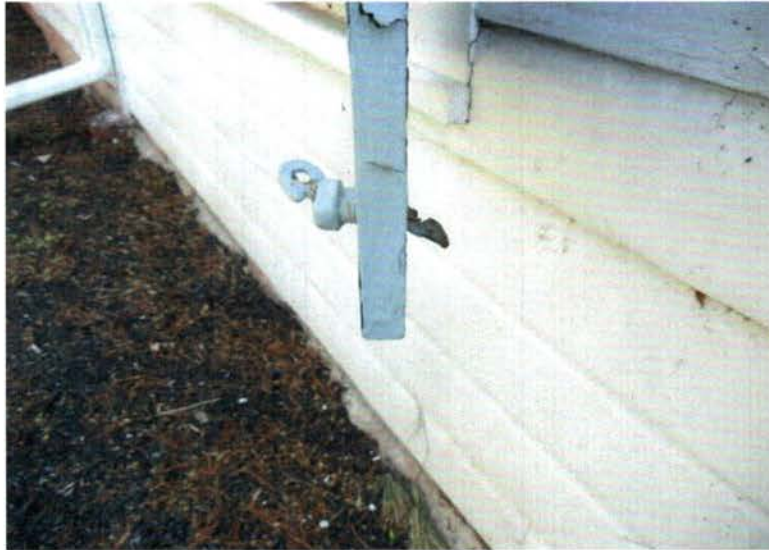
Photo 27: Rather than typical counter weighted swivel shutter dogs, they were held in the open position with a toggle hardware that engaged a hook attached to the clapboard.

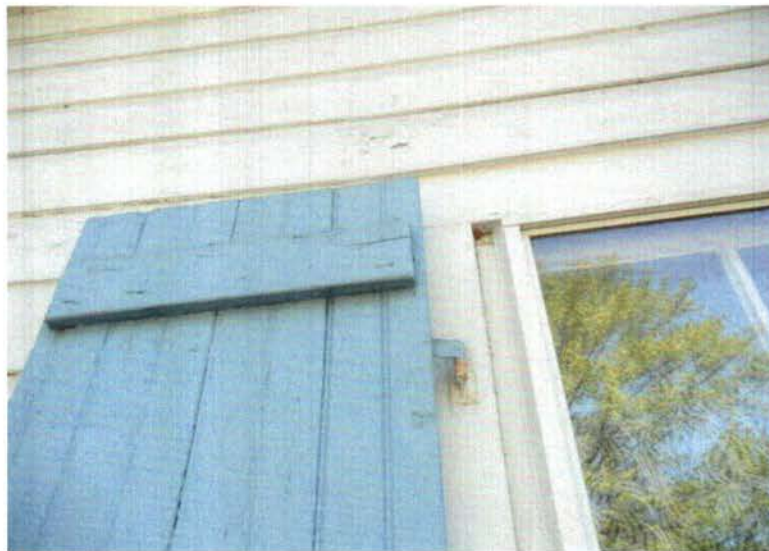
Photo 28: All first and second floor windows have been outfitted with white aluminum triple track storm/screen units. The shutters are, therefore, purely decorative.

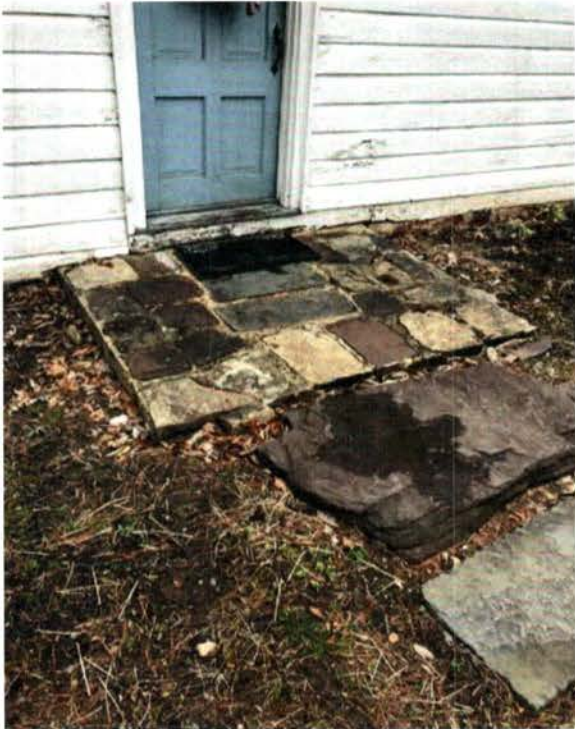
Photo 29: West elevation's existing flagstone stoop at Door A. This main entrance would be adapted to provide barrier-free access in a reversible way. A wood platform would be constructed over much of the stoop and align with the 1st floor with a gentle ramp would be built to the right (slope not to exceed 1:20).

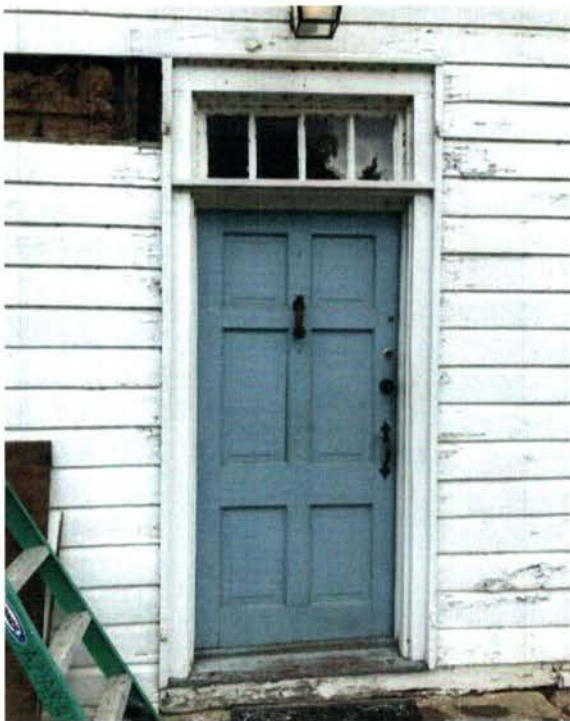
Photo 30: Existing leaf at Door A dates to the 20th century. The area probed to the left of the door revealed that the west elevation of Builds A1 and A2 were shimmed out at the bottom and given new siding to conceal the fact that the elevation is not plumb.

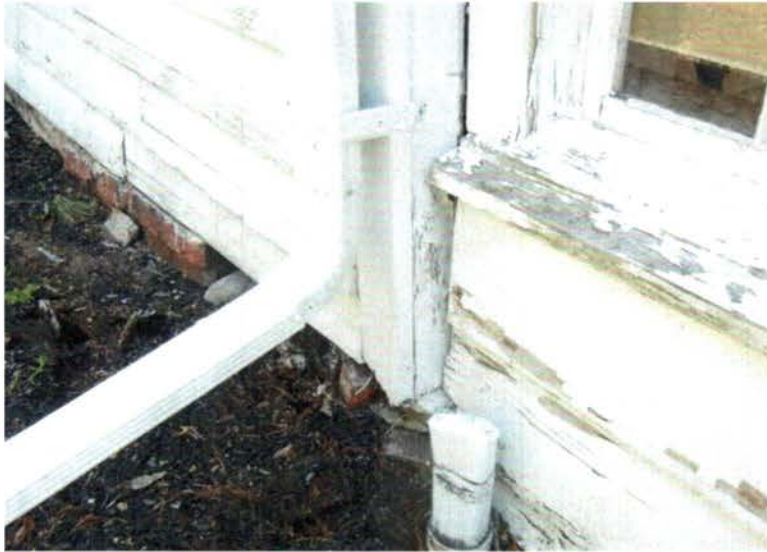
Photo 31: The south corner of Build A1's west elevation where it meets Build D. The rectangular section white aluminum downspout, elbow and extension are recent replaced the capped ground inlet. Significant damage to the SW corner of the stone foundation wall, however, was caused by prolonged and unchecked water seepage at the location.

A. The southwest corner of the exterior foundation wall (Build A1) is of specific concern. Years of unchecked drainage from a roof leader into a blocked underground conduit at this location resulted in the slow but steady disintegration of the mortar and deformation of the stone rubble foundation wall at this corner.

This corner location will require reconstruction. This effort would include the temporary shoring of the first floor framing above, cataloging of individual foundation stones as they are removed, excavation (including archaeological monitoring) to pour new reinforced concrete footings, rebuilding the foundation stones to replicate their original arrangement with the proper mortar and backfilling the exterior grade.

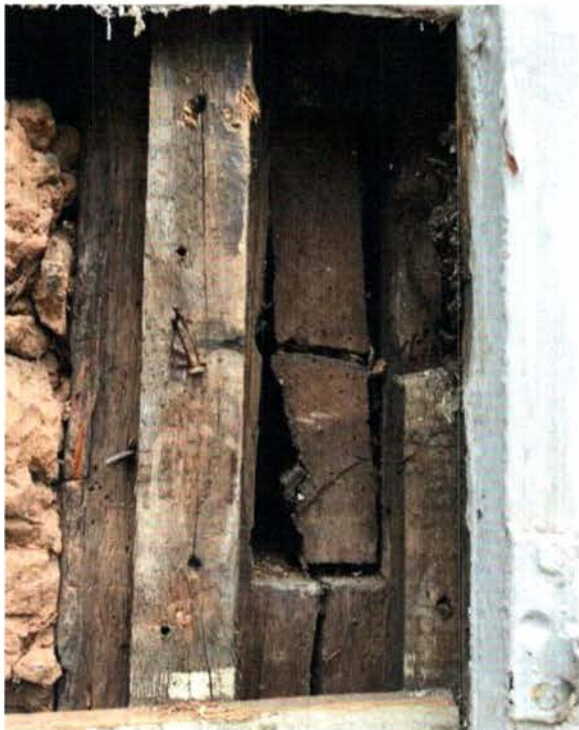
Photo 32: Detail (west elevation) of Photo 30 showing the area to the left of Door A's transom. The rectangular opening in the wood is a mortise in the post and reveals the end of the tenon. The splits in the wood notwithstanding, the wood is in sound condition. A shim to make the wall plumb is visible to the left of the mortise.

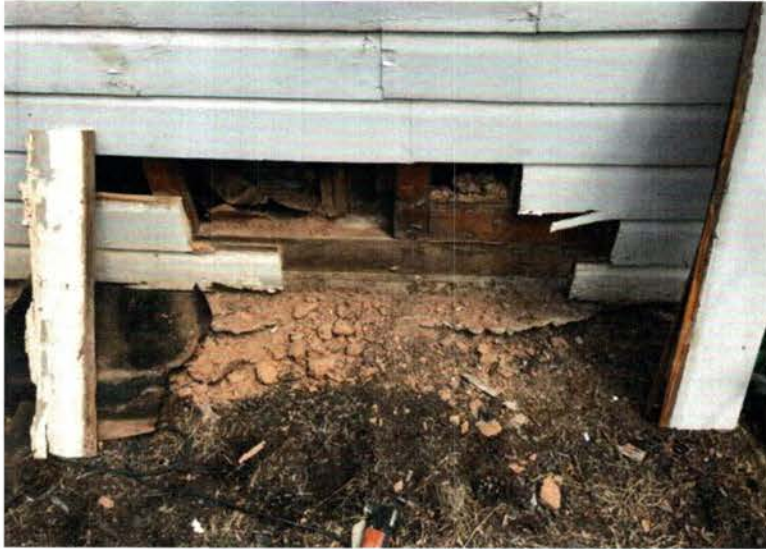
Photo 33: Another probe was made immediately below on the west elevation. It reveals redundant framing to allow for the plumb exterior siding.

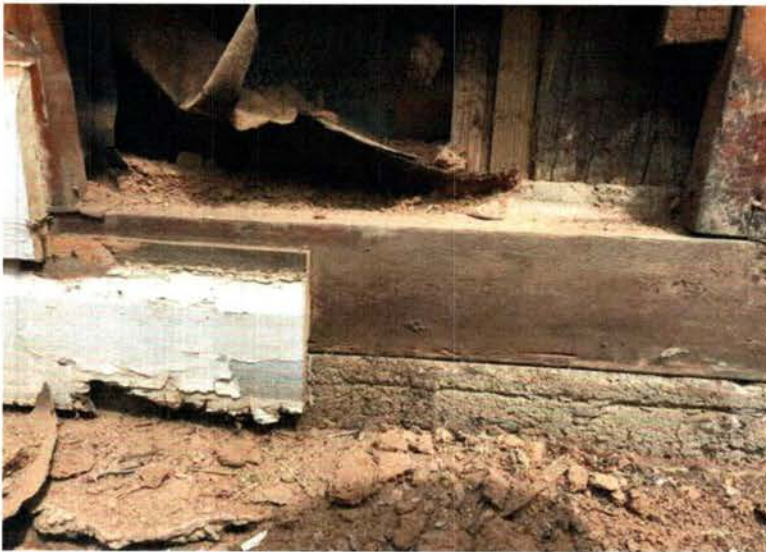
Photo 34: The same probe also revealed an upper new wood sill atop poured in place concrete curb (both likely installed in the mid-20th century). As with other low probes, it appears that concrete was used to replace the original timber sill that was lost to deterioration.

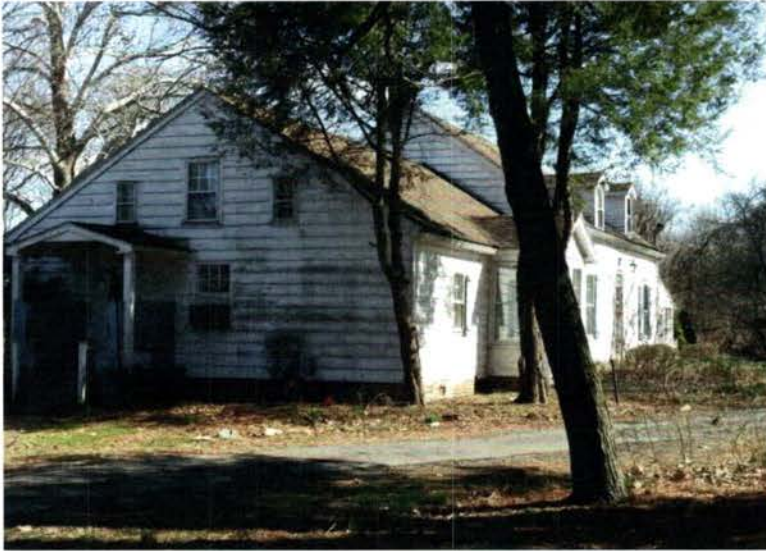
Photo 35: Angled view of the north and west elevations. Trees located too close to the house's perimeter have since been removed.

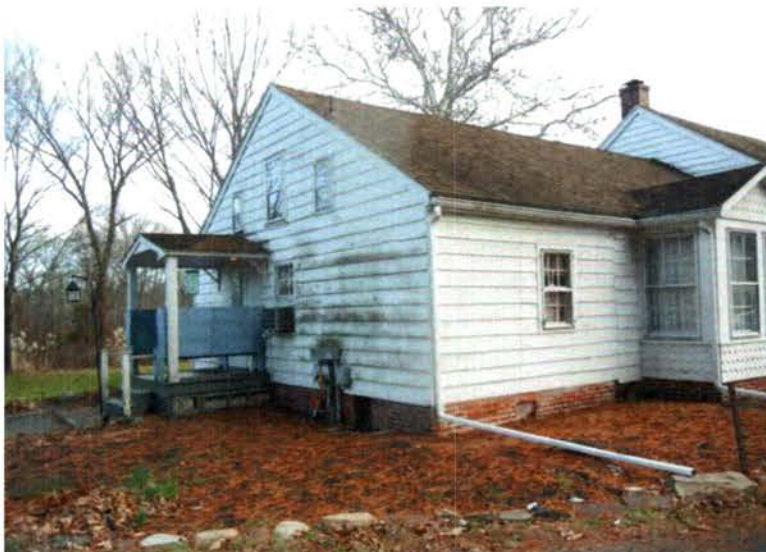
Photo 36: North and (partial) west elevations after tree removal.
