Historic Structures Report for **Symen Van Wickle House**

1289 Easton Avenue, Franklin Township, New Jersey

April 2019

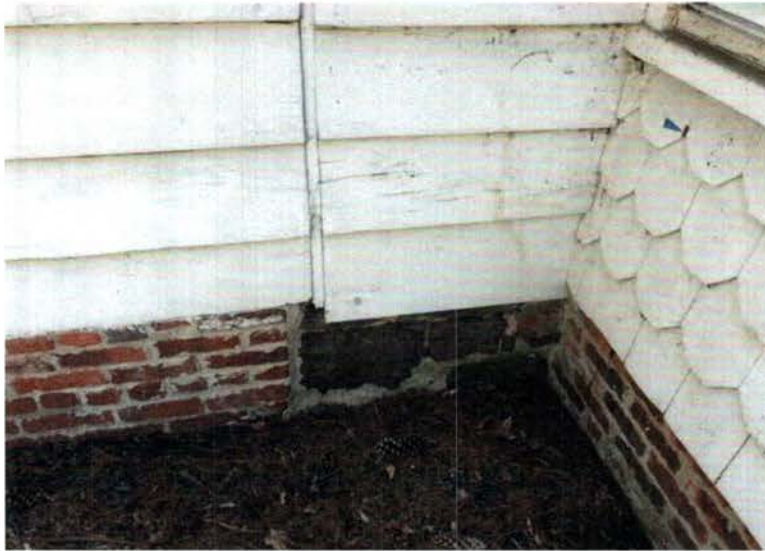
Photo 37: Detail view of west elevation at north face of projecting bay window. The stone is an indication of the north end of Build B foundation wall. To the left, the brickwork marks the beginning of Build C. The brickwork extending at a right angle is of the projecting bay window. The similarity of the brickwork indicates the two areas were constructed at the same time.

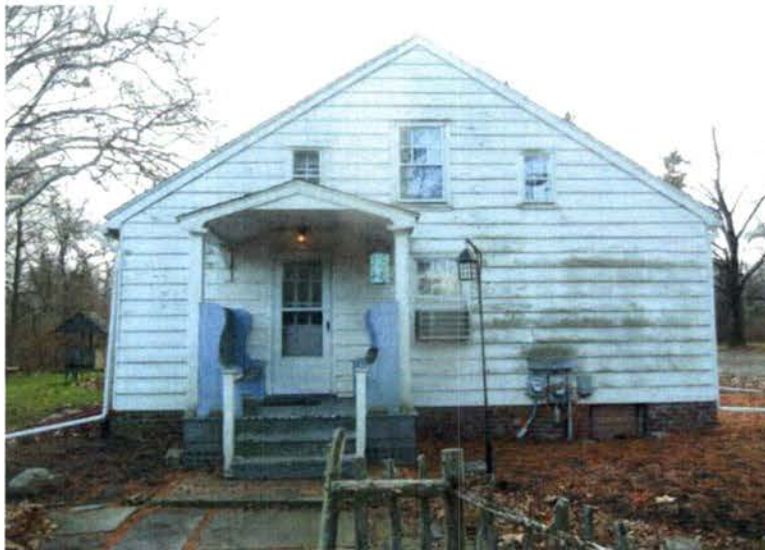
Photo 38: Overall view of the north elevation, the end of Build C. In addition to properly treating the biological growth, prepping and painting the siding, aspects of this elevation that require attention include removal of the covered porch (an addition that postdates the HABS drawings) in favor of a simple wood porch deck and steps, the reopening the cellar window to facilitate ventilation and mitigating the impact of flooding by raising the electrical meters.

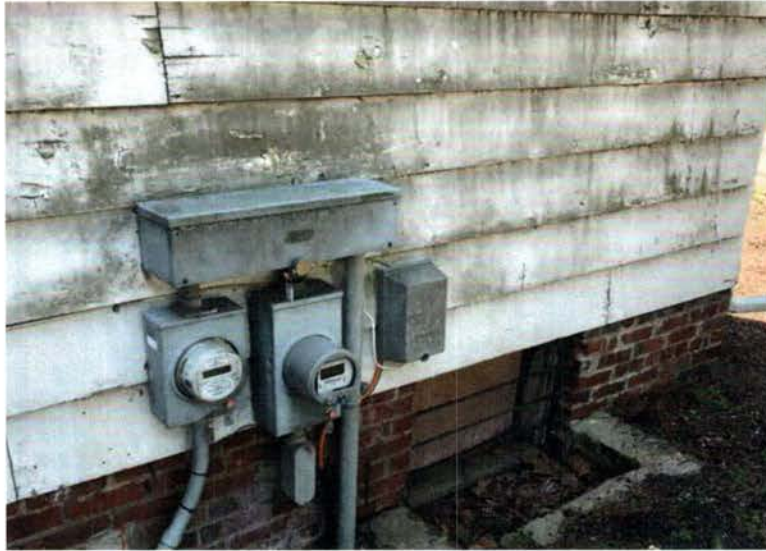
Photo 39: Detail of the north elevation showing the biological growth on the clapboard siding, relatively low incoming electrical service, and sealed cellar window in the brick foundation (only one of two windows that provide the cellar and crawlspaces with natural ventilation - see Photo 12).

- A. *Reopen the two original cellar level windows. Fabricate and install new wood replacement sash with screens.*
 - B. *Introduce new mechanical ventilation and mechanical dehumidification at the cellar level.*

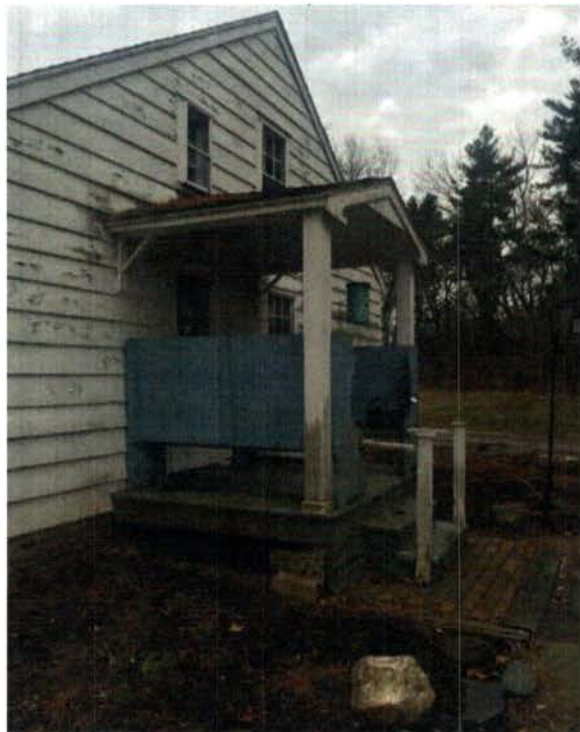
Photo 40: Oblique view of the north elevation looking SW. The covered porch's foundations appear to rely on CMU blocks. Moreover, the area is routinely undermined by groundhog activity (frequent burrowing).

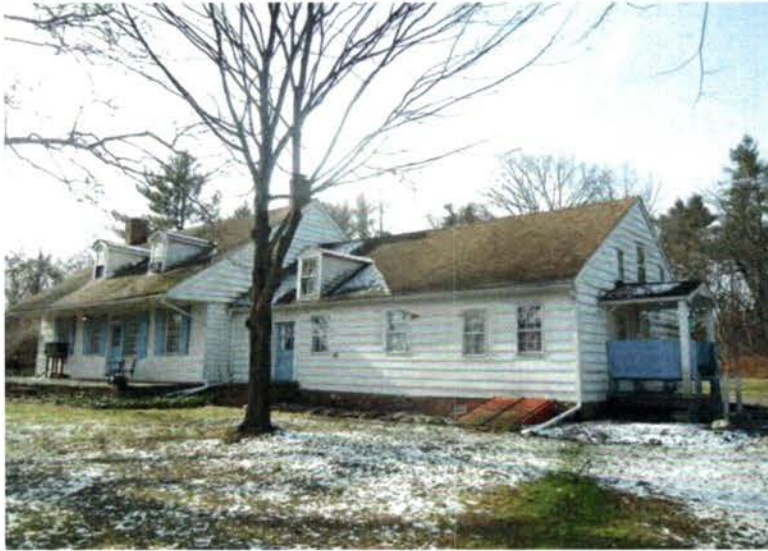
Photo 41: Overall view of the east and north elevations looking SW.

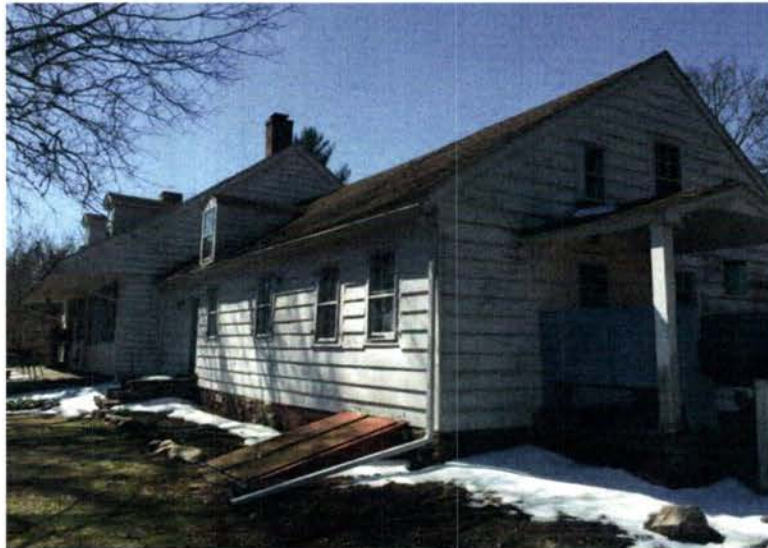
Photo 42: Closer view of the long east and short north elevations looking SW. The metal areaway doors entrance into the cellar of Build C (often referred to as "Bilco" doors after a prominent company that manufactures them) is a relatively recent change and should be replaced in favor of a new wood areaway entrance shown in the HABS drawings.

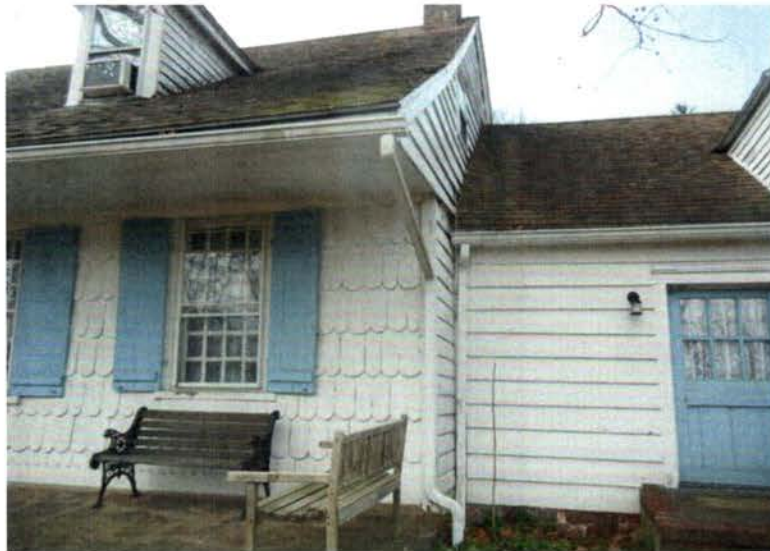
Photo 43: Detail view of the east elevation where Build A2 meets Build B. The six panes in the door pictured (Door C to the Dining Room) were created by altering the vertical boards at the top half of the Dutch door which used to be solid.

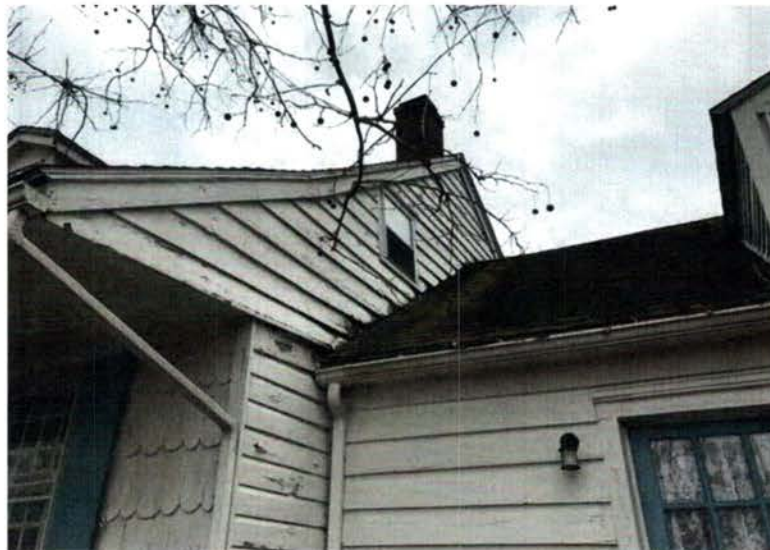
Photo 44: Related close-up view of the previous image looking up to the exposed north wall of Build A2 as it meets the roof over Build B. Different siding is apparent in this image from the earliest round butt shingles (east elevation of Build A2) to straight clapboard (east elevation of Build B and upper north gable of Build A2) to a limited narrow section of German ship-lap siding (lower north end of Build A2). Overhanging branches are numerous and leaves are too close to exterior surfaces and promote wood decay.

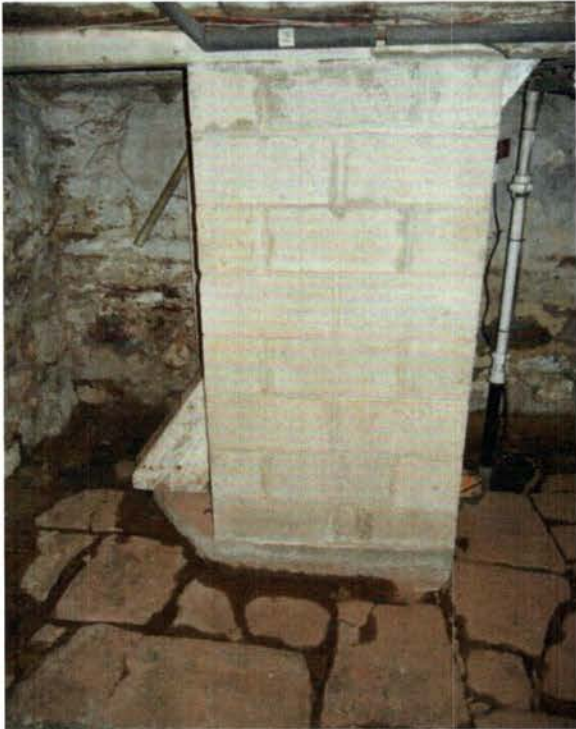
Photo 45: Cellar A (Room 001) looking north. The CMU pier was constructed to provide additional support. It mostly conceals the stairs down from the first floor. One of three sump pumps (#3) is in the background to the right.

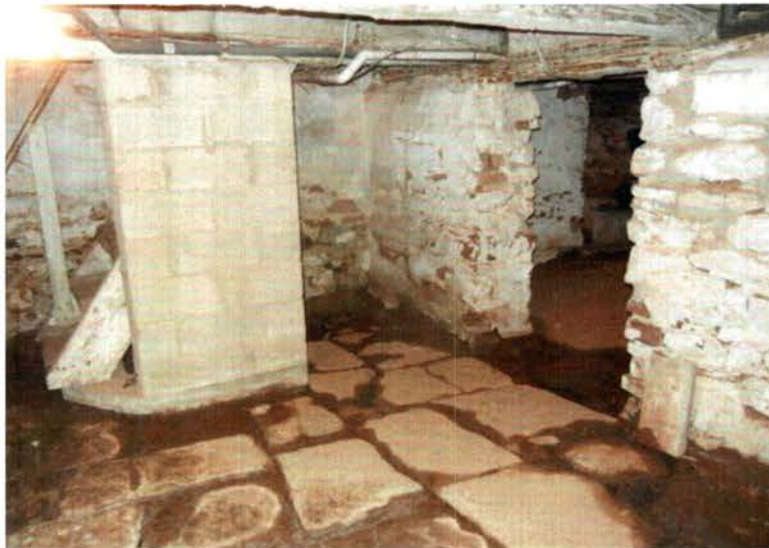
Photo 46: Cellar A (Room 001) looking NE. The room occurs under the western part of Build A1.

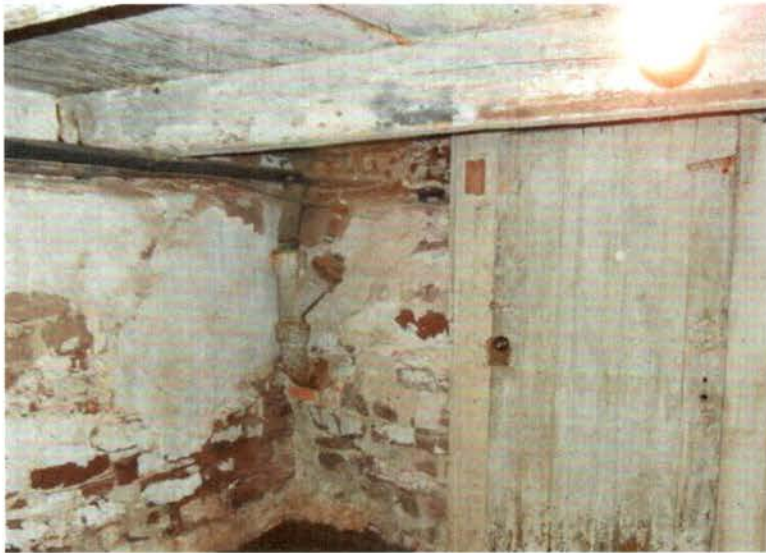
Photo 47: Cellar A (Room 001) looking SE. The wood door leads up the area-way to the hothouse. A sanitary line exits the south wall. Surviving whitewash on the underside of the 1st floor framing and stone foundation walls indicate an effort to make these below grade rooms more sanitary.

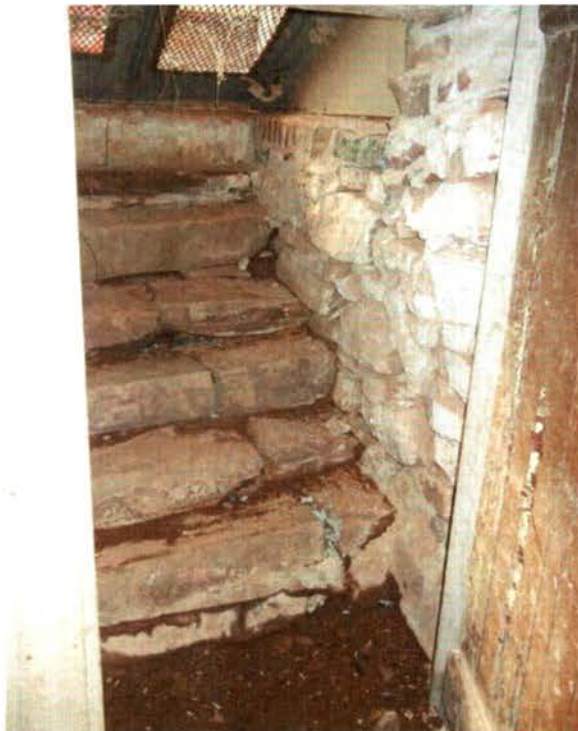
Photo 48: Cellar A (Room 001) looking south to area-way Door F.

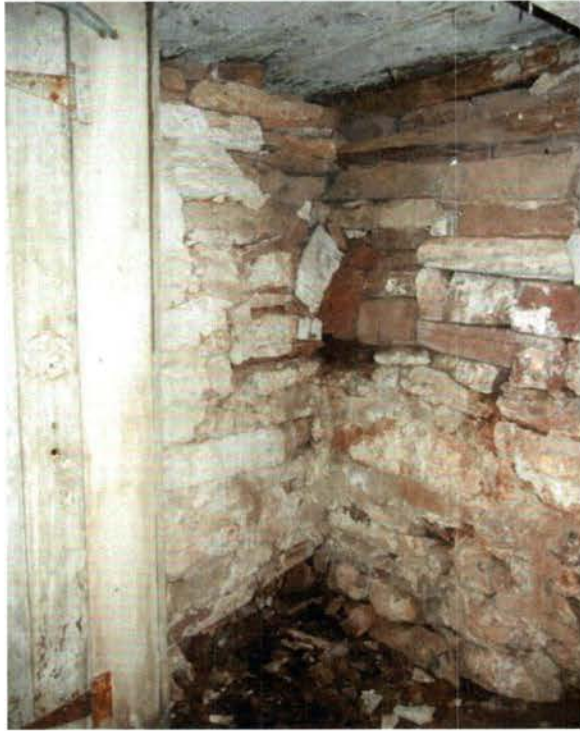
Photo 49: Cellar A (Room 001) looking to its SW corner. Significant damage to this corner of the stone foundation wall was caused by prolonged and unchecked water seepage from a blocked inlet serving a downspout (as shown in Photo 31).

A. The southwest corner of the exterior foundation wall (Build A1) is of specific concern. Years of unchecked drainage from a roof leader into a blocked underground conduit at this location resulted in the slow but steady disintegration of the mortar and deformation of the stone rubble foundation wall at this corner.

This corner location will require reconstruction. This effort would include the temporary shoring of the first floor framing above, cataloging of individual foundation stones as they are removed, excavation (including archaeological monitoring) to pour new reinforced concrete footings, rebuilding the foundation stones to replicate their original arrangement with the proper mortar and backfilling the exterior grade.

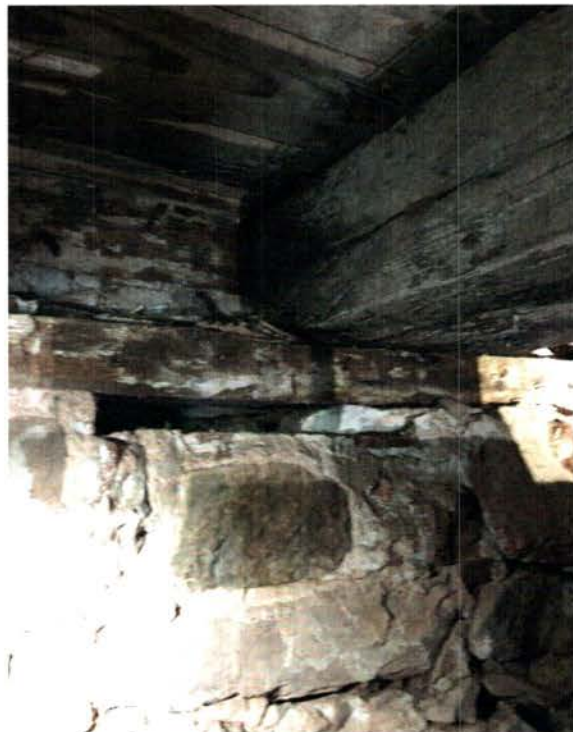
Photo 50: Cellar A (Room 001) looking west and overhead where a beam supporting the 1st floor frames into a heavy timber sill set on a wood plate which caps the stone foundation wall.

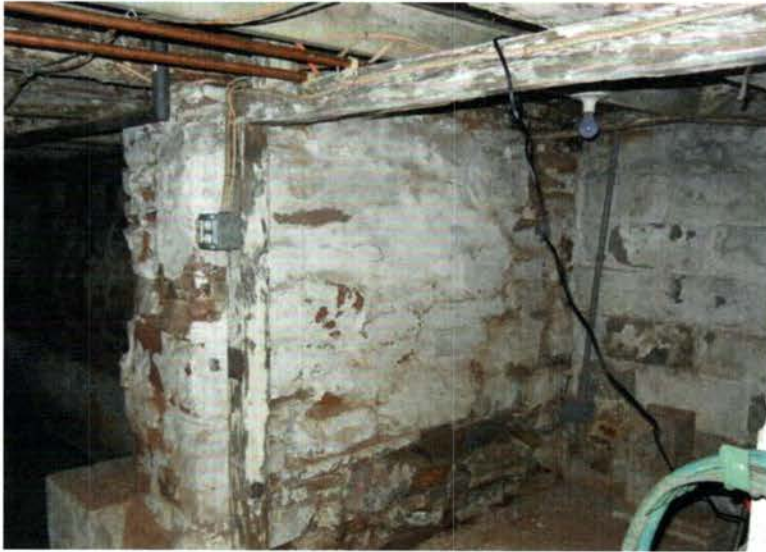
Photo 51: Cellar B (Room 002) looking NE. The room occurs under the eastern part of Build A1. An earlier opening to an areaway is sealed by CMU blocks to the right (closure made necessary when the flagstone terrace was built). An opening was created at an interior stone foundation wall to access Cellar C (Room 003).

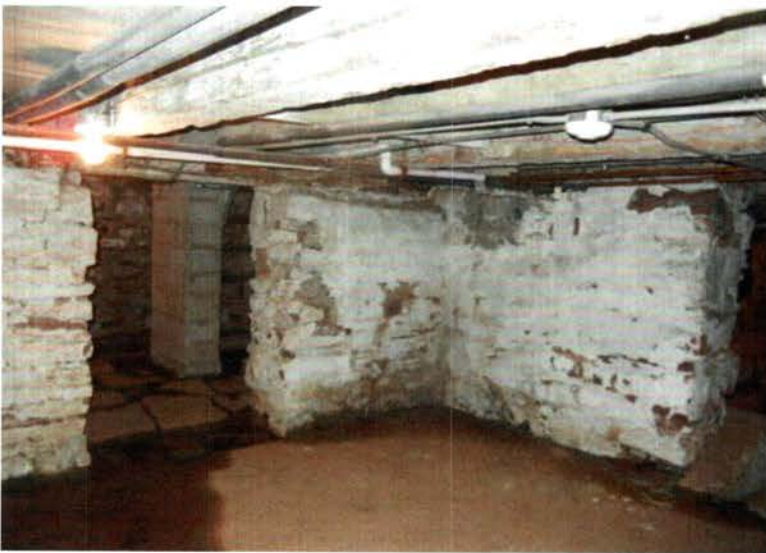
Photo 52: Cellar B (Room 002) looking NW. Beyond to the left is Cellar A (Room 001) and to the right Cellar C (Room 003). Cellar A retained its stone slab flooring while (presumably) Cellar B's floor was replaced with concrete.

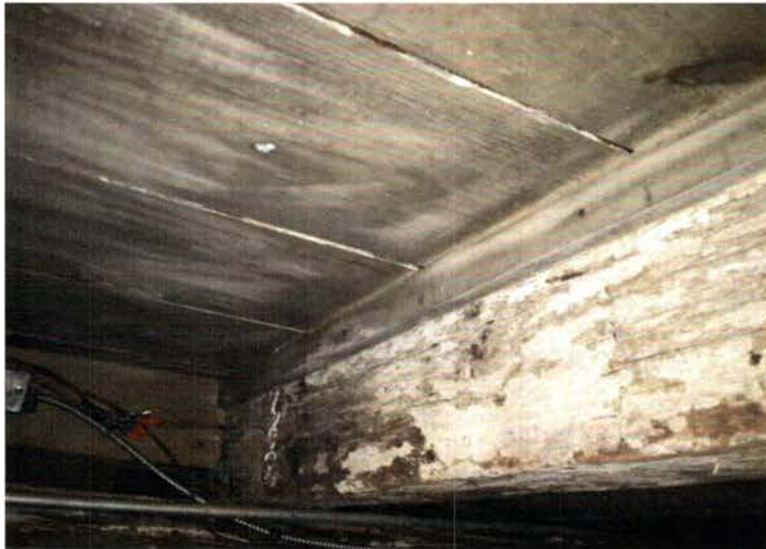
Photo 53: Cellar B (Room 002) looking generally east and overhead. Wooden strips (*nailers*) are face nailed to the beams to provide additional support to the plank flooring above.

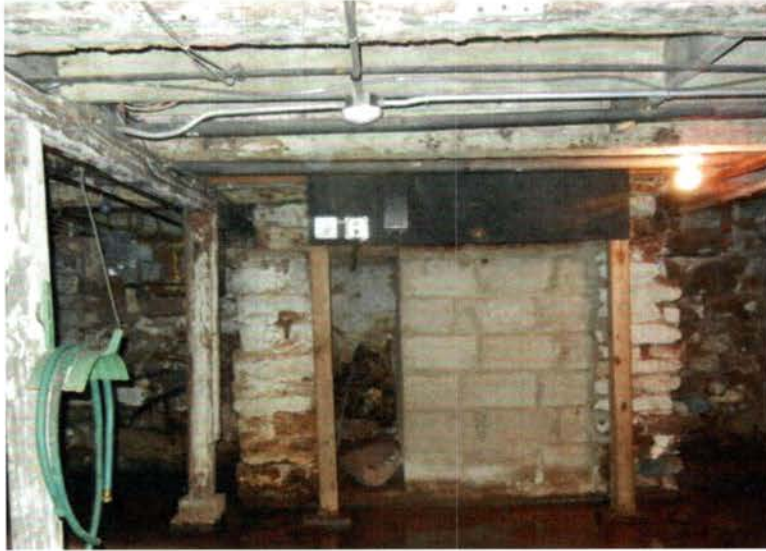
Photo 55: Cellar B (Room 002) looking south. Additional intermediate posts (not whitewashed) support the hearth of the south fireplace in Room 103 above. Further back the span of the south fireplace's flat arch is reduced by CMU infill (the reason why CMU does not fill in the entire opening under the span is not known).

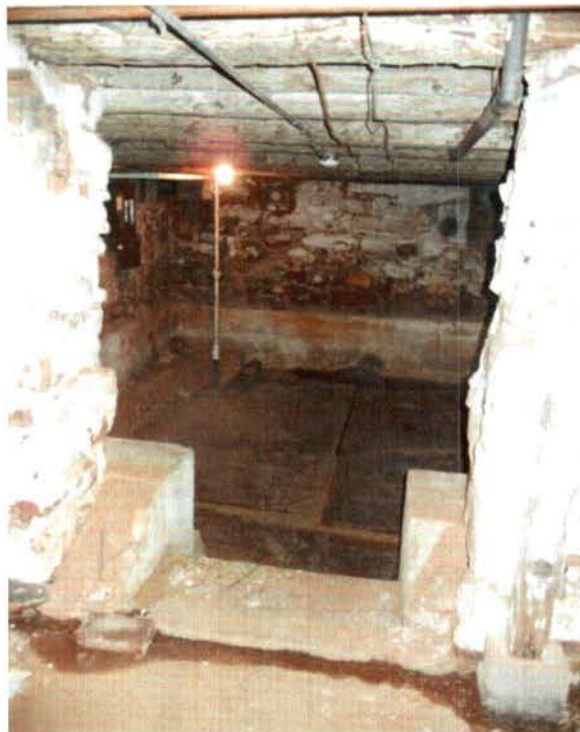
Photo 56: Cellar B (Room 002) in the foreground looking into the deeper Cellar C (Room 003) beyond. Cellar C was further excavated to make it approx. 30 inches deeper to allow for the installation of a boiler to provide central heating. The original stone foundation walls were underpinned on all sides by poured in place concrete.

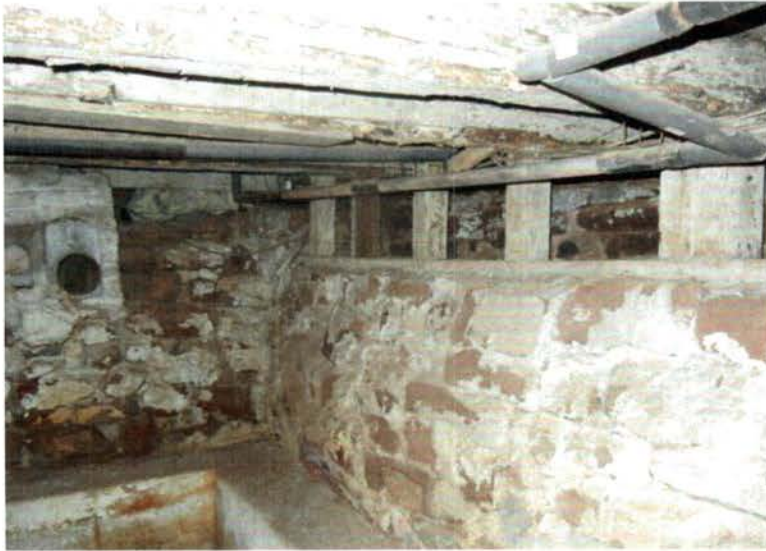
Photo 57: Cellar C (Room 003) looking NE. The previous boiler was located in this area and vented through the round opening on the north wall (north fireplace in Room 103).

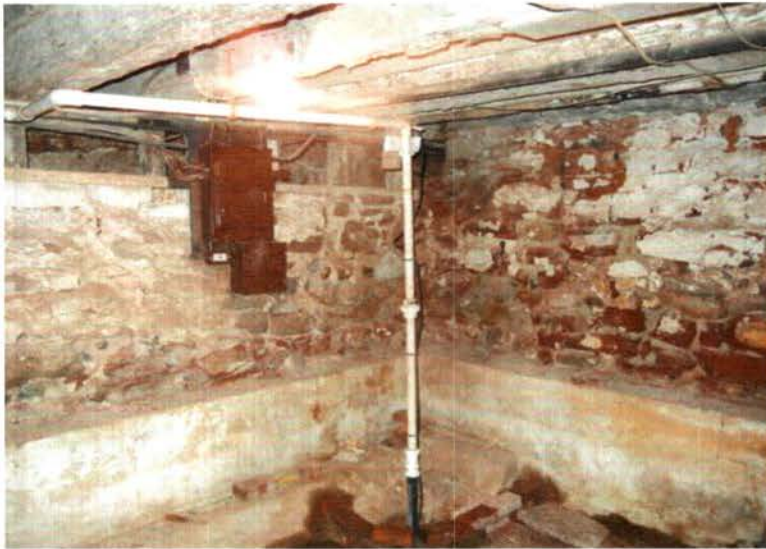
Photo 58: Cellar C (Room 003) looking NW. Sump pump #2 is located in this corner.

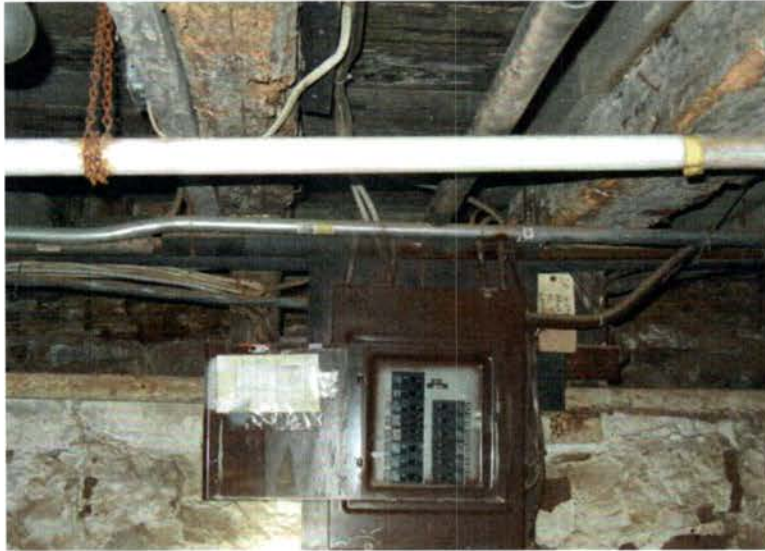
Photo 59: Cellar C (Room 003) looking west to the electrical sub-panel. Overhead original surviving heavy timber beams are flanked by 2x lumber to reinforce them and to help level the finished floor above.

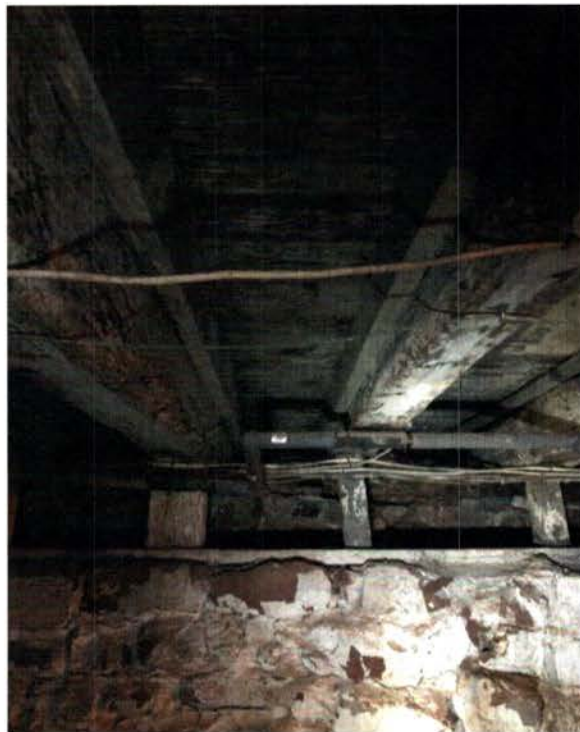
Photo 60: Cellar C (Room 003) looking west. As in the image above, overhead original surviving heavy timber beams are flanked by 2x lumber to reinforce them and to help level the finished floor above. Between the deep cellar and crawlspace beyond *stub posts* support the beams. They are atop on a wood plate which caps the inner stone foundation wall.

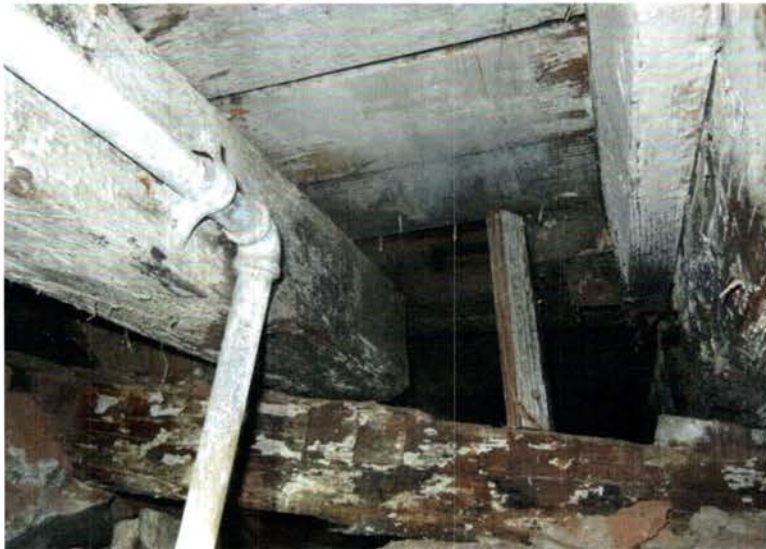
Photo 61: Cellar C (Room 003) looking west (near south corner) to a crawlspace or unexcavated area (Room 004) beyond. The collapsed framing in this area has been shored up in a temporary fashion which needs to be made more permanent.

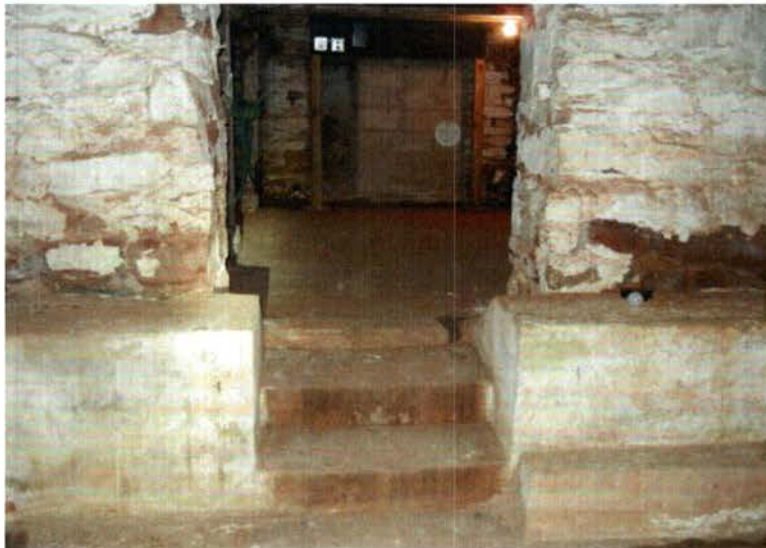
Photo 62: Cellar C (Room 003) looking south into Cellar B beyond showing the concrete original stone foundation walls in the foreground underpinned by poured in place concrete (compare this image with Photo 56).

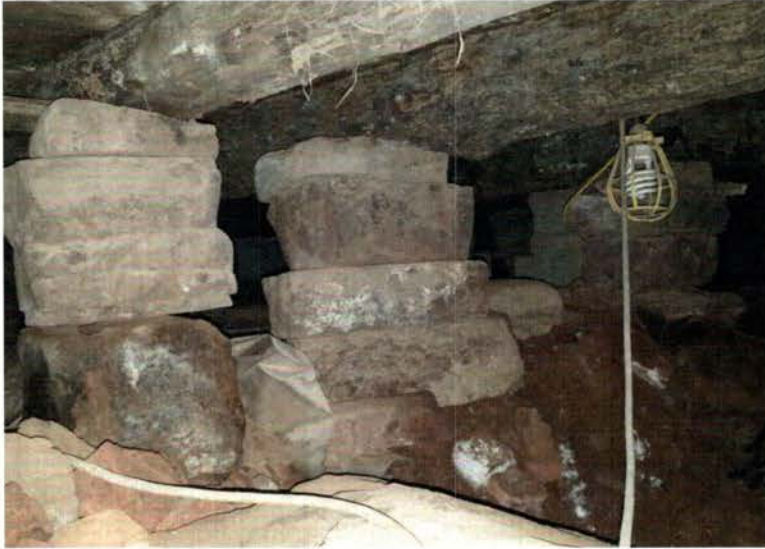
Photo 63: Crawlspace or unexcavated area (Room 006) showing improvised and irregular stone piers at 1st floor framing to provide support at mid span.

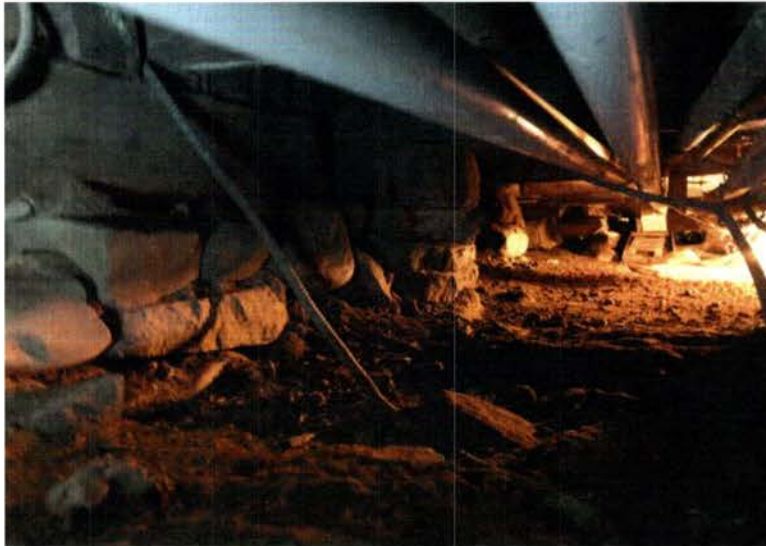
Photo 64: Crawlspace or unexcavated area (Room 006) showing remnants of an irregular stone foundation wall dividing the area from the adjacent unexcavated area (Room 005).

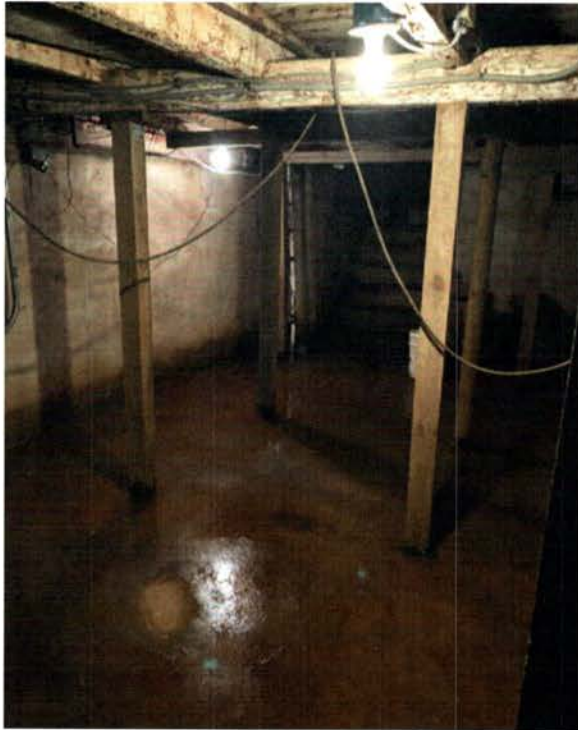
Photo 65: Cellar D (Room 007) at Build C below the Kitchen (Room 108). Two rows of intermediate beams and posts were installed to provide additional support to the original 1st floor framing. Persistent ground water is a problem particularly in this area. Sump pump #1 is in the background as well as steps leading up to an areaway.

This framing will require replacement of the major beams and posts on new footings in order to support the kitchen above (while retaining the existing 3x8 joists in place). In addition, a damp proof course (DPC) should be installed at the south wall in the Cellar of Build C to prevent the rise of moisture in this wall.

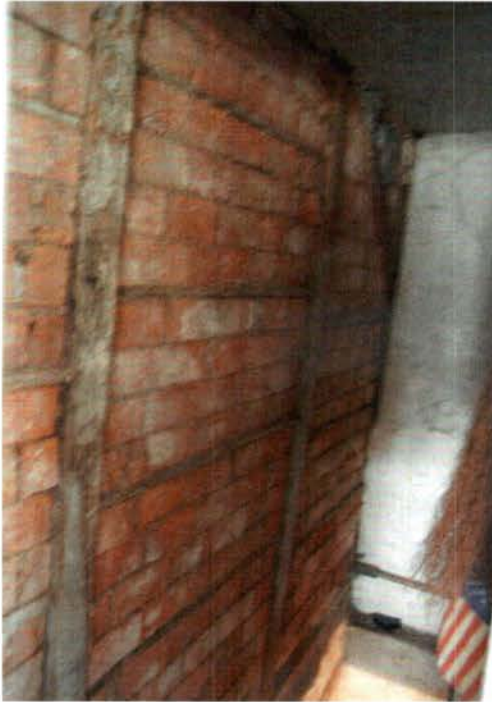
Photo 67: Looking west from the Kitchen (Room 108) down to Cellar C (Room 007) at the level of the 1st floor. This left wall area is common with the north wall of Bedroom #3 (Room 106). The areas between the studs are filled with non-structural handmade low-fired brick, mud mortar and horizontal wood nailers that serve to hold lath in order to plaster.

Photo 99: Bedroom #3
(Room 106) looking north.
This wall is common with
(the opposite face of) the wall
shown in Photo 67.

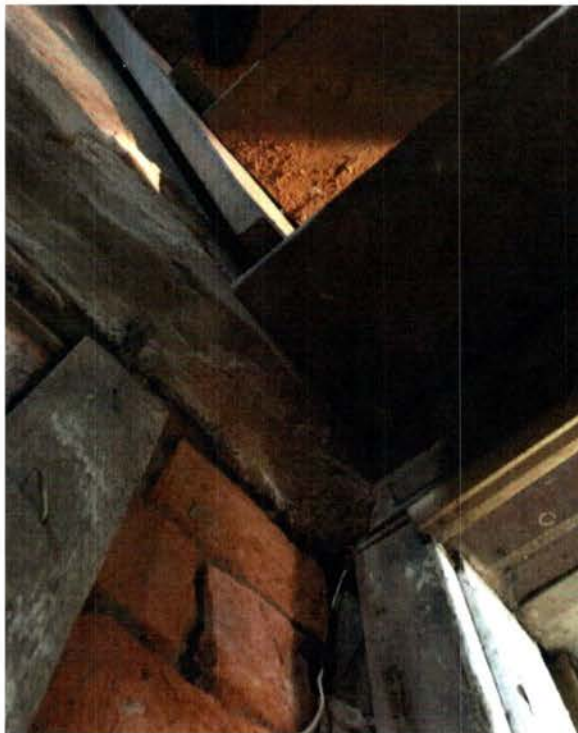
Photo 68: Looking down from the Kitchen (Room 108) to Cellar C (Room 007) at the level of the 1st floor. Excessive moisture from below, “rising damp,” has caused the brick to disintegrate, powder and land on the stair treads.

- A. *Repair the damaged plaster surfaces at the north walls in Rooms 106 and 107.*
 - B. *Substantially rebuild or replace in-kind the wood stairway leading from the Kitchen*

(Room 108) to the cellar in Build C (Room 007), as it presents a safety hazard.

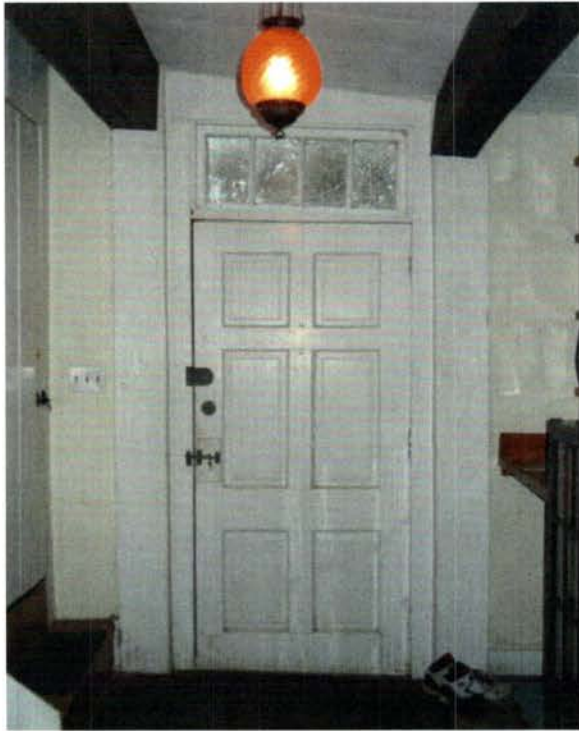
Photo 69: Foyer (Room 101) looking west to Door A, the main entrance. A hallmark of Dutch framing, all windows and doors are located between the posts of the heavy timber anchor-bents. The noticeable slant of the ceiling above the door is a long-standing condition, as it is documented in the HABS drawings. The 2nd floor is level as sleepers were placed atop the right beam (and all beams of the anchor-bents to the north) so that the settlement is not detected on the upper floor.

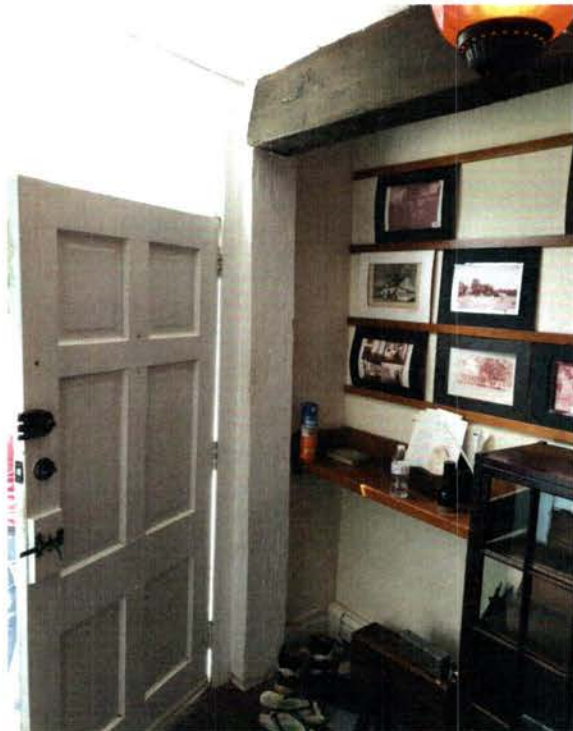
Photo 70: Foyer (Room 101) looking NW. The upright post (painted white) is shouldered to allow the beam (dark stained) to sit. This location is the west end of Anchor-Bent A6 and its framing intersection was probed on the exterior (see Photos 30 & 32).

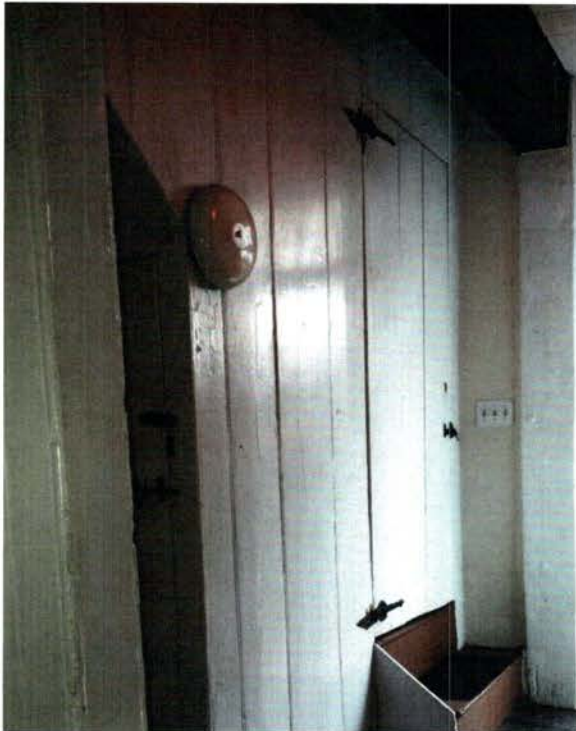
Photo 71: Foyer (Room 101) looking SW to the left of Door A. The stairway enclosure is made of beaded vertical boards. This view was also photographed by HABS (see Figure #10 on page II-112 of this report).

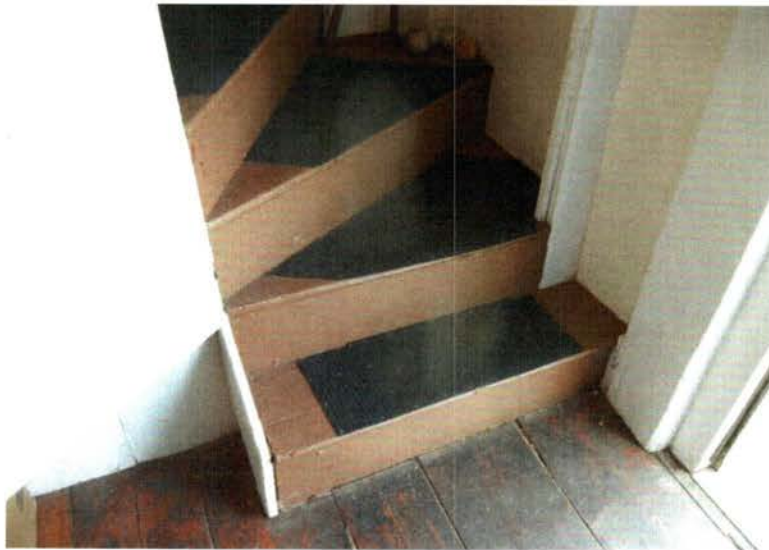
Photo 72: Foyer (Room 101) looking at the winder stairs up to the 2nd floor.

Photo 121: Hall (Room 201) as viewed ascending the stairs to the caretaker's apartment and also shown in Photo 72 from the Foyer (Room 101).

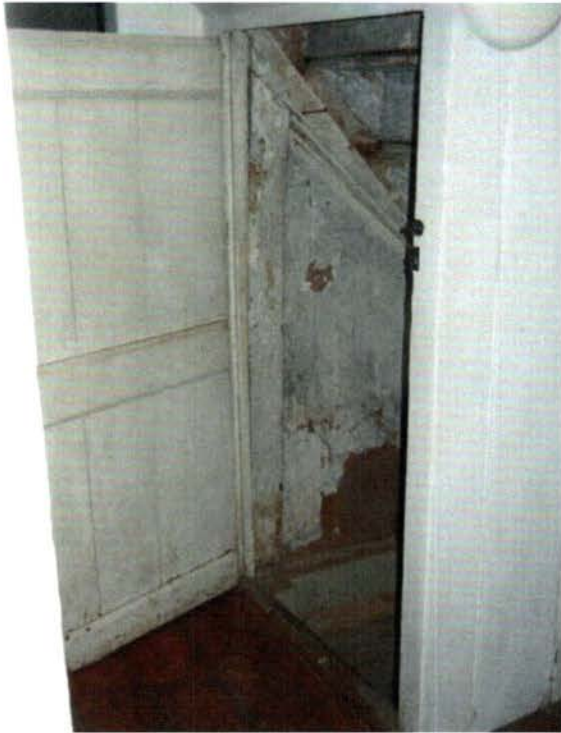
Photo 73: Foyer (Room 101) looking SW to the door and cellar stairs (the base of which is in Photos 45 & 46).

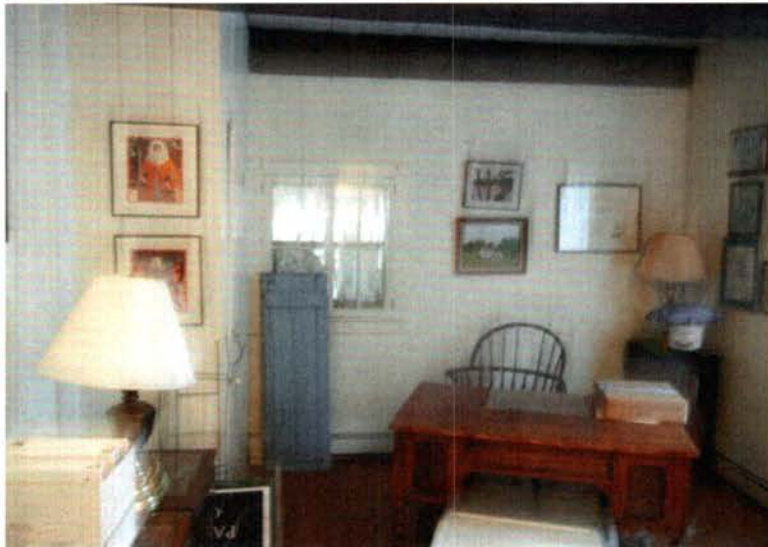
Photo 74: Office (Room 102) looking south and the paired casement window that opens into the Hothouse.

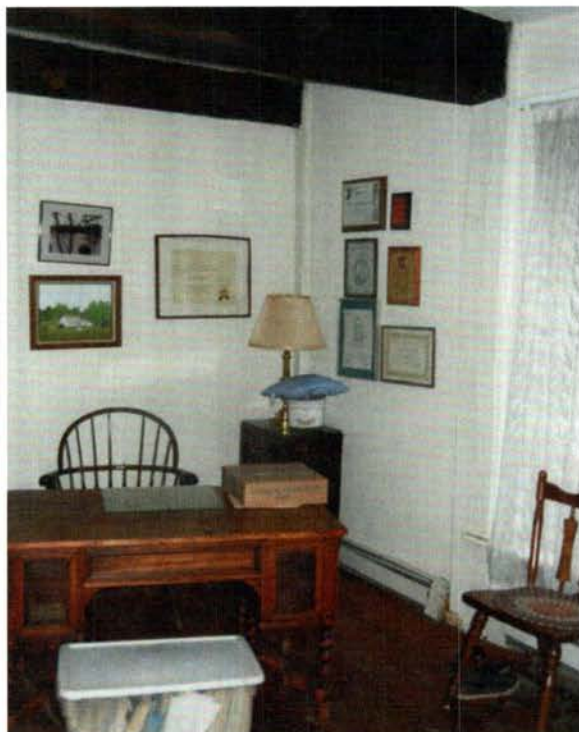
Photo 76: Office (Room 102) looking SW. Hot water baseboard provides heat. Unfortunately, its supply piping was installed by boring through the base of the posts of the anchor-bents.

Photo 92: Bedroom #2 (Room 104) looking at the base of the west wall. As noted in Photo 76, hot water baseboard provides heat but, unfortunately, its supply piping was installed by boring through the base of the posts of the anchor-bents.

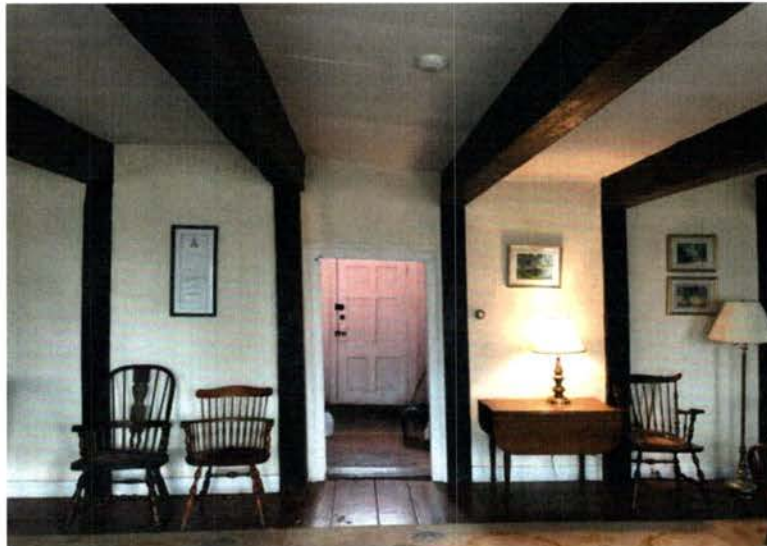
Photo 78: Living Room (Room 103) looking west to the Foyer (Room 101). The anchor-bent to the left of the door opening was likely the location of the original north exterior wall of Build A1.

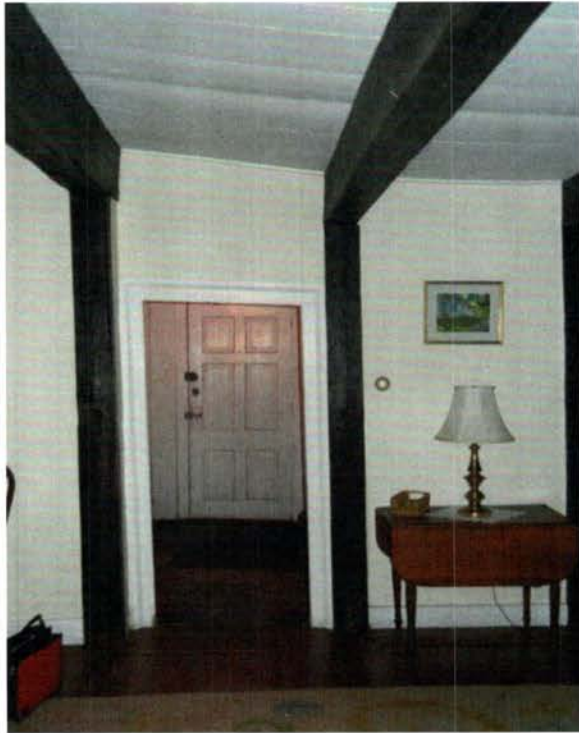
Photo 79: Living Room (Room 103) looking west. As noted in Photo 69, the noticeable slant of the ceiling above the door is a long-standing condition, as it is documented in the HABS drawings.

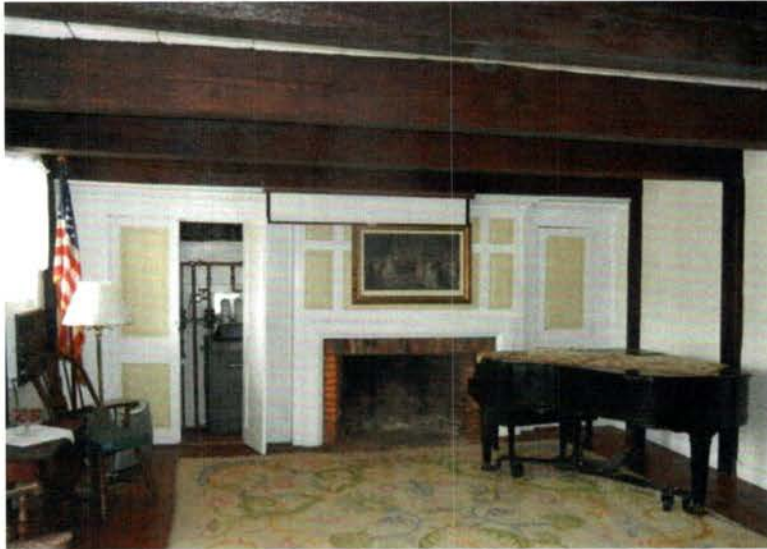
Photo 81: Living Room (Room 103) looking south to the south fireplace and the Mechanical Closet (Room 103A) to the east (left).

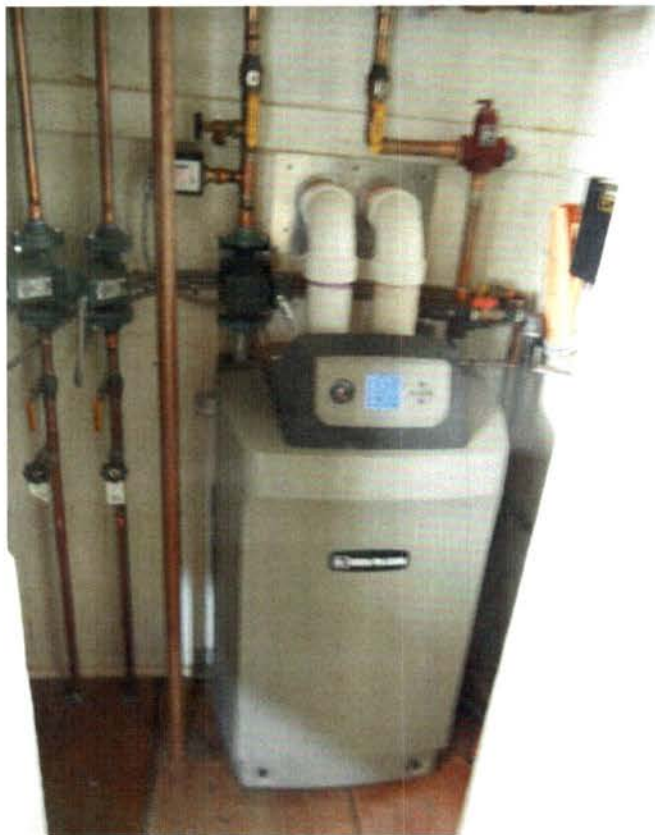
Photo 84: Room 103A,
Mechanical Closet - Gas-
fired side vent boiler installed
in recent years for heating.
This space is located
immediately to the left (east)
of the south fireplace.

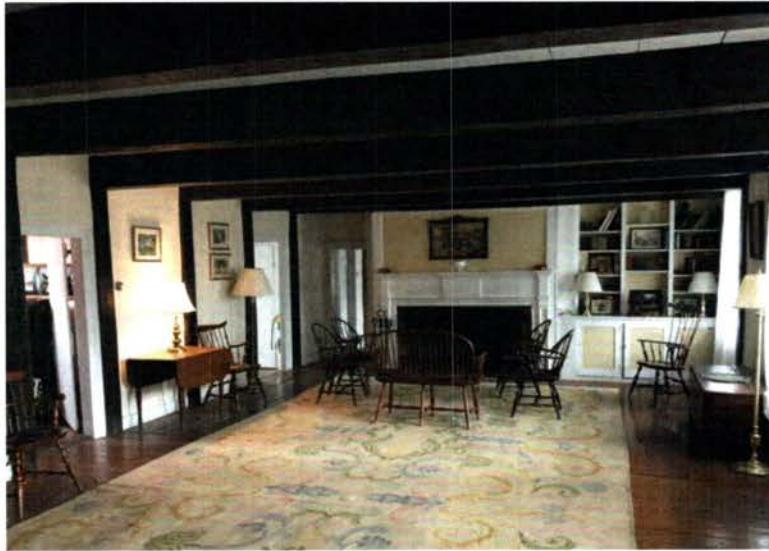
Photo 85: Living Room (Room 103) looking north to the north fireplace. The bookcase to east (right) postdates the HABS drawings. Its removal may provide additional information about the house's changes over time.

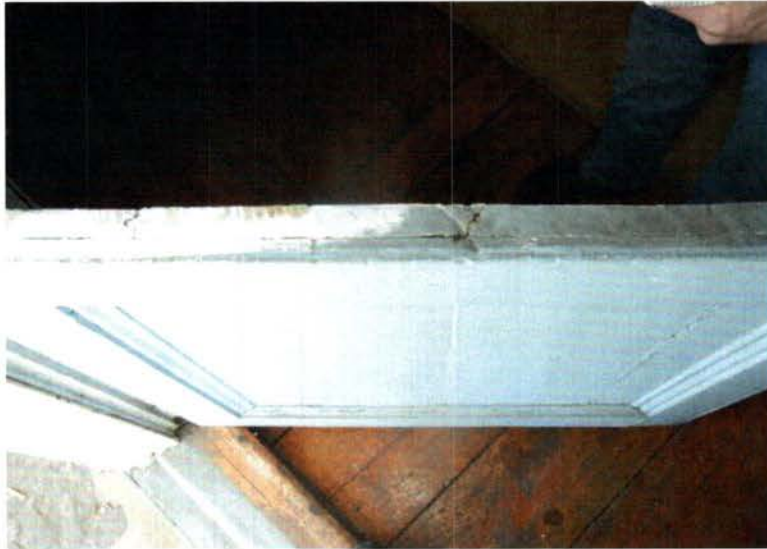
Photo 87: Living Room (Room 103) looking down on the bottom portion of the Dutch door leaf (Door D) constructed of double tongue and double grooved vertical boards.

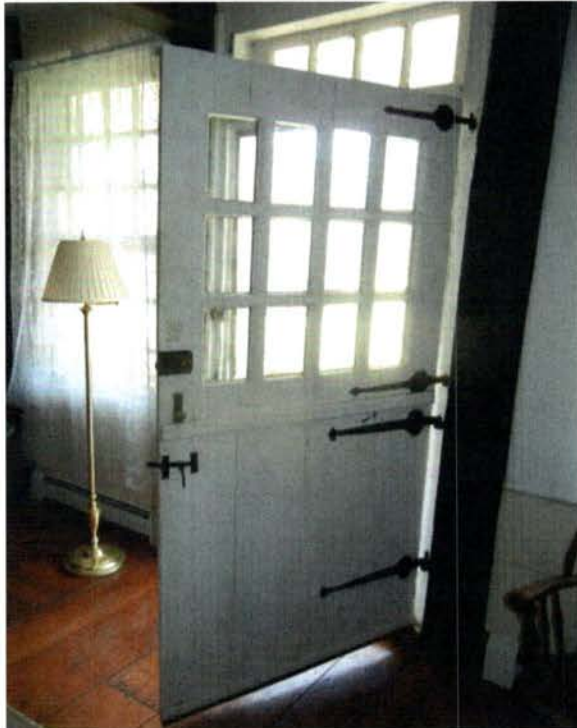
Photo 88: Living Room (Room 103) looking the interior face of Door D in situ. Like Door C in Photo 43, the panes in the door's upper leaf were created by altering (cutting into) the vertical boards, as it too used to be solid.

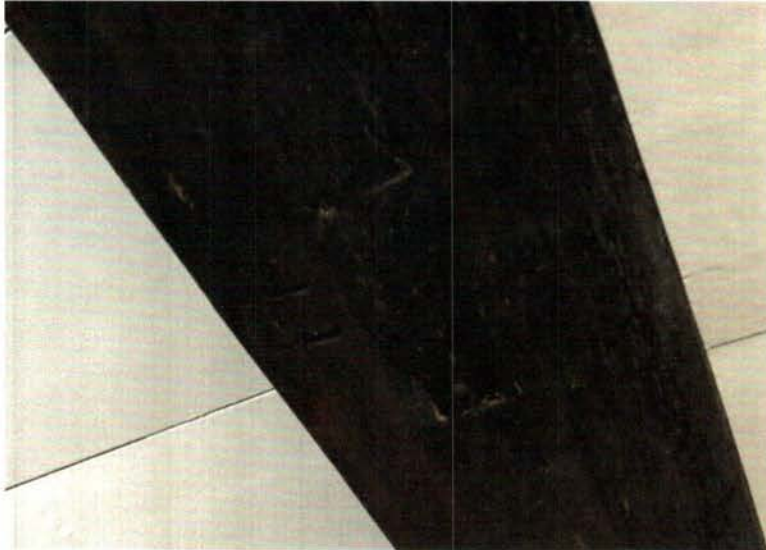
Photo 89: Living Room (Room 103) looking up at the underside of Anchor-Bent A4. Here the Roman numeral marks are next to the filled in mortise of an earlier stud location. This condition here and elsewhere on the underside of this beam indicate an original exterior north wall.
