Historic Structures Report for **Symen Van Wickle House**

1289 Easton Avenue, Franklin Township, New Jersey

April 2019

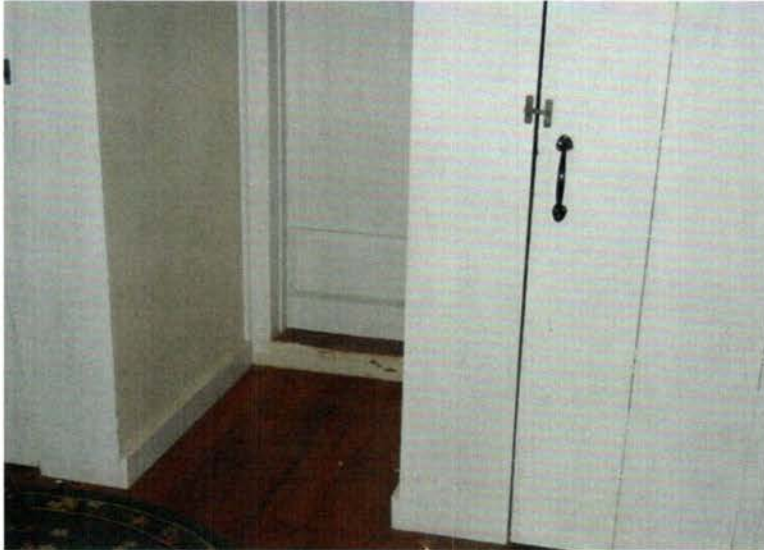
Photo 91: Bedroom #2 (Room 104) looking north. The closets constructed here are not original. In part, they help to conceal the plumbing of the half-bath on the floor above. These closets would be removed and the opening into the Bathroom beyond would be widened to provide access to improved toilet facilities to meet ADA requirements

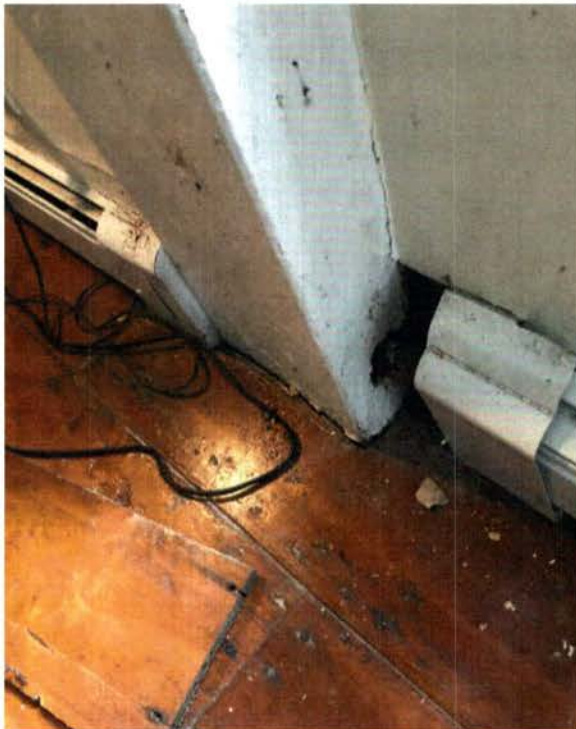
Photo 92: Bedroom #2 (Room 104) looking at the base of the west wall. As noted in Photo 76, hot water baseboard provides heat but, unfortunately, its supply piping was installed by boring through the base of the posts of the anchor-bents.

Photo 76: Office (Room 102) looking SW. Hot water baseboard provides heat. Unfortunately, its supply piping was installed by boring through the base of the posts of the anchor-bents.

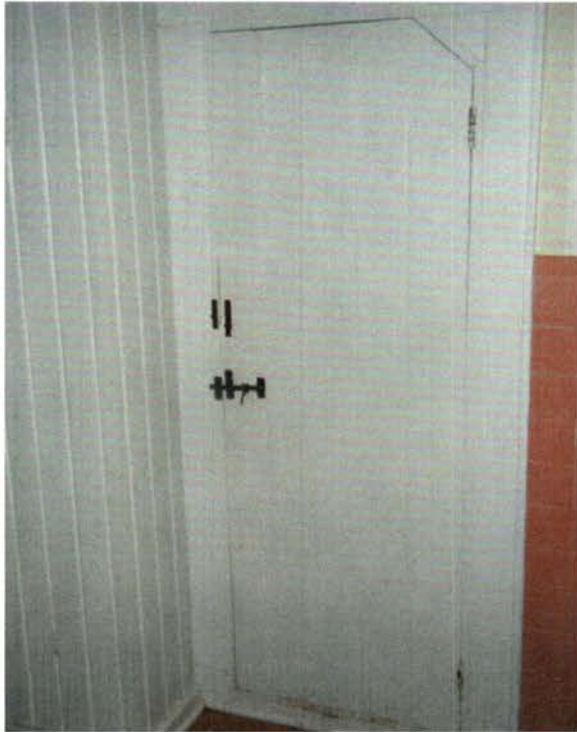
Photo 97: Bathroom (Room 105) looking south to the door to Bedroom #2 (Room 104). This opening would be widened in order to serve the barrier-free/ADA compliant lavatory.

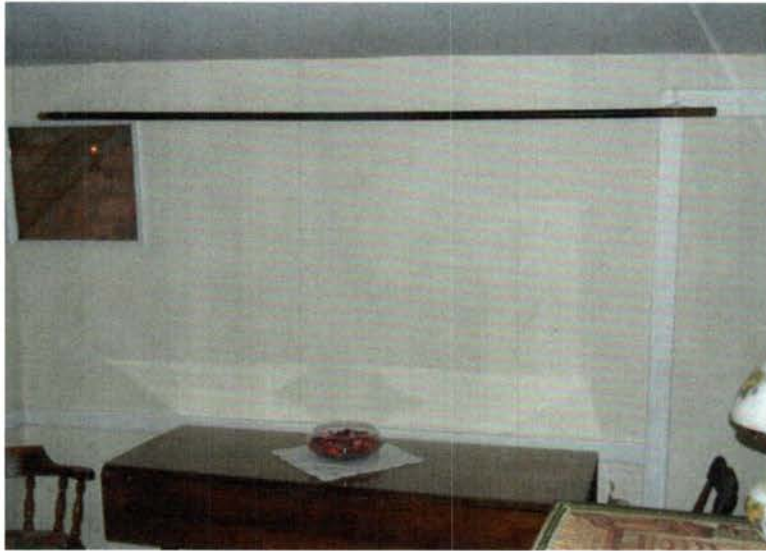
Photo 99: Bedroom #3
(Room 106) looking north.
This wall is common with
(the opposite face of) the wall
shown in Photo 67.

Photo 67: Looking west from the Kitchen (Room 108) down to Cellar C (Room 007) at the level of the 1st floor. This left wall area is common with the north wall of Bedroom #3 (Room 106). The areas between the studs are filled with non-structural handmade low-fired brick, mud mortar and horizontal wood nailers that serve to hold lath in order to plaster.

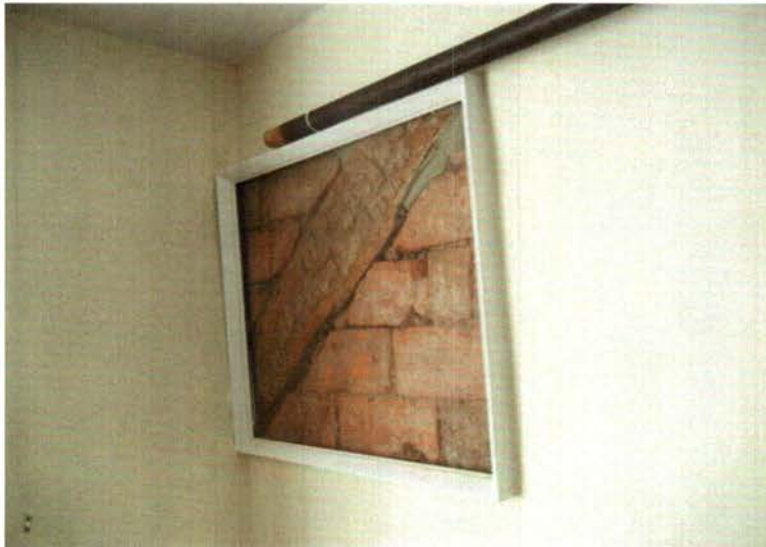
Photo 100: Bedroom #3
(Room 106) looking NW. A
“window to the past” shows
the non-structural handmade
low-fired brick, mud mortar
and diagonal wood strut that
has been gouged in order to
receive (key with) plaster.

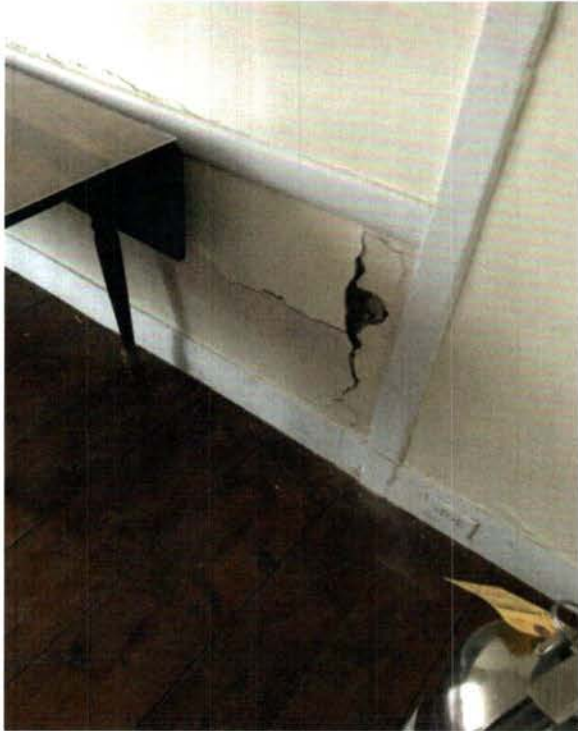
Photo 101: Bedroom #3 (Room 106) looking north. This lower wall area is common with (the opposite face of) the wall area shown in Photo 68. Excessive moisture from below is the source of the plaster failure.

- A. *Repair the damaged plaster surfaces at the north walls in Rooms 106 and 107.*
 - B. *Substantially rebuild or replace in-kind the wood stairway leading from the Kitchen*

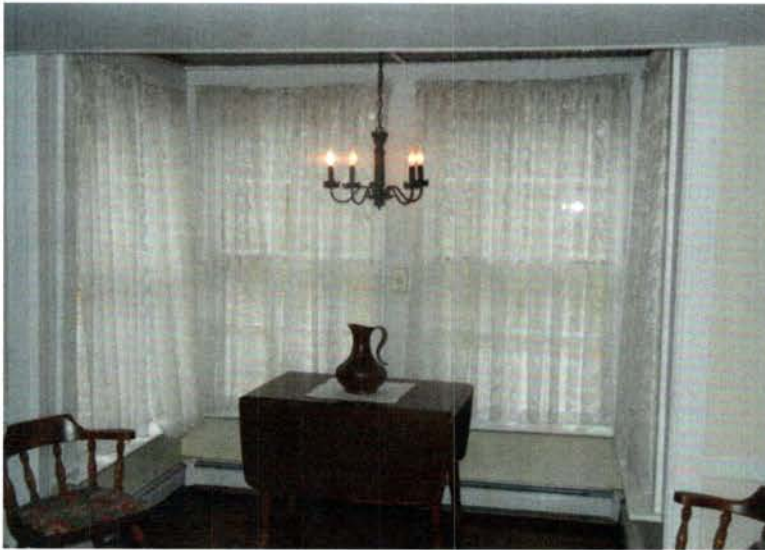
Photo 102: Bedroom #3 (Room 106) looking west to the projecting bay window. This area is labeled “new addition” on the HABS drawings.

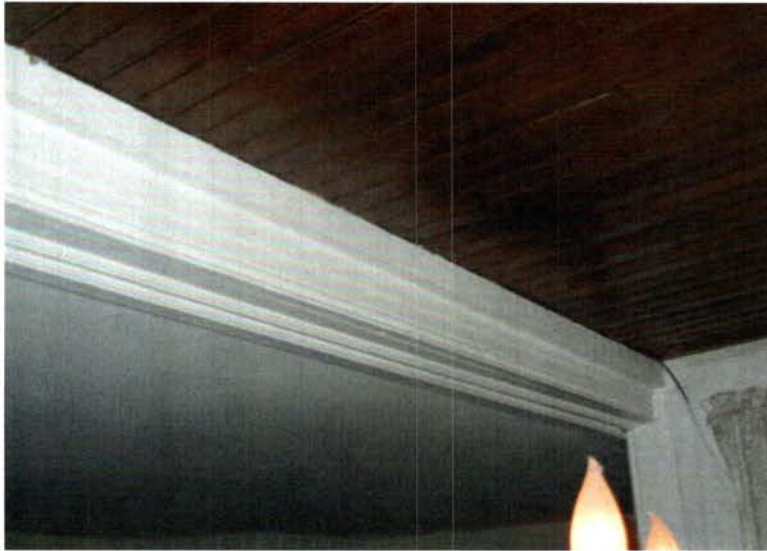
Photo 103: Bedroom #3 (Room 106) looking up at the ceiling and the transition from earlier area (left) to the “new addition.”

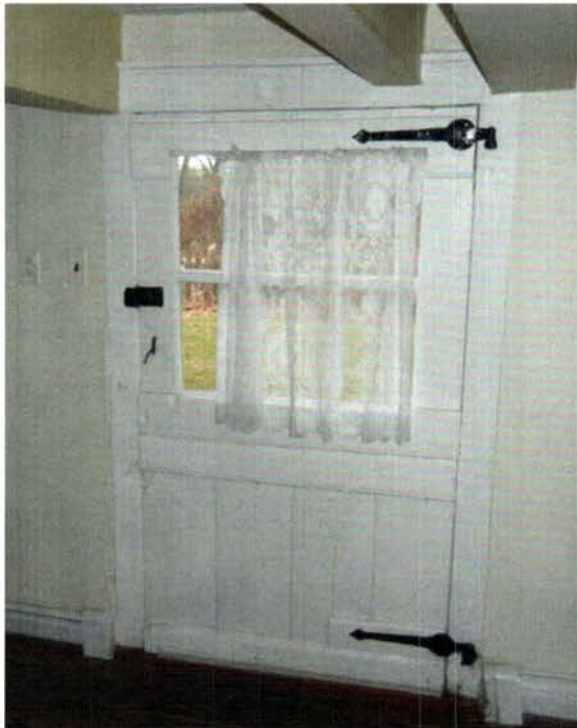
Photo 106: Dining Room (Room 107) looking east and Door C. Like the Dutch door in the Living Room (Room 103), the upper leaf has been altered to provide multiple panes. For reasons unclear, all beams overhead in this room have been boxed with wood boards. Two beams at the upper corners of the door show the locations of anchor-bents. The boxed "beam" between them is actually a plumbing line and is boxed in like the beams in order to camouflage it.

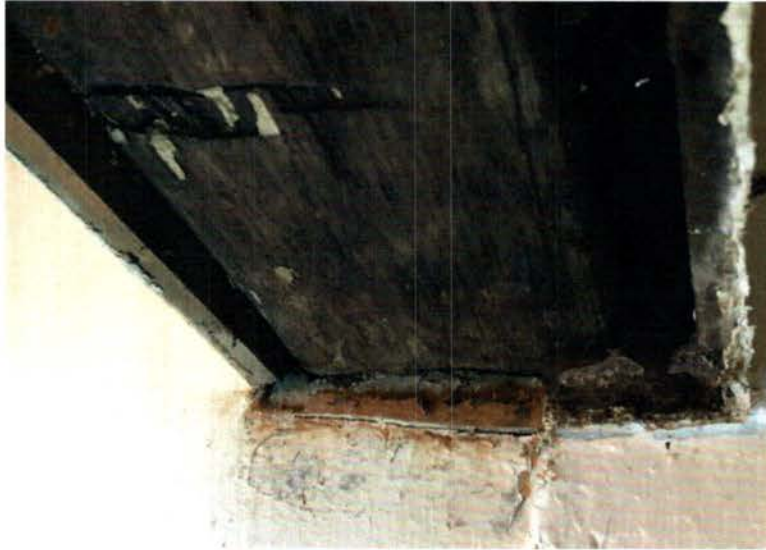
Photo107: Dining Room
(Room 107) looking at probe
made to reveal the condition
of the boxed beams.

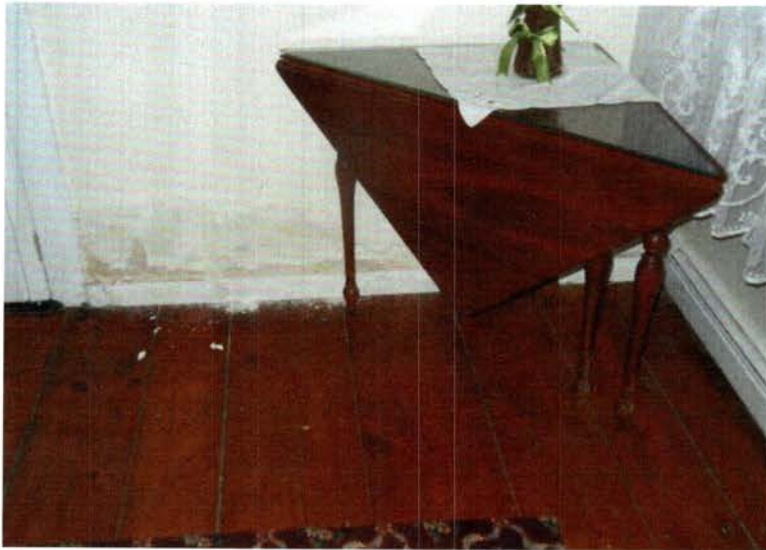
Photo 110: Dining Room
(Room 107) looking north.
Similar to the condition
in Photo 101, this lower
wall's deterioration is due
to excessive moisture from
below.

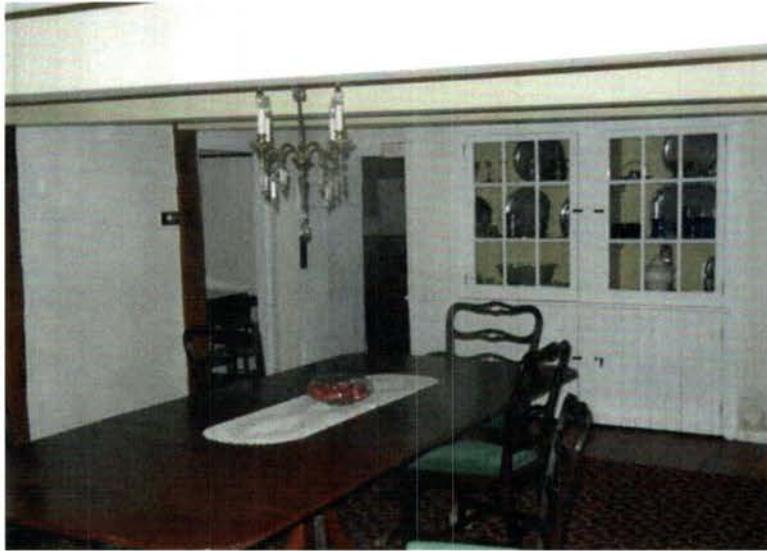
Photo 111: Dining Room (Room 107) looking north. The cupboards shown here replaced an earlier fireplace.

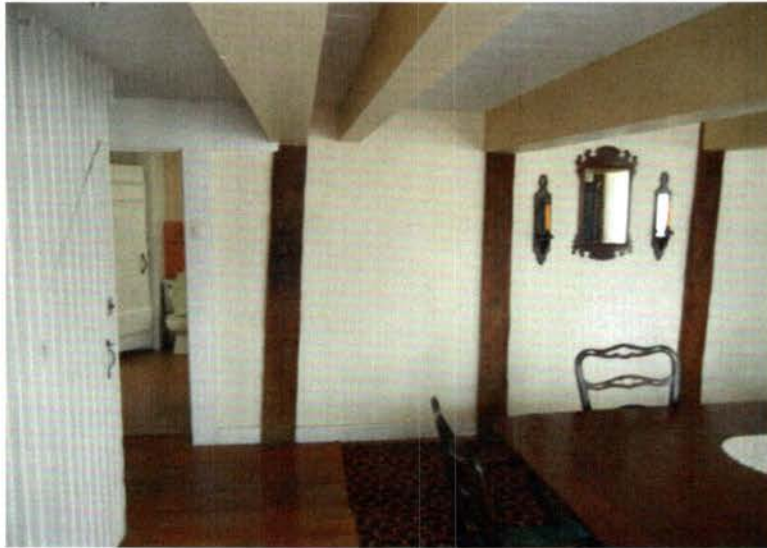
Photo 112: Dining Room (Room 107) looking west. Despite the out of plumb condition of certain posts, there is no sign of distress in the finishes adjacent to them.

Photo 145: Open Attic (Room 205) looking at the top of posts that create a step. The posts are exposed as the west wall of the Dining Room (Room 107) shown in Photo 112. This is possible evidence that Build B expanded to the west.

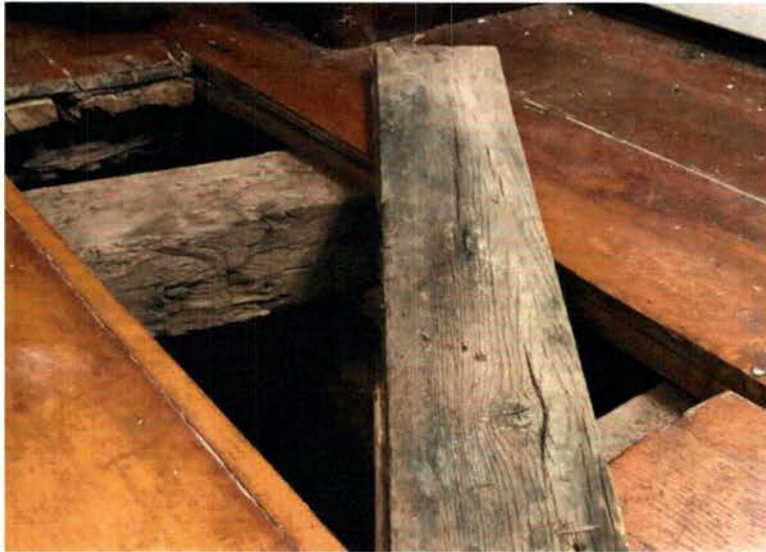
Photo 113: Dining Room (Room 107) looking NE near the east wall. An existing opening in the floor allowed closer observations of the unexcavated crawlspace below (Room 006).

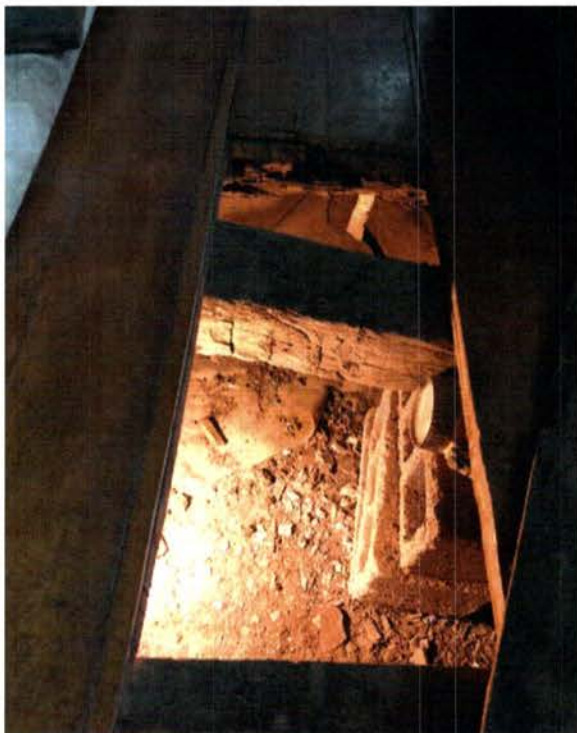
Photo 114: Dining Room (Room 107) looking into the existing access opening. A double layer of plank flooring is revealed as well as a previous stopgap intervention to support the first floor framing, namely snugging in CMUs on their side to support original framing.

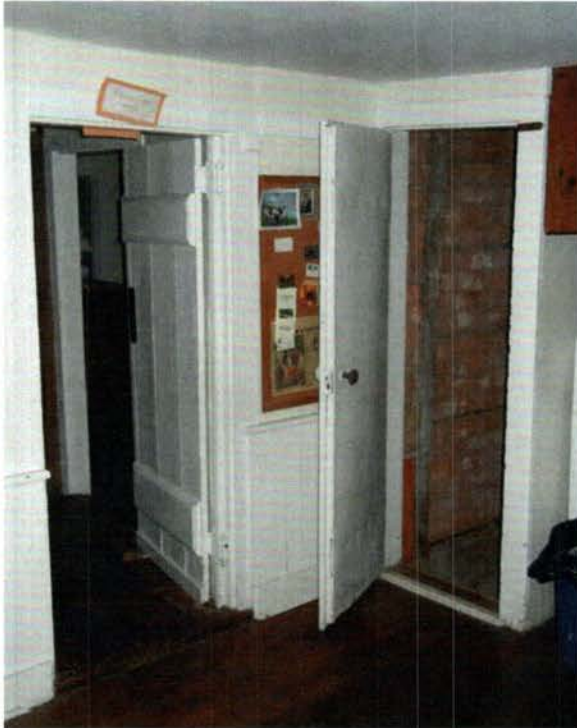
Photo 115: Kitchen (Room 108) looking SW and the door leading to Cellar D. The wall in the background is also described in Photos 67 & 68.

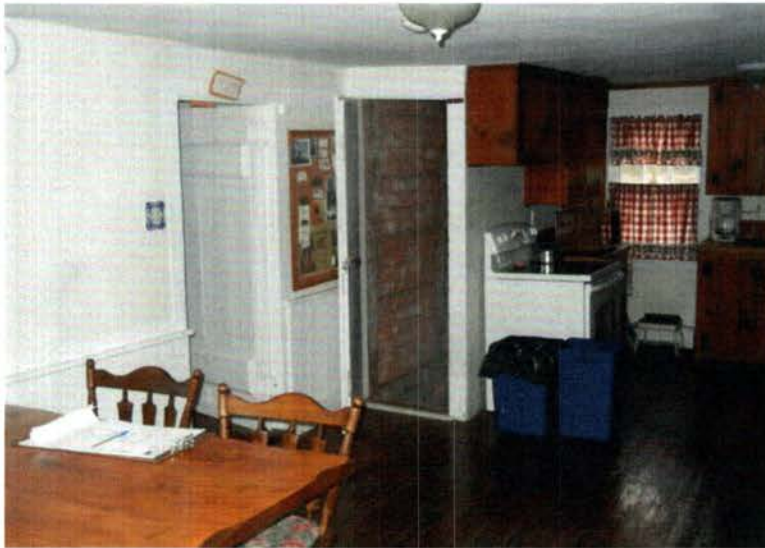
Photo 118: Kitchen (Room 108) looking west. A wall that once divided the area created a Pantry (in the area where the range/oven is shown) has been removed to create one larger room.

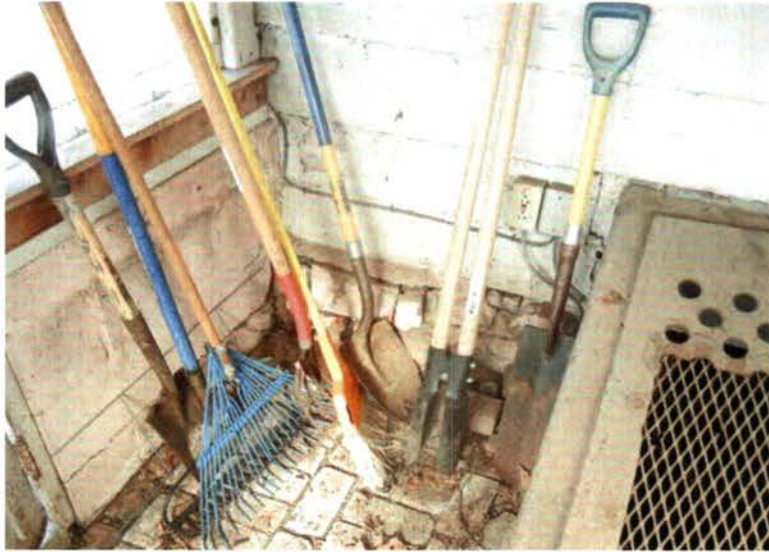
Photo 119: The NW corner of the Hothouse (Room 110) or Build D showing the brick paver floor and the metal areaway door leading to Cellar A (Room 001).

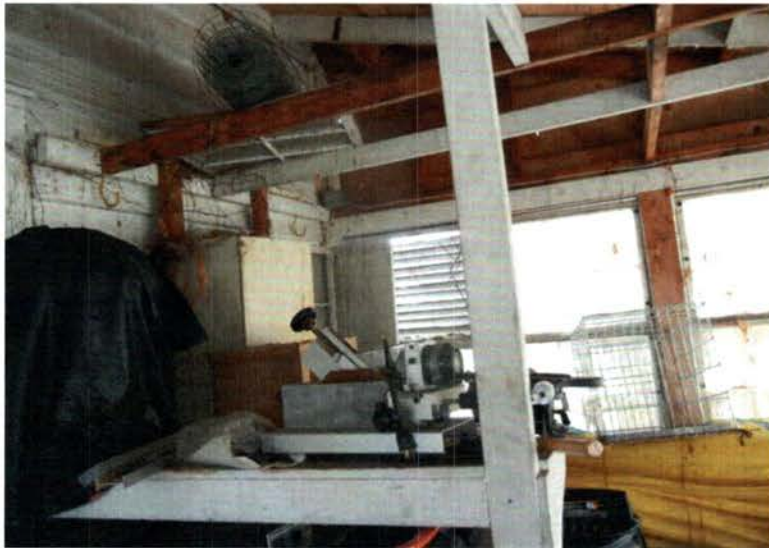
Photo 120: The NE corner of the Hothouse (Room 110) or Build D showing the interior frame and the translucent covers on the interior side of the double hung windows.

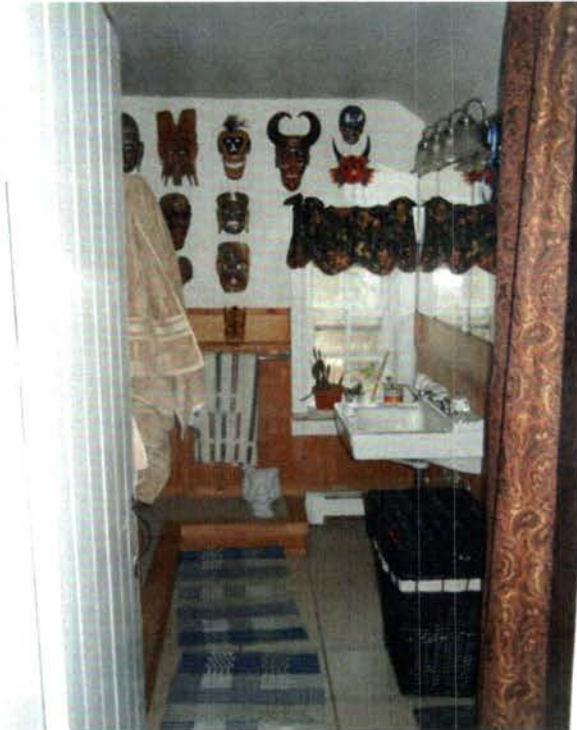
Photo 123: Hall (Room 201) looking south into the Bath (Room 202). The raised platform to the left allowed for the installation of plumbing without disturbing the ceiling of the room below, as this is part of Build A1.

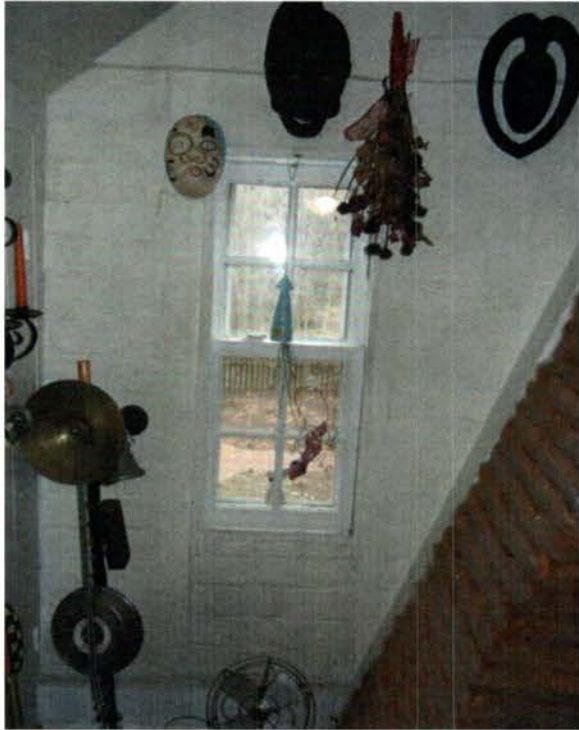
Photo 125: Closer view of the Kitchen (Room 203) looking south to the exposed brick chimneystack, window, wood framing and brick infill (or “nogging”) at the south gable. Both the wood frame and nogging at this location have been painted white.

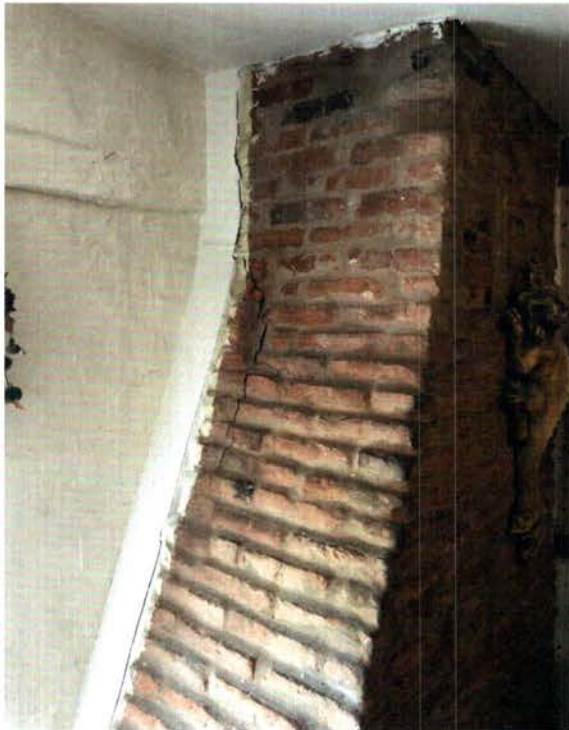
Photo 126: View of the Kitchen (Room 203) looking SW south to the exposed brick chimneystack and the crack that developed in recent years.

The south gable end wall of the original structure located above the hothouse addition (Build D) was visibly out of plumb, with the top of the wall at the ridge of the roof outboard of the lower wall at the hothouse roof/second floor elevation (see Photo F). The angle of this wall does not appear to have visibly shifted since the time of our original site visit. A crack in the brick of the chimney at this wall location was observed from inside the second floor of the structure and was measured to be approximately 3/16" wide at its widest point.

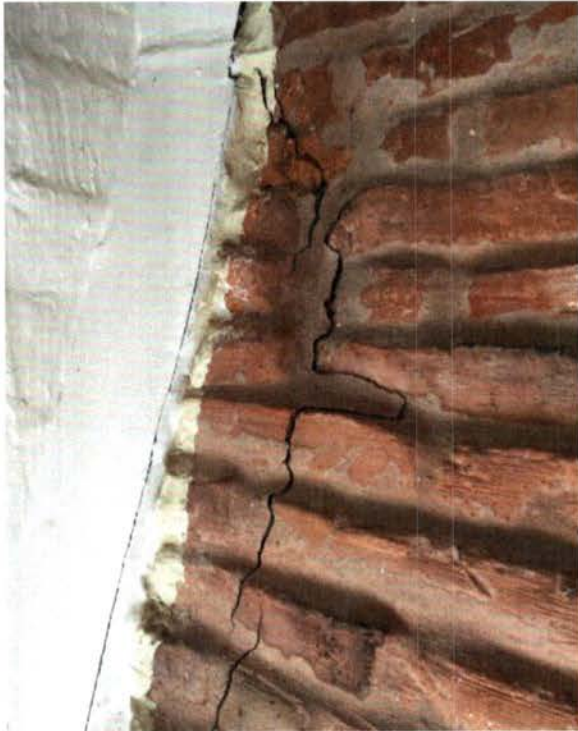
Photo 127: Kitchen (Room 203) looking SW south to the thru-unit crack at the exposed brick chimneystack. The freshness of the crack and the out of plumb condition of the south gable of Build A1 are part of the same mechanism of deterioration (see also Photo 22).

- C. *Conduct an invasive investigation inside (within) the uppermost attic of Build A (above the ceiling of the caretaker's apartment) to determine the cause for the slump of its ridgeline and the outward rotation of its south gable. Include the installation of a gauge to monitor the crack at the chimneystack inside the caretaker's second floor kitchen.*

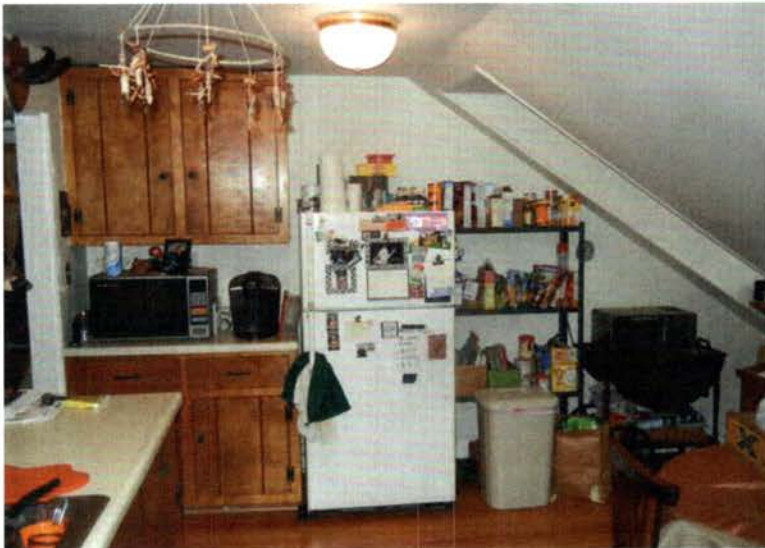
Photo 128: Kitchen (Room 203) looking north. The locations of the dormers in Builds A1, A2 and B (indicated in this room by the gap in the sloping ceiling) occur between existing roof rafters.

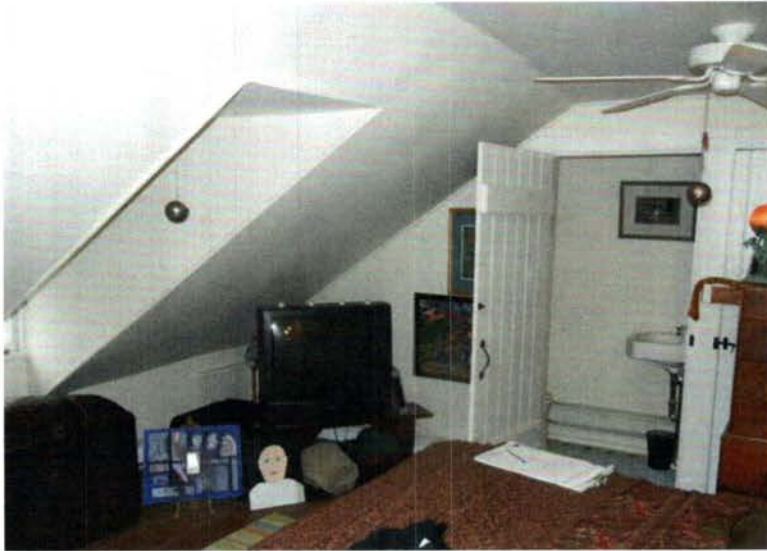
Photo 129: Bedroom #5 (Room 204) looking north. The installation of the half bath or Lavatory in the background necessitated the closets shown in Photo 91.

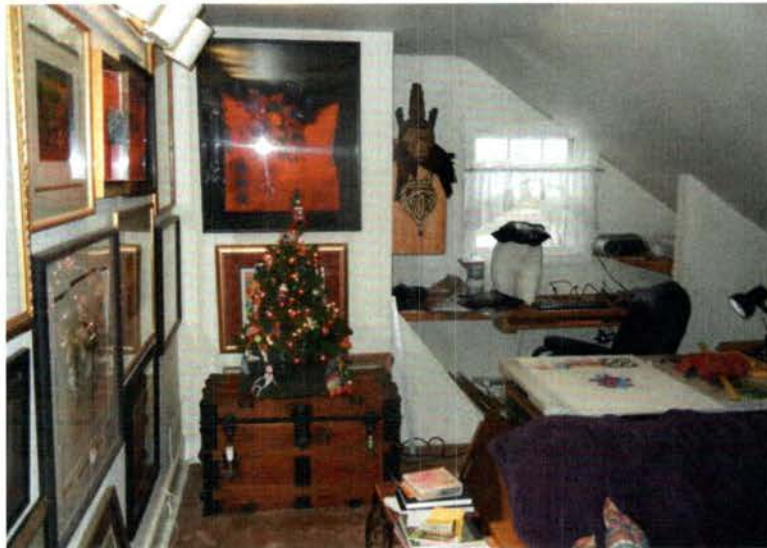
Photo 132: Living Room
(Room 204A) looking north.
The window shown here is
at the original gable end of
Build A2.

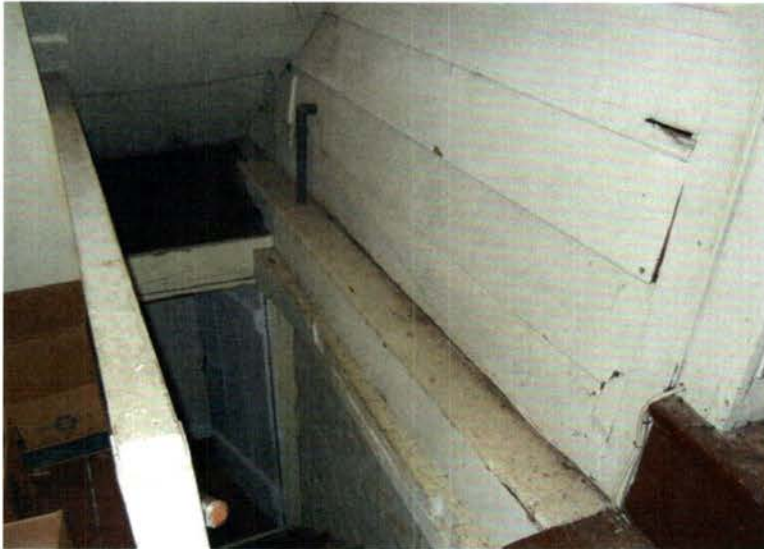
Photo 137: Open Attic
(Room 205) looking SE.

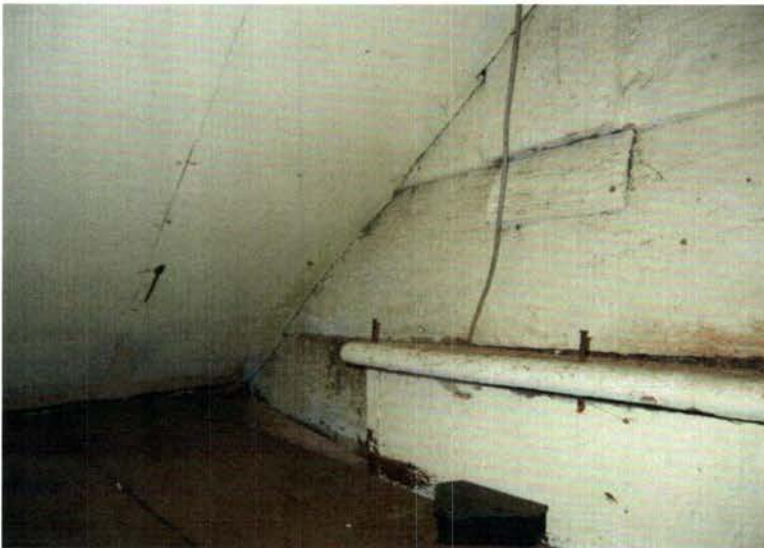
Photo 138: Open Attic
(Room 205) looking SE,
detail of previous view. The
clapboard was originally
exposed as the north wall of
Build A2.

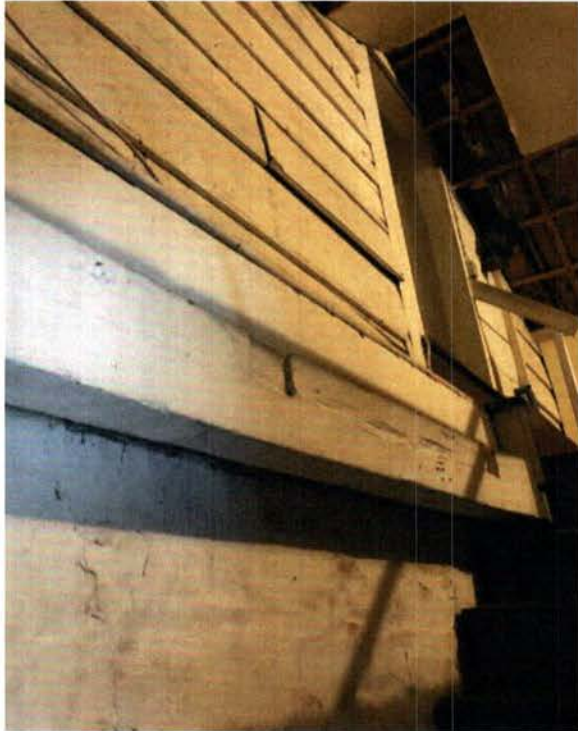
Photo 139: Open Attic (Room 205) looking up from the stairs from the Dining Room (Room 107). Notches in the beam of Anchor Bent B1 indicate that framing was removed in order to install the stairs.

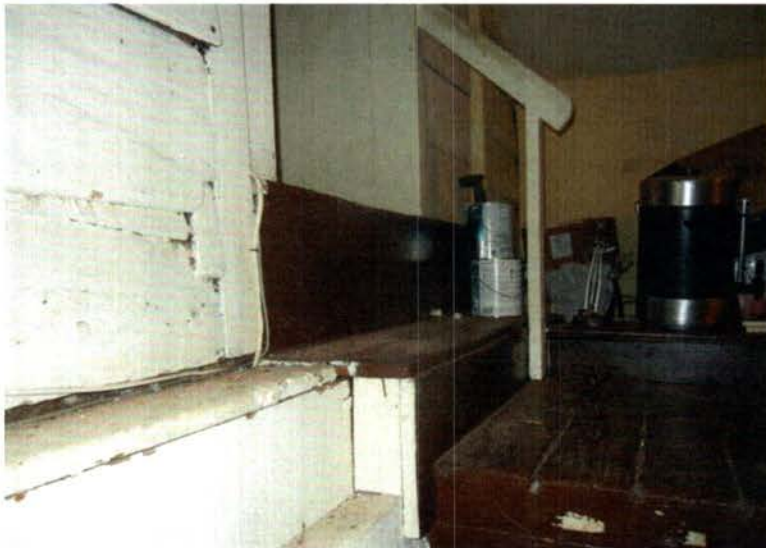
Photo 140: Open Attic (Room 205) looking west. The steps lead up to the 2nd floor level of Build A.

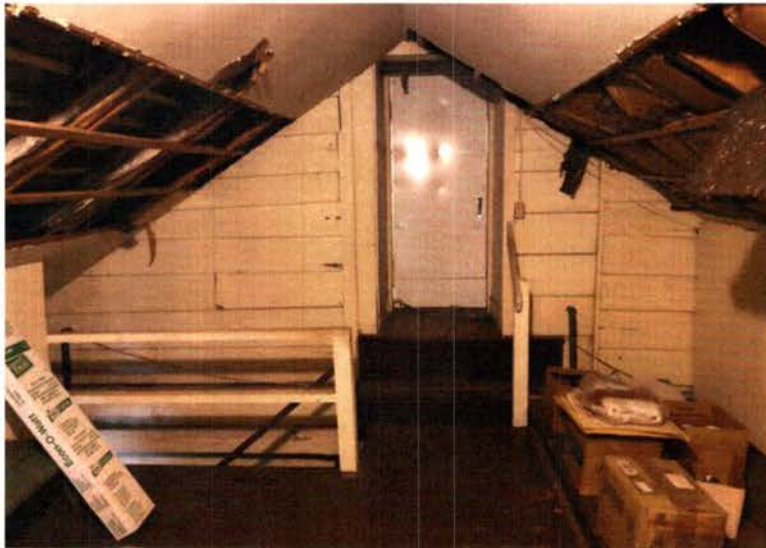
Photo 142: Open Attic (Room 205) looking south after the removal of finishes. The door open into Bedroom #5 (Room 204) but is sealed. Early or original beaded clapboard covers the left and right areas of this wall. It was once exposed as the north elevation of Build A2.

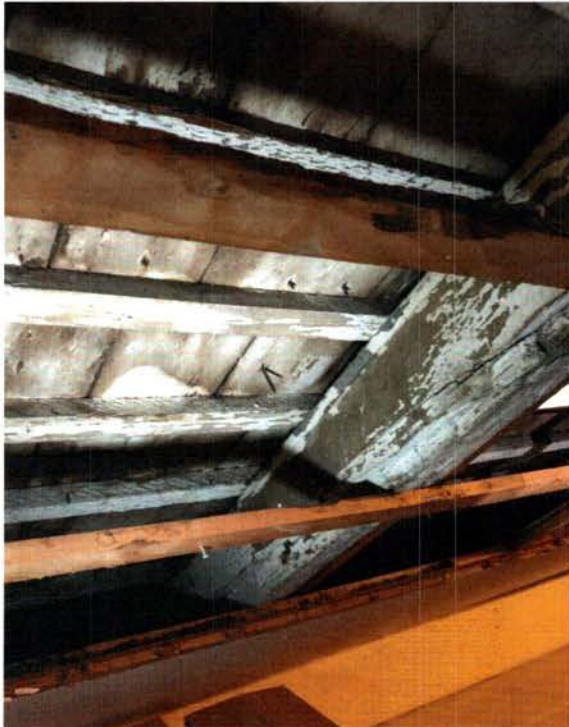
Photo 144: Open Attic (Room
205) detail. Partial removal
of finishes in this room has
revealed the whitewashed
rafters and the underside of a
wood shingle roof.

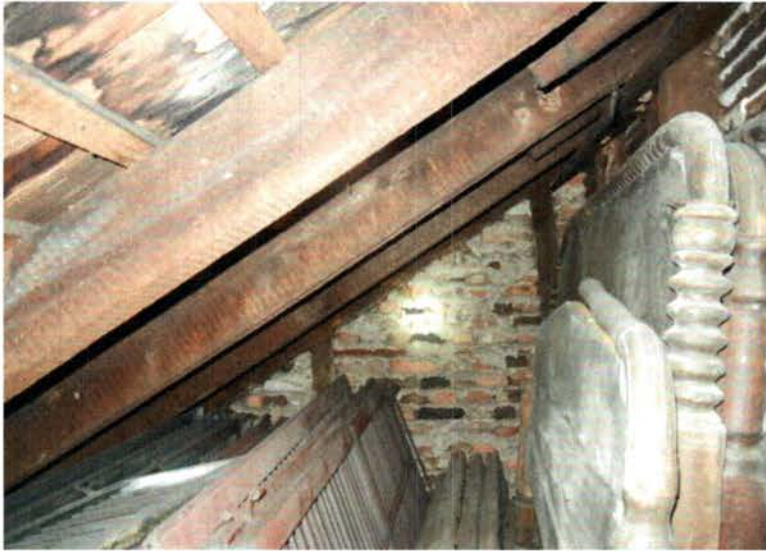
Photo 149: Kneespace (Room 206) looking south shows the brick nogging infill between Builds B and C rises to the attic level. The louvered shutters stored here are likely the type depicted in an early photo (see Figure #6 on page II-108 of this report).

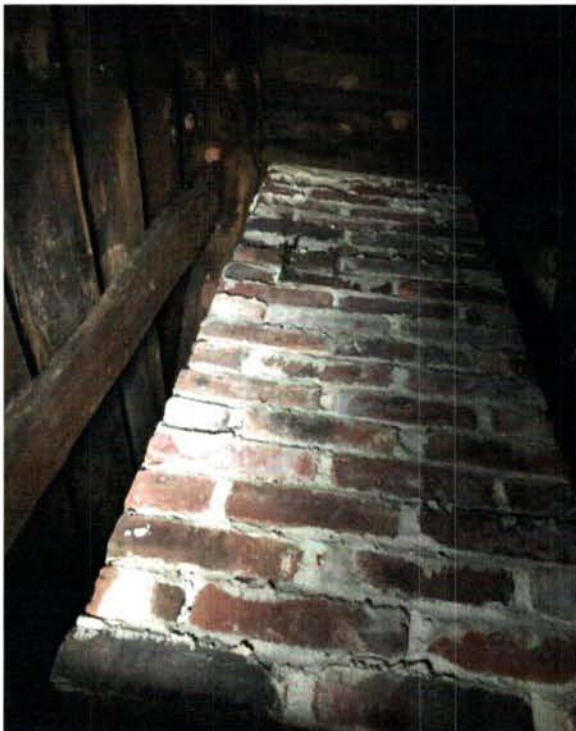
Photo 150: North end of the attic over Build A2 (Room 300). This chimneystack serves the north fireplace in the Living Room (Room 103).

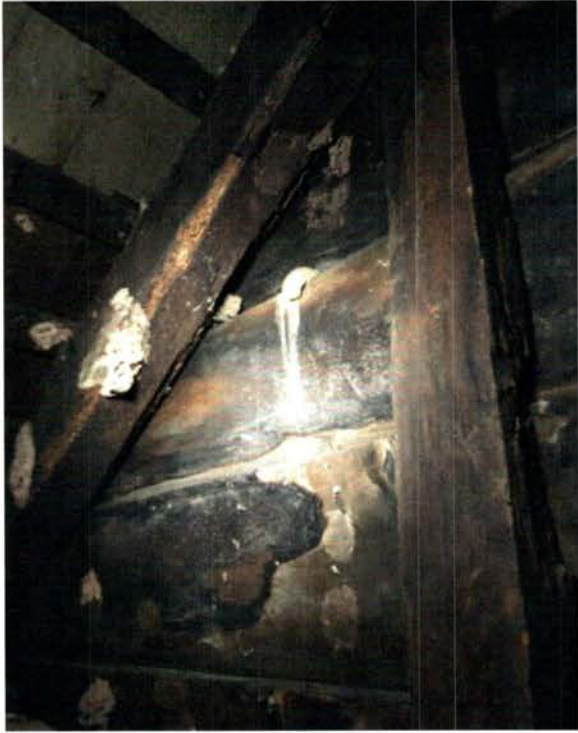
Photo 151: Attic over Build A2 (Room 300) showing the rear face of clapboards that at one time were exposed as the north face of this build.

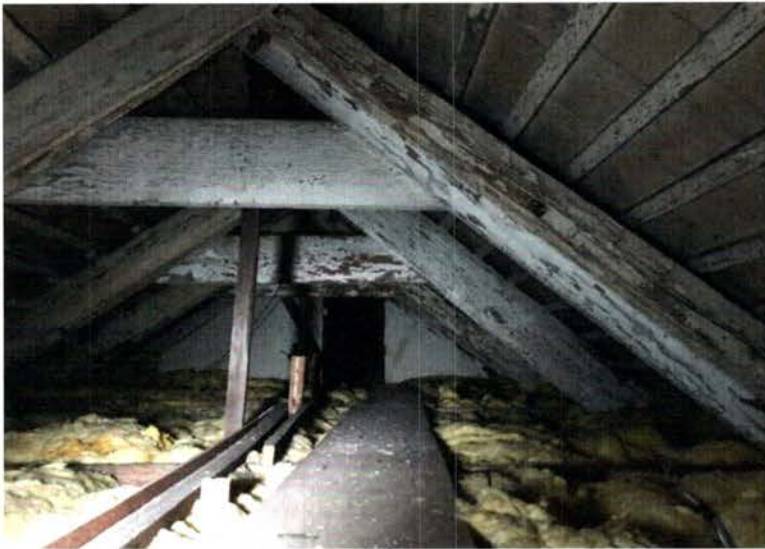
Photo 152: Attic over Build A2 (Room 300) looking south to the attic of Build A1. An the intermediate wall with the opening is possible further proof that Builds A1 and A2 were constructed at different periods.

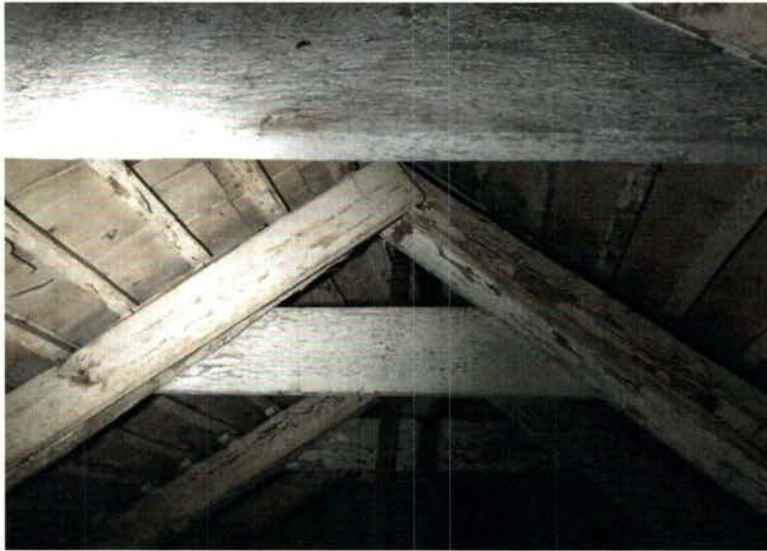
Photo 153: Attic over Build A2 (Room 300) looking south to Build A1 showing how face nailed 2x lumber has been used to strengthen the roof frame in this area.

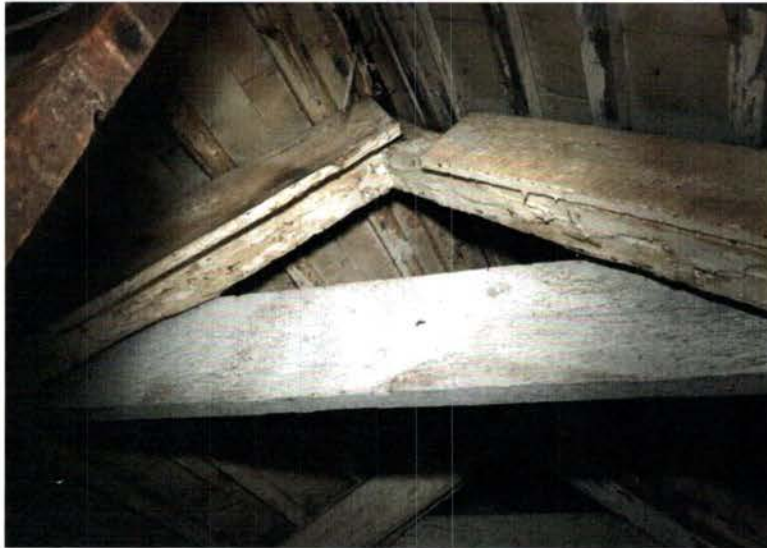
Photo 154: Attic over Build A2 (Room 300) reveals that 2x members have been surface mounted to the rafter in order to level out the roof plane.

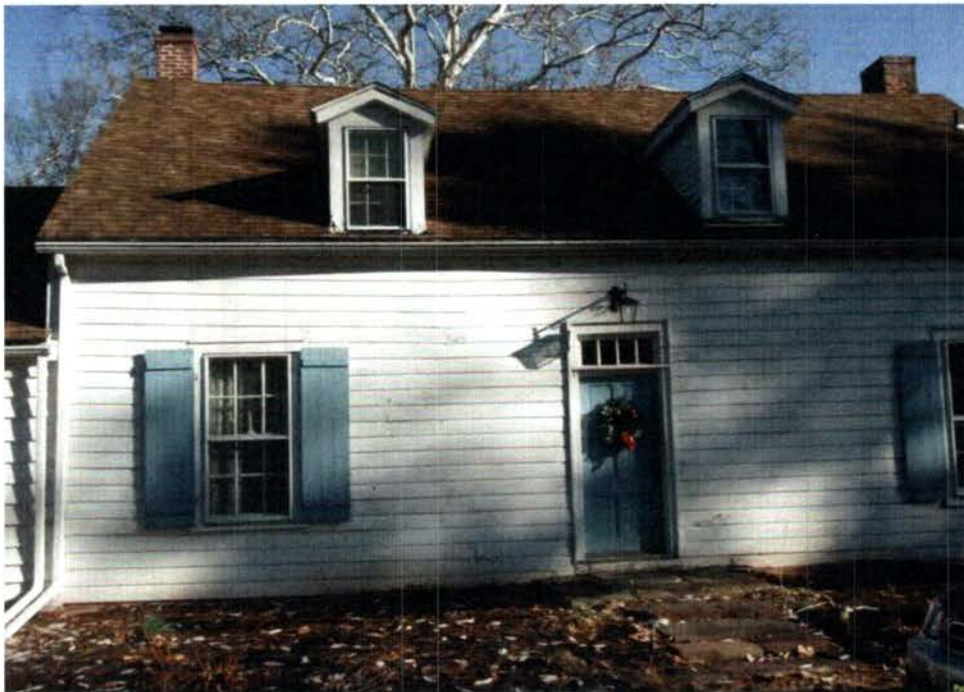
Photo B: West side of house in area of shifted siding and sagging roof

The roof of the structure consisted of asphalt shingles which were reportedly installed around 1977. We noted large areas of visible roof sagging between the dormers and adjacent to the north dormer on the west side of the original structure (Build A). The wood siding below this area was also observed to have shifted (see Photo B). A perceptible change in roof slope was observed between the dormers on the east side of the original structure, Build A. Some vegetative growth was observed on the dormers on the east side of Build A and small metal plates were added at the south dormer on this side due to animal intrusion at this location (see Photo C).

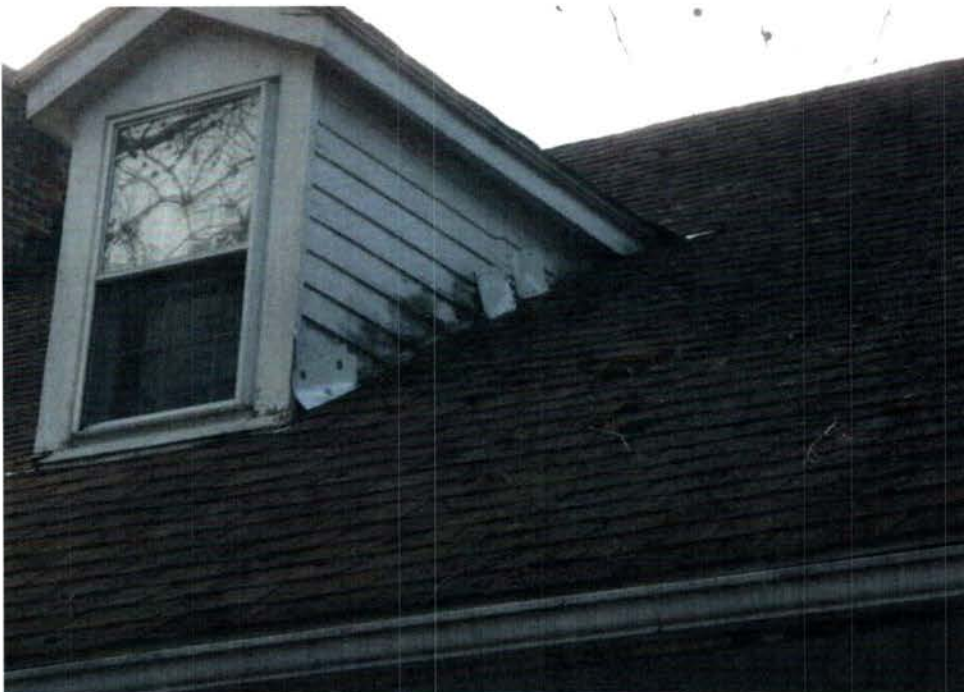
Photo C: Metal plates at south dormer on east side of original structure

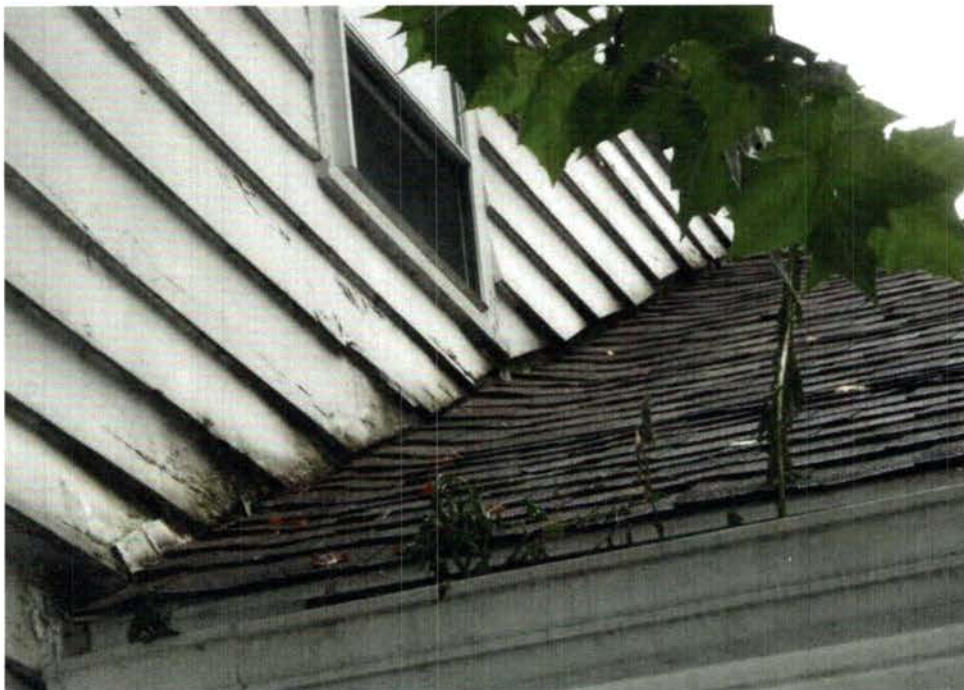
Photo D: East side of center addition roof adjacent to the original structure.

A large gap between the siding of the north end of the original structure, Build A, and the roof of the center addition, Build B, was observed (see Photo D). The clapboard wood siding at this location appeared to be newer than the other siding in the area but was poorly installed. A significant hump in the roof was observed at the intersection of the center addition and the kitchen addition (see Photo E). This location coincides with the damaged brick described further in the framing observations. Aside from this area, the ridge line of the structure appeared to be level to the naked eye.

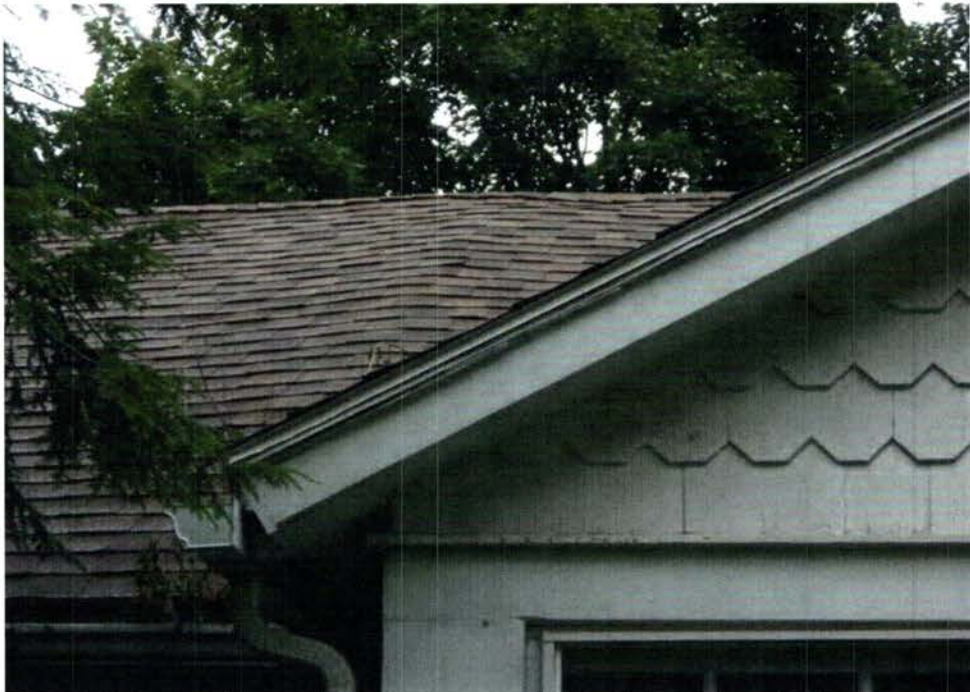
Photo E: Roof at the intersection of the center addition and the kitchen addition.

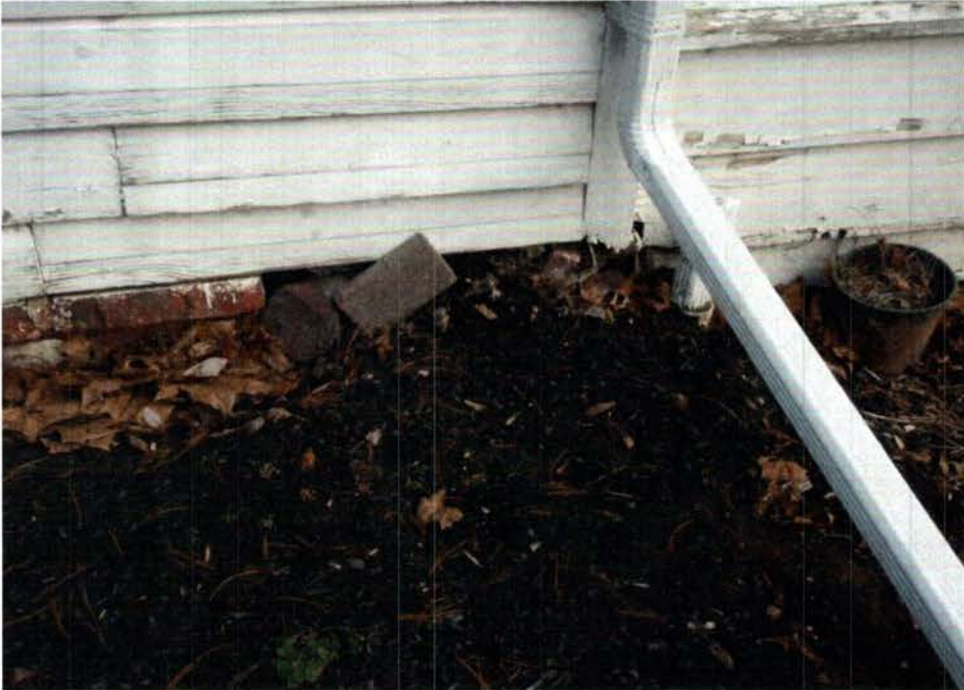
Photo G: Foundation deterioration at SW corner of original structure

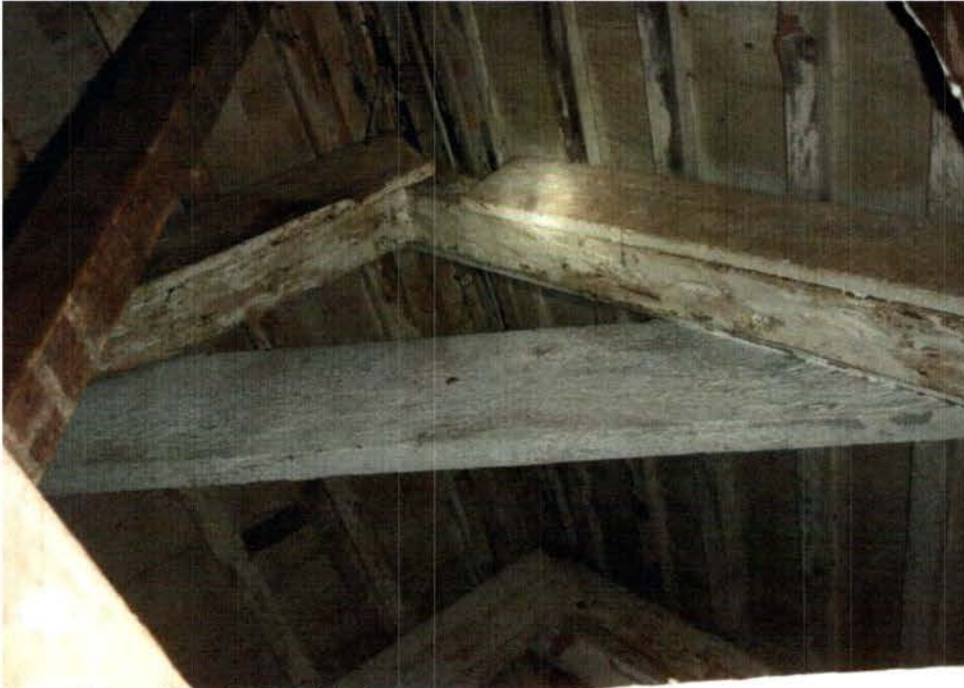
Photo H: Roof framing at original structure above Living Room (204A) and Bedroom #5 (204)
