Historic Structures Report for **Symen Van Wickle House**

1289 Easton Avenue, Franklin Township, New Jersey

April 2019

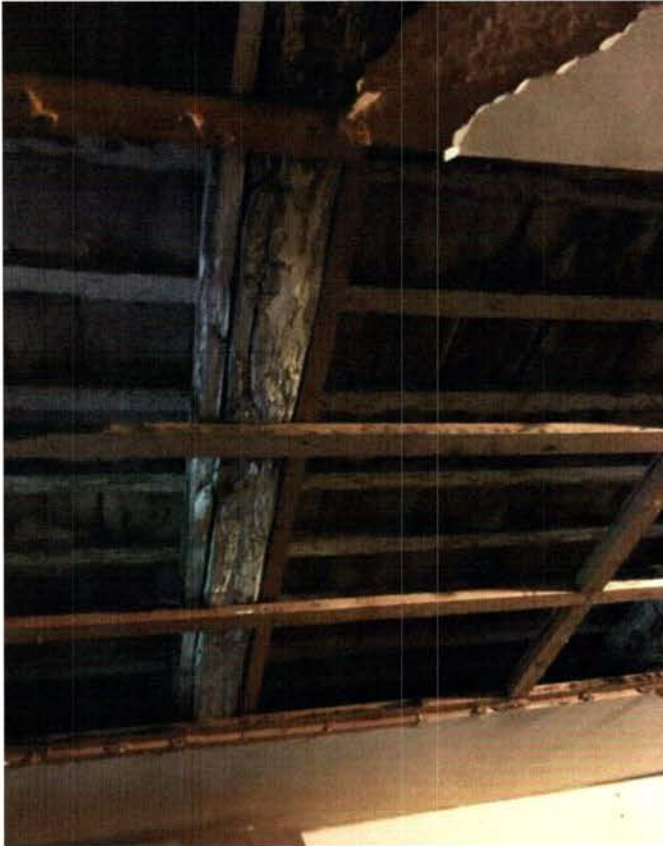
Photo I: Exposed roof framing at center addition portion of structure

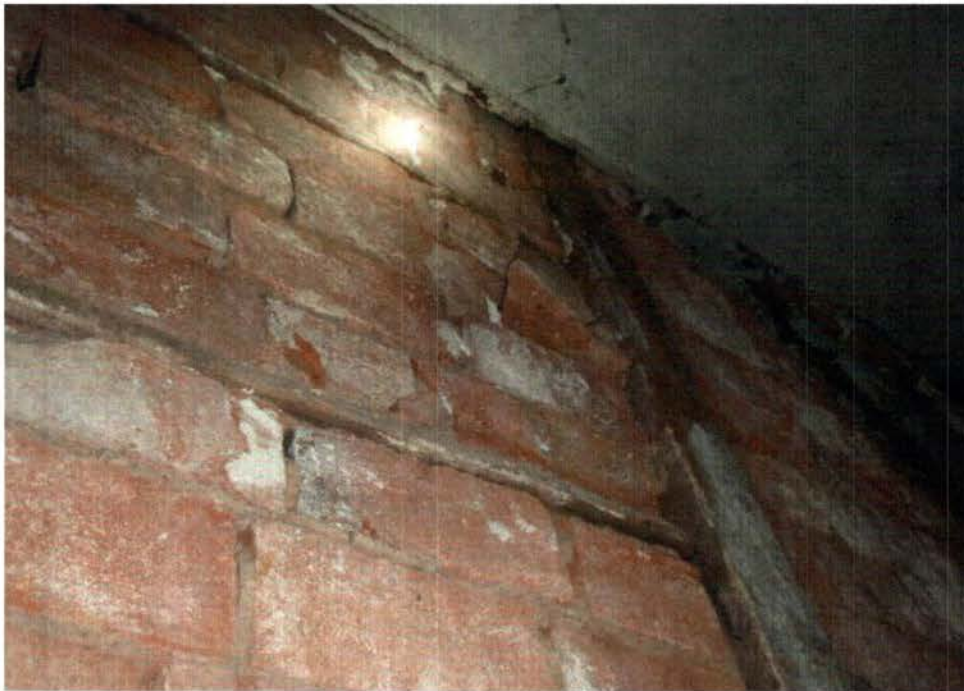
Photo J: Damaged brick at north wall of the center addition as seen from the kitchen stairwell to the basement.

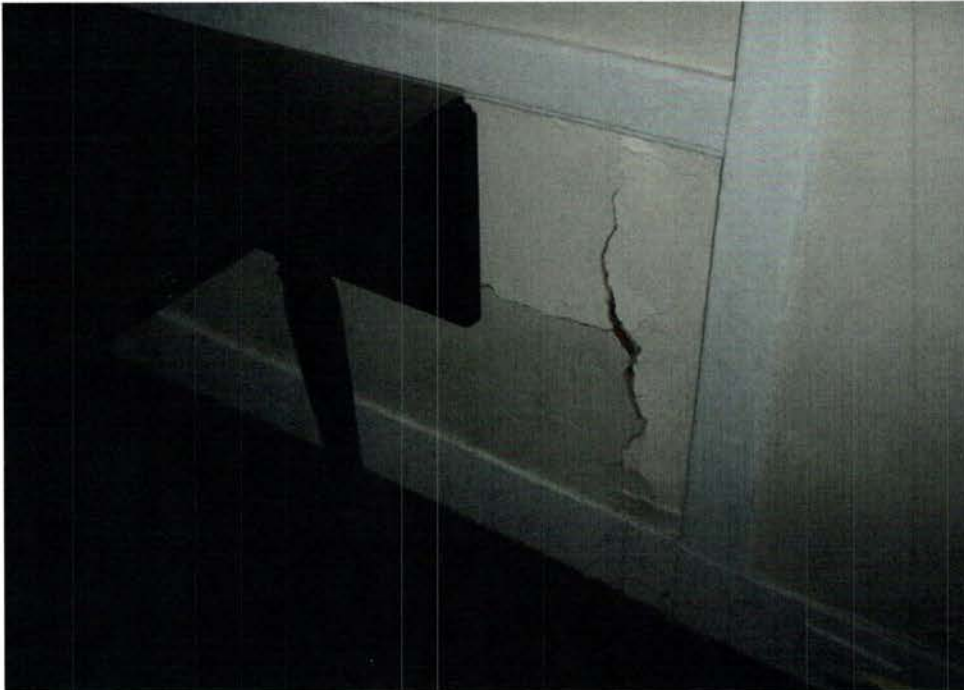
Photo K: Damage to the north wall of the center addition caused by water infiltration at the brick wall.

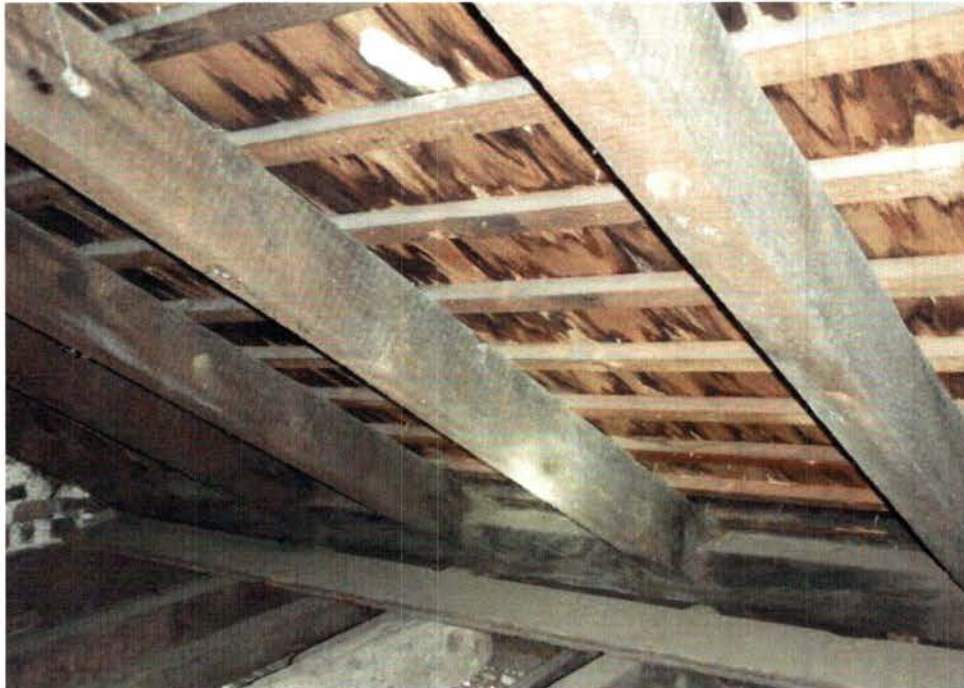
Photo L: Roof framing of the kitchen addition.

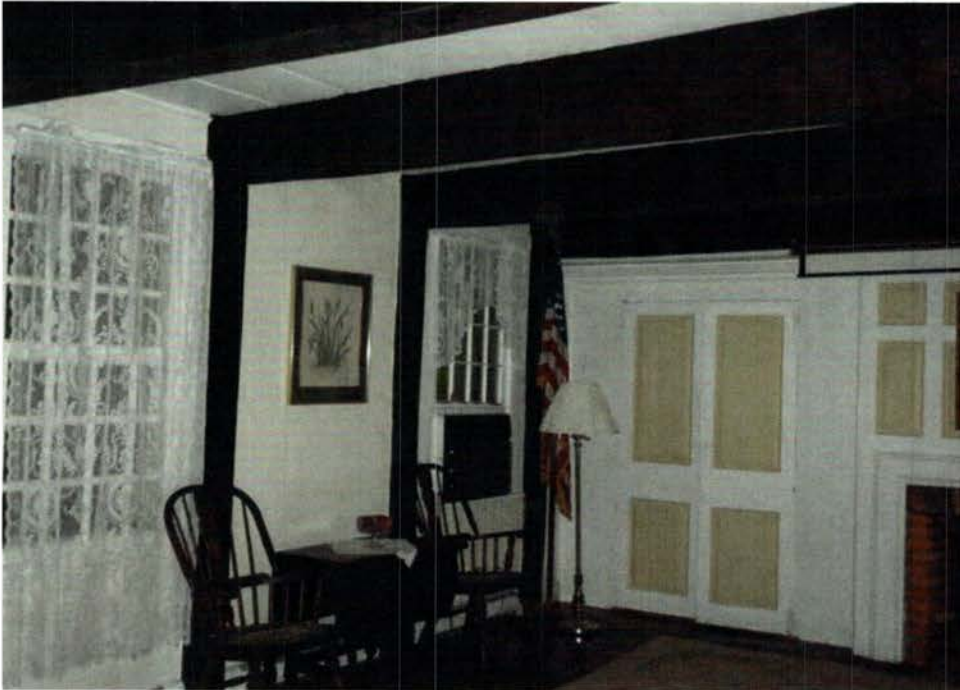
Photo M: Second floor framing in Living Room (103)

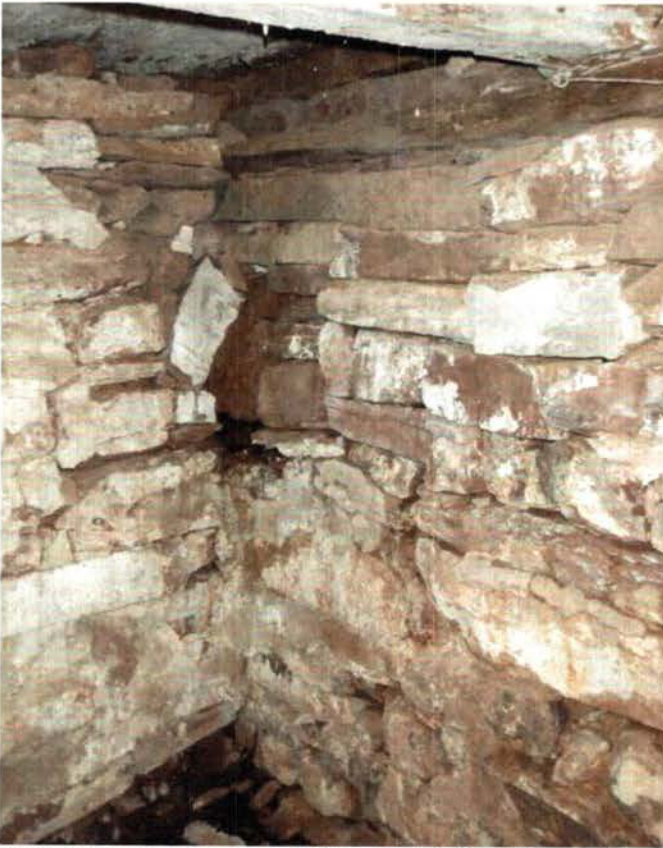
Photo N: Southwest corner of Basement A foundation wall

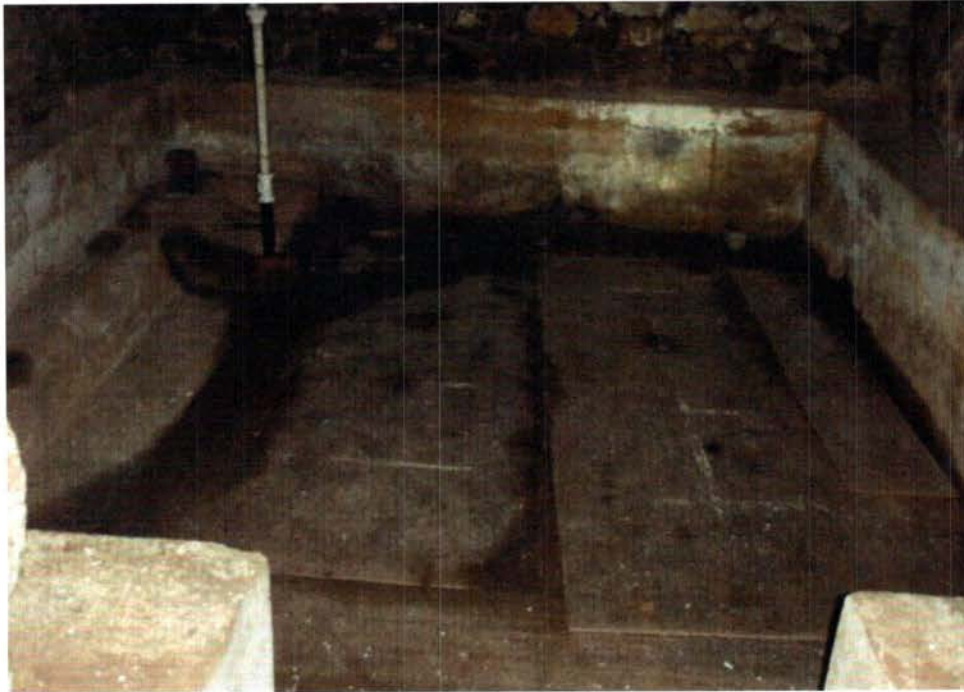
Photo O: Underpinning of Basement C

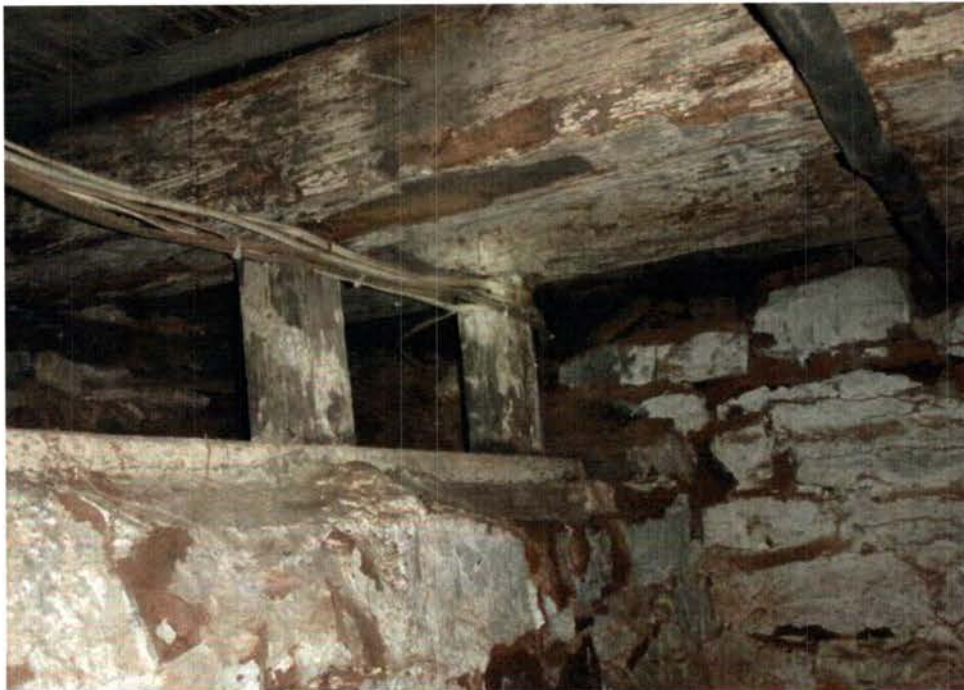
Photo P: Low wall at east side of Basement C

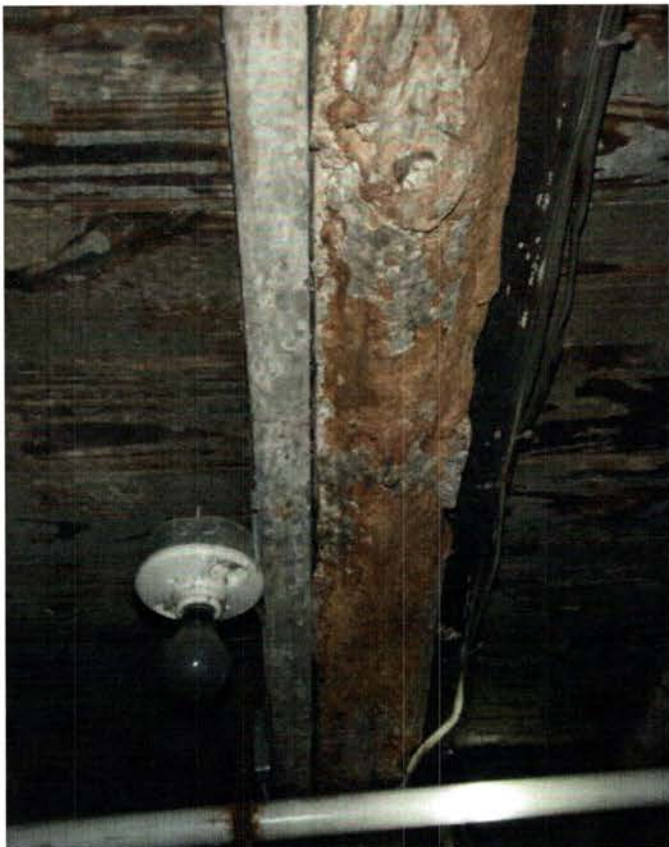
Photo Q: Damaged first floor girder in Basement C

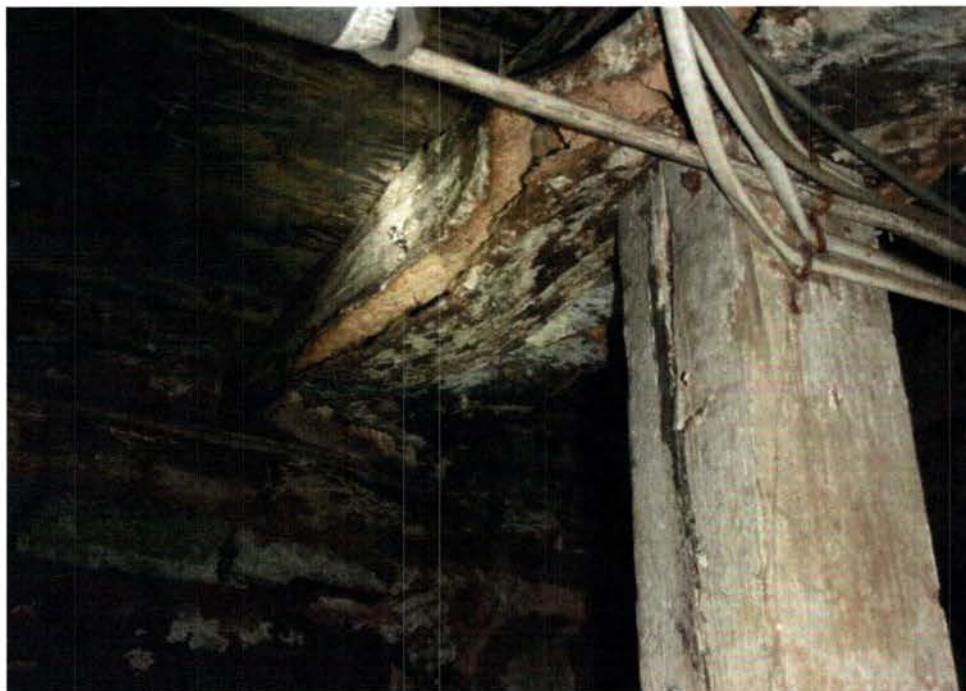
Photo R: Damaged first floor girder in Basement C

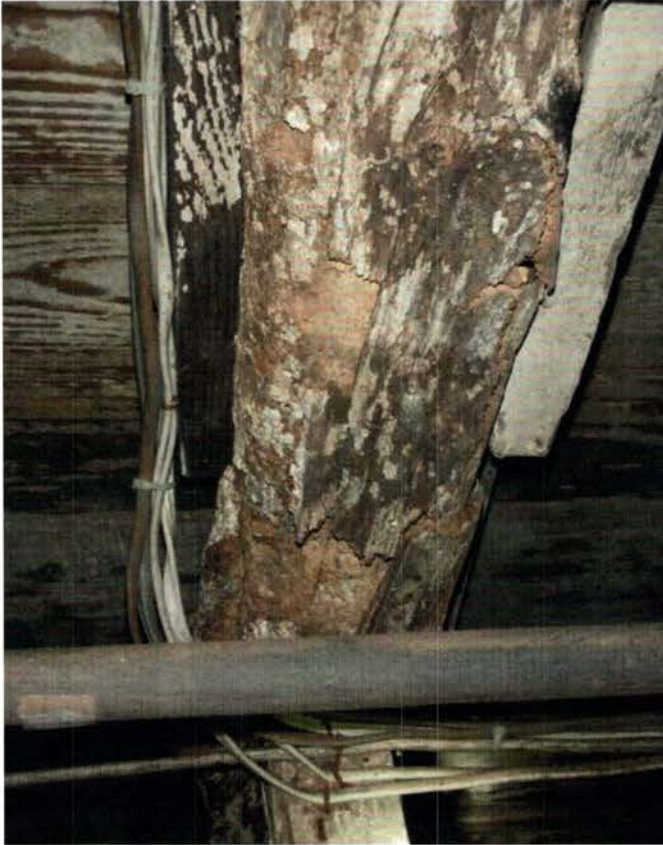
Photo S: Damaged first floor girder in Basement C

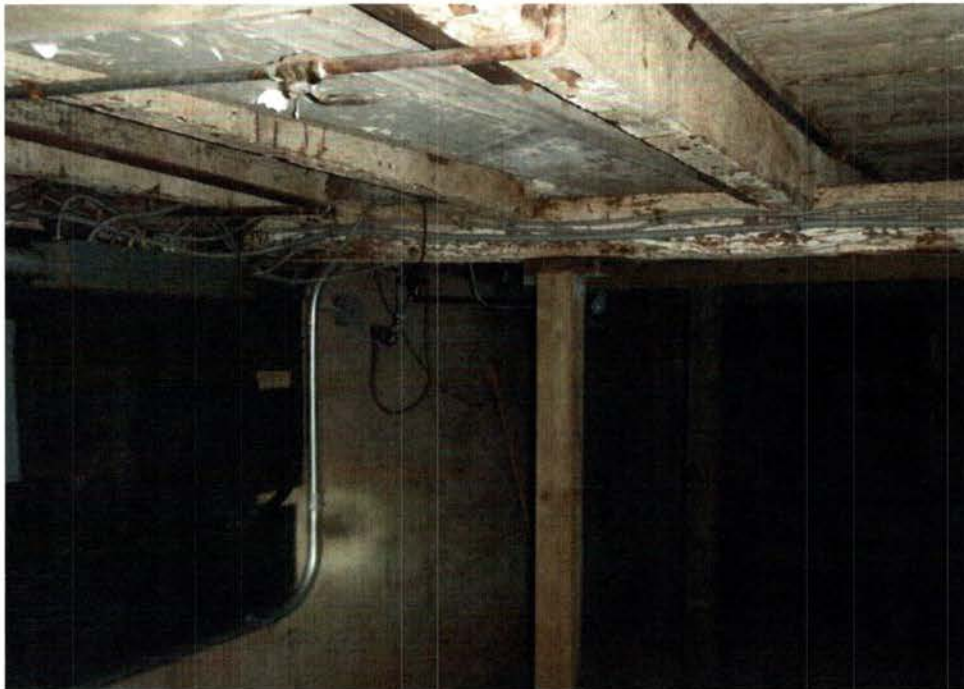
Photo T: First floor framing in Basement D

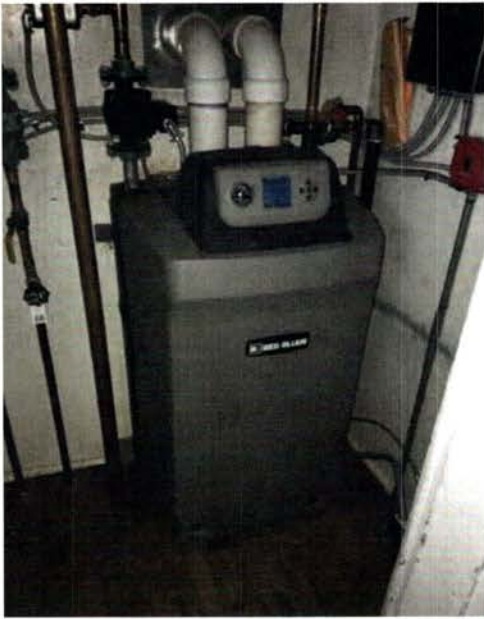
Fig. H-1
Boiler (103A)

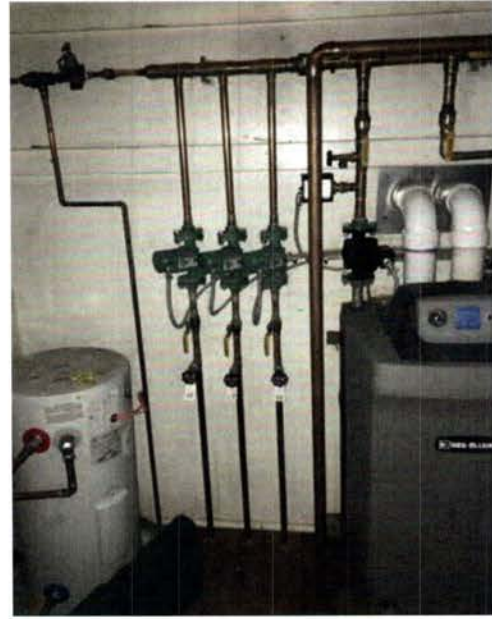
Fig. H-2
Boiler, Piping & Pumps (103A)

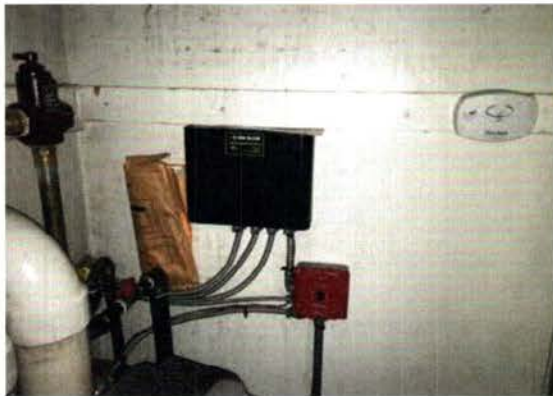
Fig. H-3
Boiler Controller & Shut Off (103A)

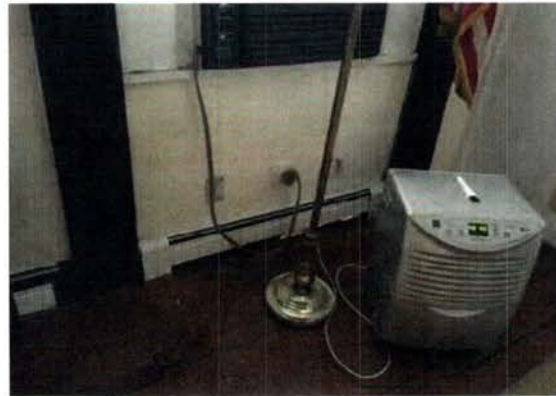
Fig. H-4
Dehumidifier (103)

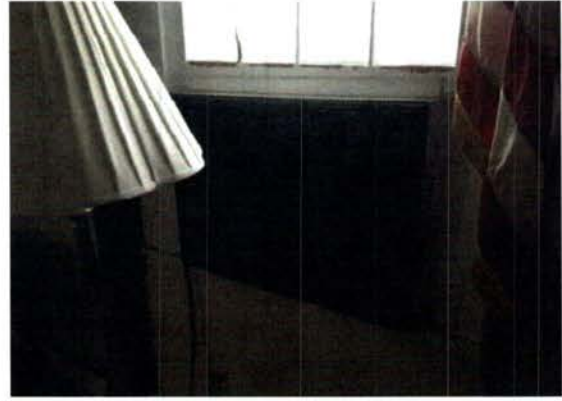
Fig. H-6
Window Air Conditioner (103)

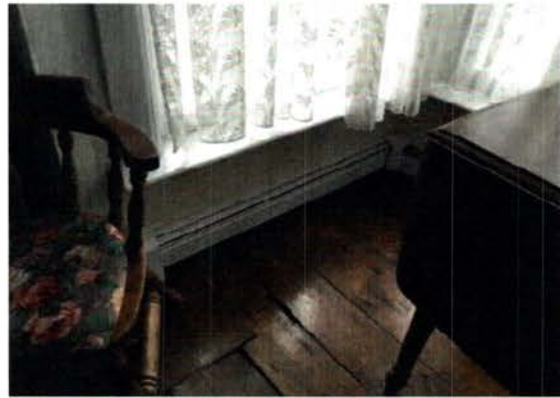
Fig. H-8
Baseboard Fin Tube Radiation (106)

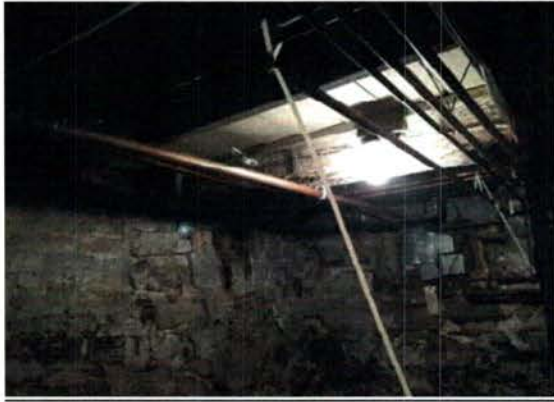
Fig. H-9
Heating Hot Water
Uninsulated Piping (002)

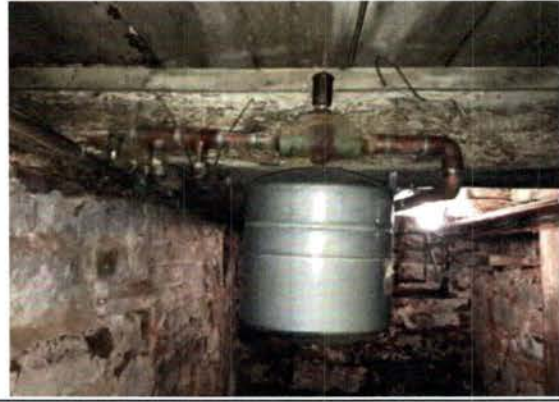
Fig. H-10
Air Separator And
Uninsulated Zone Piping (002)

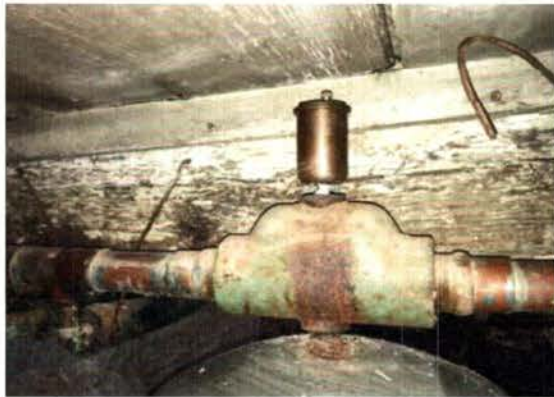
Fig. H-11
Close Up Of Air Separator (002)

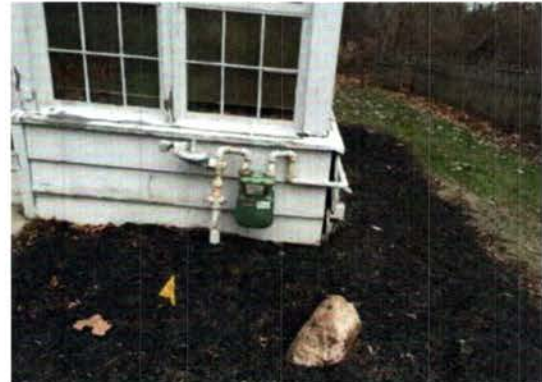
Fig. P-4- Gas Meter with exposed piping
on exterior wall.

Natural Gas Service: The distribution piping appears to be in good condition, but the piping is installed on the exterior of the building.

Natural Gas Service: Consideration should be given to removing the piping from the exterior wall and installing all of the new piping inside the building or piped underground to the boiler location. The existing piping is currently exposed on the building exterior and is exposed to weather and accidental damage.

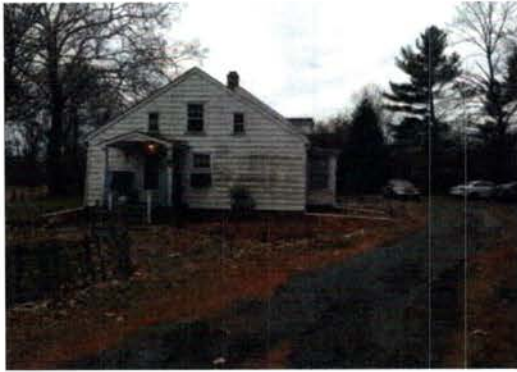
Figure E-1
Service Entrance (North Elevation)

Electrical Service: The electrical service entrance is in good condition, as are all of the existing distribution panels located within both the main house and apartment.

Electrical Service: Even though the incoming electrical service is in good condition, it is installed within the flood plain and could be damaged by a future flood. The service should be raised above the flood plain on the exterior of the building. In addition the distribution panels, for the main house are located in the basement, which is susceptible to flooding as well, and the panels should be relocated to the first floor or the second floor attic to reduce the risk of future damage due to flooding.

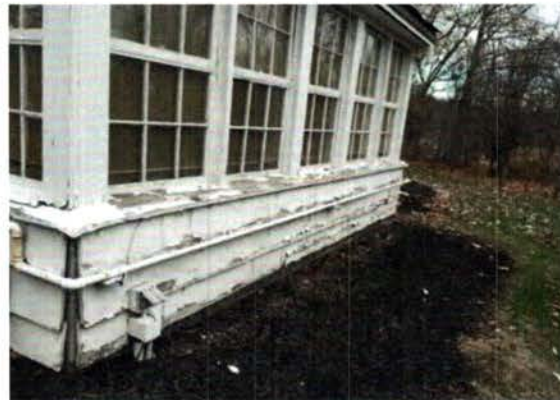
Figure E-16
Exterior Receptacle

Devices: The switches and receptacles throughout the building were in good condition. However the devices mounted to the exterior are in poor condition (See Figure E16).

Devices: The exterior devices should be replaced. Also, if it is determined that the receptacle in the bathroom in the main house is not GFCI protected, a GFCI circuit breaker shall be installed in the panel per code to protect the users of this device.

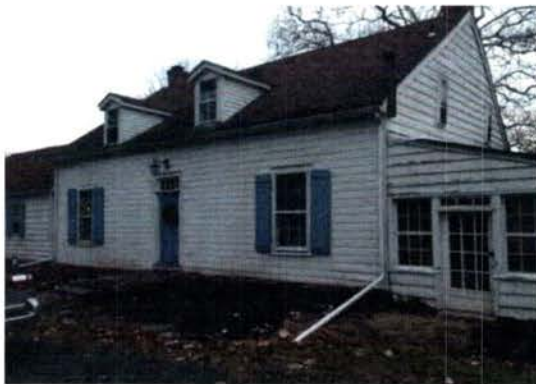
Figure E-17
Parking Area Lighting

Lighting: The lighting fixtures throughout the interior of the house were in good shape. However the exterior lighting for the parking area appears to be old along with the wooden support. Also the landscaping lighting located in the garden are broken (See Figure E17&E18). In addition there is currently no exterior emergency lighting installed at the site.

Lighting: The exterior lighting fixture which is utilized for the parking area shall be provided with a new support as well as the landscaping lighting shall be replaced in the garden.

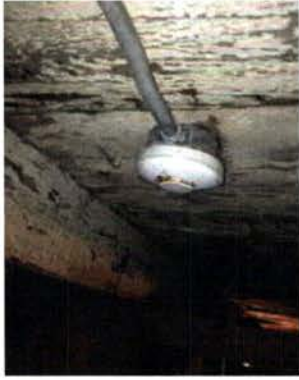
Figure E-19
Rusted Heat Detector (001)

Fire Alarm System: The fire alarm panel and annunciating devices were in good condition however there were several heat detectors located within the basement that were rusted (See Figure E19).

Fire Alarm System: The rusted heat detectors located in the basement shall be replaced in with weather resistant models that will be able to withstand the moist environment that is present in the basement.

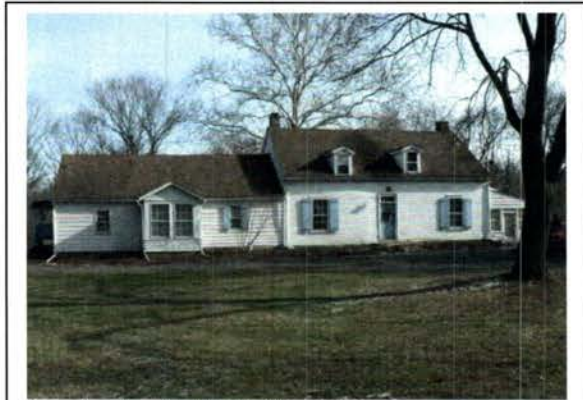
- There is no evidence of finishes that date to ca. 1772 original construction on exterior clapboard samples. Although analysis in "Build A" has focused only on a limited number of samples, clapboards possess abbreviated chroma-chronologies and do not display any evidence of original/early finishes that have been noted on the west façade. The presence of what appears to be a weathered wood substrate onto which the earliest *detectable* finish was applied suggests that earlier finishes may have been lost or removed. Additional analysis of window sashes in Build A may be warranted to compare to sashes from the west façade. Earliest clapboard finishes found were preserved on the interior of Room 205.

West façade with "Build A" at right.

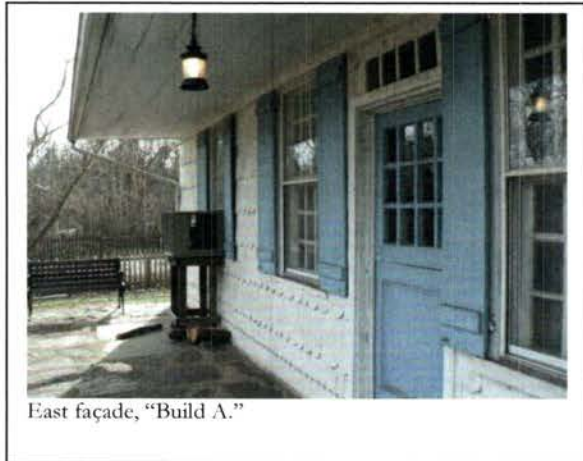
- Fish scale shingles display evidence of what are believed to be comprehensive chroma-chronologies, and were originally painted *reddish brown* (Munsell 2.5YR 3/2-3/4).
- Although minor alterations may have been made, much of the window trim displays evidence of comprehensive or near-comprehensive chroma-chronologies, and is either original or early. The earliest finishes are similar or identical in shade to those which have been noted for shingles, *reddish brown* (Munsell 2.5YR 3/4).
- The vintage of window sashes, including the transom window within the exterior door surround has yet to be conclusively determined, but they appear to be original or early. The earliest finish is a *pale yellow* (Munsell 2.5Y 7/2-8/2) paint layer.

East façade, "Build A."

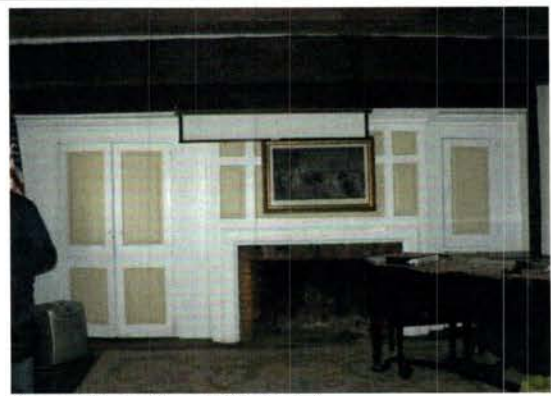
- Several features in the space that is currently Room 103 (Living Room, located in “Build A”) display evidence of what appear to be finishes that date to the earliest phase of construction ca. 1722 – including the fireplace surround at the south end of the room, the door and trim surrounding the opening to the exterior in the center of the east wall, window trim in the north end of the room and door trim surrounding the opening in the center of the west wall. The earliest detectable finish on the aforementioned features is similar or identical to that which has been noted as an original ca. 1722 finish on certain exterior elements – a *reddish brown* (Munsell 2.5YR 3/2-3/4) paint layer.

Room 103, south end, “Build A.”

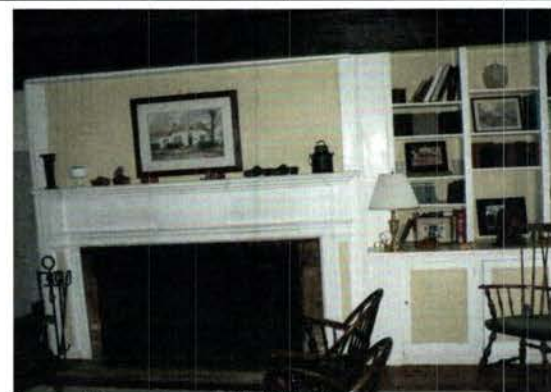
- Vintage has not been clearly established for the fireplace surround in the north end of Room 103. It should be noted, however, that the fact a sample taken from the surround does not contain the *reddish brown* paint layer found elsewhere in this space, but rather that the earliest layer is *grayish blue* (Munsell 10B 6/1), a shade which is more strongly associated with a later build, raises the possibility that the north fireplace surround dates to later than ca. 1722; the style suggests later Federal era as well, possibly as early as 1785.

Room 103, north end, “Build A.”

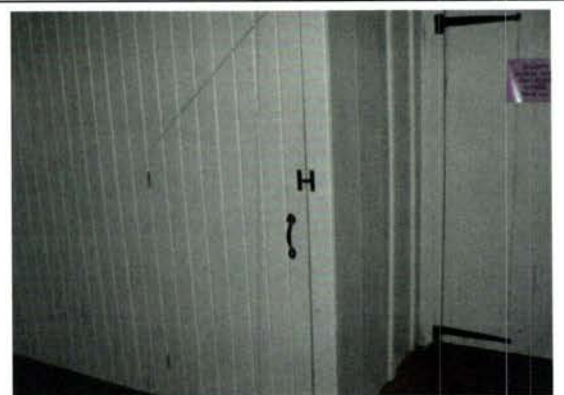
forms part of the stair enclosure at the south end of the room. Several layers of a *grayish yellow* finish are present on the wall. Not only do the color (*grayish yellow*) and characteristics (opacity, thickness and autofluorescence in UV) differ from those of the aforementioned *medium gray* paint layer, but they also match those of the earliest detectable finishes on a clapboard which was originally exposed at the north end of "Build A" but which is now enclosed in Room 205 (Attic). Those observations, combined with roughness of and previous damage to some of the boards suggest that some of the boards used to enclose the stair in Room 107 are, in fact former exterior clapboards which were salvaged and re-used in this space. Narrow boards which form the northern face of the stair enclosure appear to be newer but have not been analyzed.

Room 107, stair enclosure with wide boards at right "Build B."

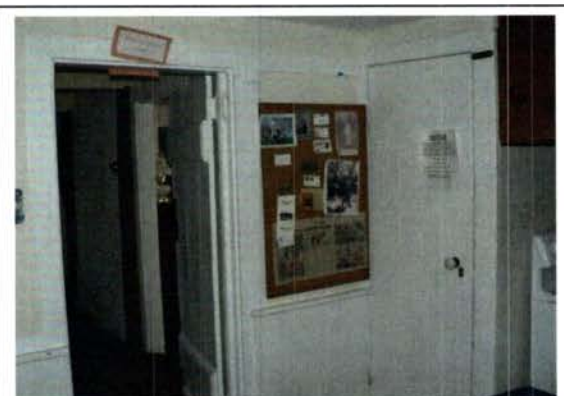
- Interpretation in Room 108 (Kitchen) is very preliminary and a work in progress.
- The earliest finish on a narrow wainscoting board on the east wall is similar or identical to the earliest finishes found in Room 107 ("Build B"/Dining Room) – a thin, *medium gray* (Munsell 10B 6/1) paint layer. The similarity suggests either that this portion of the wainscoting is contemporary/roughly contemporary with "Build B" or that this element was removed from "Build B," salvaged and reused when Room 108 (Kitchen) was completed during construction of "Build C."

- Noting that painting campaigns in kitchen spaces do not always correspond to those in primary spaces or spaces that are more formal (such as halls, dining rooms and living rooms), it is difficult to directly correlate chroma-chronological information from many samples in Room 108 to those elsewhere in the building. It is reasonably clear, however, that trim elements surrounding or adjacent to the openings within the north and south walls are contemporary with one another, and that the number of layers present could suggest a 19th century vintage. It is also clear that wide board wainscoting which is below the window opening and adjacent to the aforementioned narrow board wainscoting on the east wall is comparatively modern, possibly dating to the 20th century.

Room 108, looking south, "Build C."

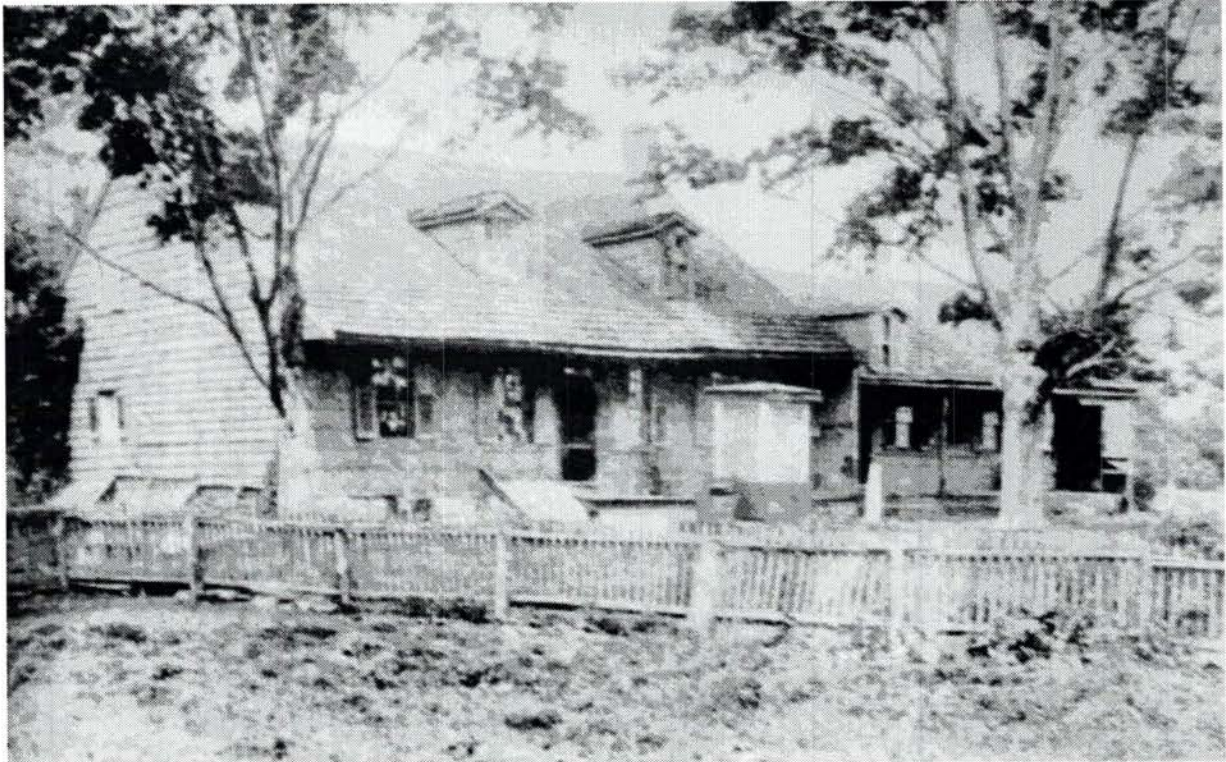
Archival photograph provided by Michael Calafati Architect, LLC, depicting east façade, apparently lacking kitchen addition associated with "Build C."

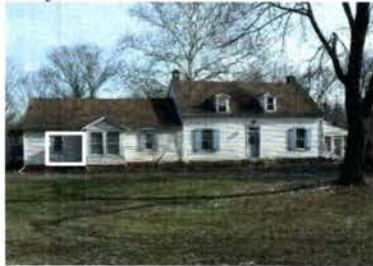
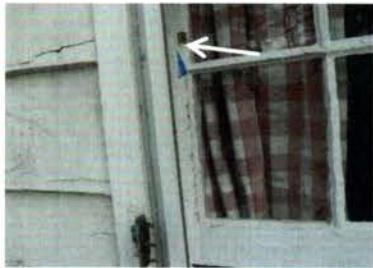
Location:	West Façade	Section Build:	C
Sample:	EXT-01		
Element:	Window sash (W108)		
Analysis:	<input type="checkbox"/> Manual cross-section/RLM	<input checked="" type="checkbox"/> Embedded cross-section/RLM	<input checked="" type="checkbox"/> Ultraviolet fluorescence
	<input type="checkbox"/> Binder characterization	<input type="checkbox"/> Pigment analysis	<input type="checkbox"/> Exposure window

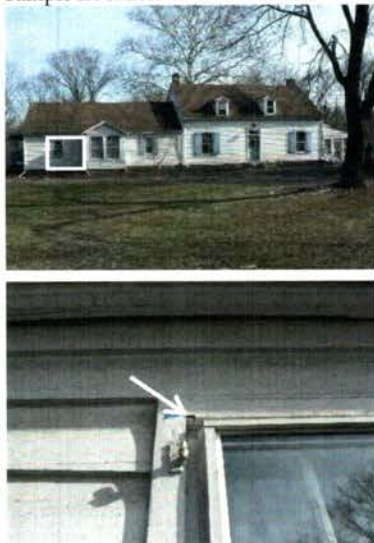
Location:	West Façade	Section Build:	C		
Sample:	EXT-02				
Element:	Window trim (W108)				
Analysis:	<input type="checkbox"/> Manual cross-section/RLM <input type="checkbox"/> Binder characterization	<input checked="" type="checkbox"/> Embedded cross-section/RLM <input type="checkbox"/> Pigment analysis	<input checked="" type="checkbox"/> Ultraviolet fluorescence <input type="checkbox"/> Exposure window		
Sample Location:		Photomicrograph:

Chromachronology:					
Campaign	Layer	Munsell Color	Color Name	Autofluorescence	Notes
	Substrate: Wood				
Build C	Finish	~10YR 6/4	Light yellowish brown	Grayish white	Possibly multiple layer
	Finish	~N2.25/-2.5Y 2/2	Blackish brown	Dull gray/Little	
	Finish		Grayish white	Grayish bluish white	
	Finish		Grayish white	Grayish bluish white	
	Finish		Grayish white	Dull gray	
	Finish		Yellowish white	Yellow gray	
	Finish		Yellowish white	Dull	
	Finish		Yellowish white	None gray

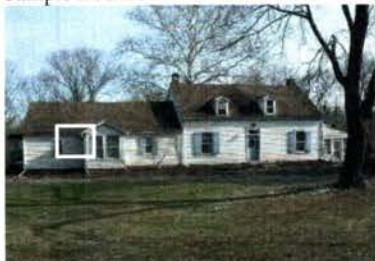
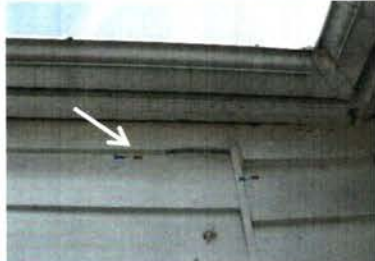
Location:	West Façade	Section Build:	C	
Sample:	EXT-03			
Element:	Clapboard			
Analysis:	<input type="checkbox"/> Manual cross-section/RLM	<input checked="" type="checkbox"/> Embedded cross-section/RLM	<input checked="" type="checkbox"/> Ultraviolet fluorescence	<input type="checkbox"/> Exposure window
	<input type="checkbox"/> Binder characterization	<input type="checkbox"/> Pigment analysis	<input type="checkbox"/>

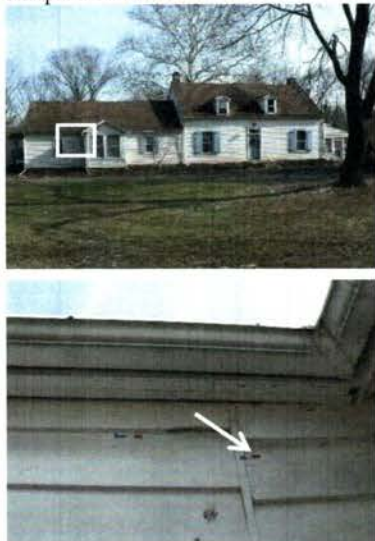
Location: West Façade		Section Build: B	
Sample: EXT-04		Element: Clapboard	
Analysis:	() Manual cross-section/RLM	(x) Embedded cross-section/RLM	(x) Ultraviolet fluorescence
	() Binder characterization	() Pigment analysis	() Exposure window

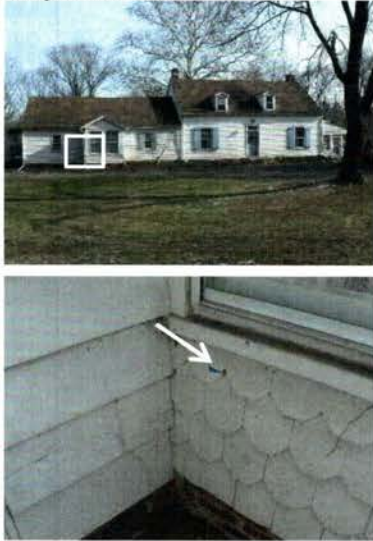
Location:	West Façade	Section Build:	(later addition)		
Sample:	EXT-05				
Element:	Fish scale shingle (window addition)				
Analysis:	<input type="checkbox"/> Manual cross-section/RLM	<input checked="" type="checkbox"/> Embedded cross-section/RLM	<input checked="" type="checkbox"/> Ultraviolet fluorescence		
	<input type="checkbox"/> Binder characterization	<input type="checkbox"/> Pigment analysis	<input type="checkbox"/> Exposure window		
Sample Location:		Photomicrograph:

Chromachronology:					
<u>Campaign</u>	<u>Layer</u>	<u>Munsell Color</u>	<u>Color Name</u>	<u>Autofluorescence</u>	<u>Notes</u>
	Substrate: Wood				
	Primer +	~5Y 7/4	Grayish yellow	Grayish yellow	Likely painted intending to match the clapboards on the house
	Finish	~2.5Y 5/2	Grayish yellowish brown	Brown	
	Finish		Gray	Grayish yellow	
	Finish		Gray	Bluish white	
	Finish		Pale yellow	Yellow	
	Finish		Yellowish white	Bluish white

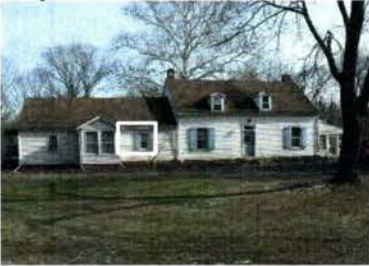
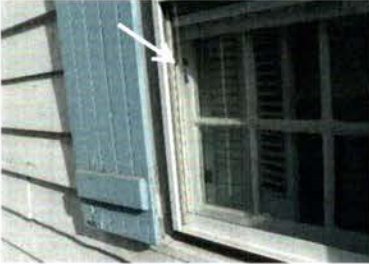
Location:	West Façade	Section Build:	B		
Sample:	EXT-06				
Element:	Window sash (W103)				
Analysis:	() Manual cross-section/RLM	(x)	Embedded cross-section/RLM		
	() Binder characterization	()	Pigment analysis

Chromachronology:					
<u>Campaign</u>	<u>Layer</u>	<u>Munsell Color</u>	<u>Color Name</u>	<u>Autofluorescence</u>	<u>Notes</u>
	Substrate: Wood				
	Finish (fragment)		Yellowish white	Yellow	
	Finish		Grayish yellow	Dull yellow	
	Finish		Grayish yellow	Dull grayish yellow	
	Finish		Grayish yellow brown	Bluish gray	
	Finish		Reddish brown	Dull yellow brown	
	Finish		Grayish white	Grayish bluish white	Possibly phosphorescent?
	Finish		Pale yellow	Yellow	
	Finish		Yellowish white	Grayish white	
	Finish		Grayish white	Dull gray	
	Finish		Yellowish white	Yellow gray	
	Finish		Yellowish white	Dull	
Observations:

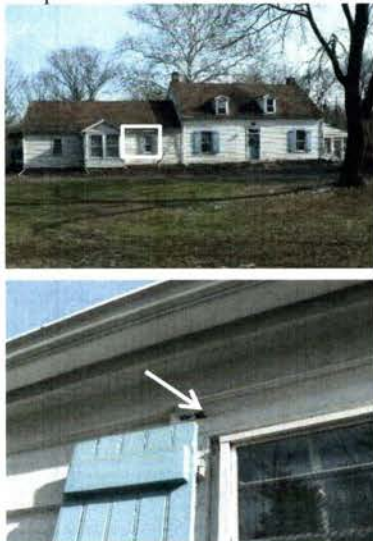
Location:	West Façade	Section Build:	B		
Sample:	EXT-07				
Element:	Window trim (W103)				
Analysis:	() Manual cross-section/RLM	(x)	Embedded cross-section/RLM		
	() Binder characterization	()	Pigment analysis

Chromachronology:					
<u>Campaign</u>	<u>Layer</u>	<u>Munsell Color</u>	<u>Color Name</u>	<u>Autofluorescence</u>	<u>Notes</u>
	Substrate: Wood				
Build B/C	Finish	(~10YR 6/4)	Light yellowish brown	Grayish white	Possibly multiple layers
	Finish		Blackish brown	Dull gray/Little	
	Finish		Grayish white	Grayish bluish white	
	Finish		Grayish white	Grayish bluish white	
	Finish		Pale yellow	Yellow	
	Finish		Yellowish white	Bluish grayish white	
	Finish		Pale yellow	Yellow	
	Finish		Pale yellow	Dull yellow gray	
	Finish		Grayish white	Dull gray	
	Finish		Yellowish white	Yellow gray	
	Finish		Pale yellow	Grayish white	
	Finish		Yellowish white	Dull gray	
	Finish		Yellowish white	None	
	Finish		Yellowish white	None	
	Finish		Yellowish white	Dull gray	
	Finish		Yellowish white	None	
Observations:

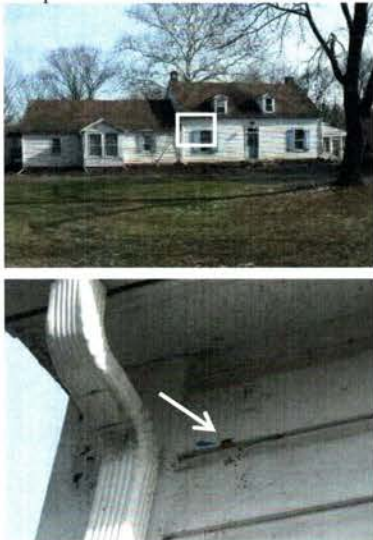
Location:	West Façade	Section Build:	A		
Sample:	EXT-08				
Element:	Upper clapboard, North end of Section				
Analysis:	() Manual cross-section/RLM	(x) Embedded cross-section/RLM	(x) Ultraviolet fluorescence		
	() Binder characterization	() Pigment analysis	() Exposure window		
Sample Location:		Photomicrograph:

Chromachronology:					
Campaign	Layer	Munsell Color	Color Name	Autofluorescence	Notes
	Substrate: Wood				
	Finish	* Unable to obtain match	-	Dull yellow Bluish gray	Fragmentary evidence of finish on weathered wood surface
	Finish		Gray	Grayish yellow	
	Finish		Gray	Grayish bluish white	
	Finish		Pale yellow	Yellow	
	Finish		Yellowish white	Bluish grayish white	
	Finish		Pale yellow	Yellow	
	Finish		Pale yellow	Dull yellow gray	
	Finish		Grayish white	Dull gray	
	Finish		Yellowish white	Yellow gray	
	Finish		Pale yellow	Grayish white	
	Finish		Yellowish white	Dull gray	
	Finish		Yellowish white	None

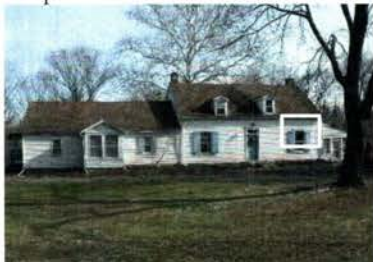
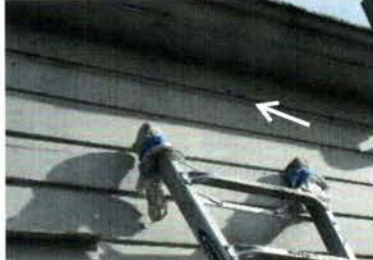
Location:	West Façade	Section Build:	A	
Sample:	EXT-09			
Element:	Upper clapboard, South end of Section			
Analysis:	() Manual cross-section/RLM	(x)	Embedded cross-section/RLM	(x) Ultraviolet fluorescence
	() Binder characterization	()	Pigment analysis	() Exposure window

Chromachronology:					
Campaign	Layer	Munsell Color	Color Name	Autofluorescence	Notes
	Substrate: Wood				
		-	-	-	* Missing at least 5 earlier finishes
	Finish		Gray	Grayish yellow	
	Finish		Gray	Grayish bluish white	
	Finish		Pale yellow	Yellow	
	Finish		Yellowish white	Bluish grayish white	
	Finish		Pale yellow	Yellow	
	Finish		Pale yellow	Dull yellow gray	
	Finish		Grayish white	Dull gray	
	Finish		Yellowish white	Yellow gray	
	Finish		Pale yellow	Grayish white	
	Finish		Yellowish white	Dull gray	
	Finish		Yellowish white	None	
	Finish		Yellowish white	None	
	Finish		Yellowish white	Dull gray	
	Finish		Yellowish white	None

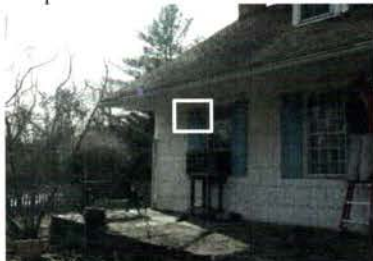
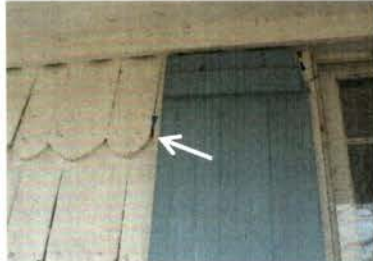
Location:	East Façade	Section Build:	A		
Sample:	EXT-10				
Element:	Fish scale shingle, North end of Section				
Analysis:	() Manual cross-section/RLM	(x) Embedded cross-section/RLM	(x) Ultraviolet fluorescence		
	() Binder characterization	() Pigment analysis	() Exposure window		
Sample Location:	Photomicrograph:

Chromachronology:					
Campaign	Layer	Munsell Color	Color Name	Autofluorescence	Notes
	Substrate: Wood				
	Finish	2.5YR 3/2-3/4	Reddish brown	Little/None	
	Finish	~2.5Y 9/2	Yellowish white	Yellowish white	
	Finish	7.5-10YR 6/4	Light brown	Yellowish gray	
	Finish	10YR 5/2	Grayish pinkish brown	Dull yellow gray	
	Finish	10YR 4/4	Yellowish brown	Bluish white	
	Finish	2.5Y 7/4	Grayish yellow	Yellow	
	Finish		Gray	Bluish grayish white	
	Finish		Gray	Bluish grayish white	
	Finish		Pale yellow	Yellow	Smooth
	Finish		Yellowish white	Bluish white	
	Finish		Yellowish white	Bluish white

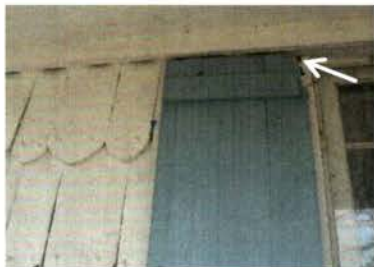
Location:	East Façade	Section Build:	A
Sample:	EXT-11		
Element:	Window trim (W117), North end of Section		
Analysis:	<input type="checkbox"/> Manual cross-section/RLM	<input checked="" type="checkbox"/> Embedded cross-section/RLM	<input checked="" type="checkbox"/> Ultraviolet fluorescence
	<input type="checkbox"/> Binder characterization	<input type="checkbox"/> Pigment analysis	<input type="checkbox"/> Exposure window

Observations:
 This piece of window trim was later added for continuity likely.

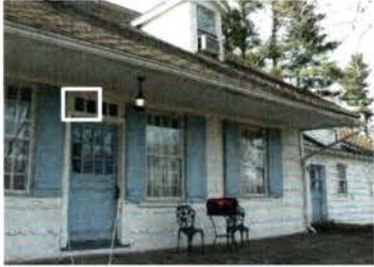
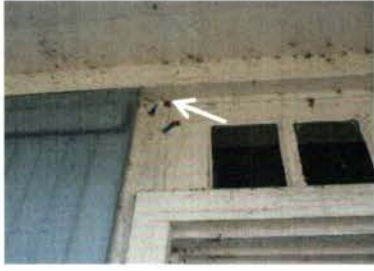
Location:	East Façade	Section Build:	A		
Sample:	EXT-12				
Element:	Transom molding above doorframe (Door D)				
Analysis:	<input type="checkbox"/> Manual cross-section/RLM <input type="checkbox"/> Binder characterization	<input checked="" type="checkbox"/> Embedded cross-section/RLM <input type="checkbox"/> Pigment analysis	<input checked="" type="checkbox"/> Ultraviolet fluorescence <input type="checkbox"/> Exposure window		
Sample Location:	Photomicrograph:

Chromachronology:					
<u>Campaign</u>	<u>Layer</u>	<u>Munsell Color</u>	<u>Color Name</u>	<u>Autofluorescence</u>	<u>Notes</u>
	Substrate: Wood				
	Finish	2.5YR 3/4	Reddish brown	None	
	Finish	2.5Y 9/2	Pale yellowish white	Light yellowish white	
	Finish	2.5Y 8/2	Pale yellow	Yellowish white	
	Finish	10YR 6/4	Light yellowish brown	Dull yellowish gray	
	Finish	TBD	Dark brown	Dull gray/Little	
	Finish		Grayish white	Gray-yel to Bluish white

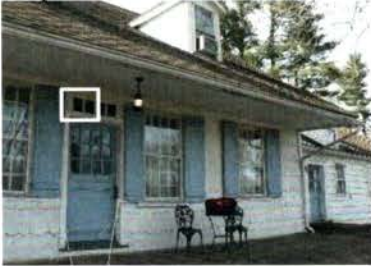
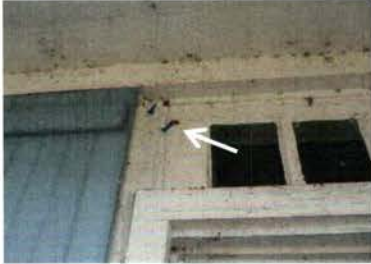
Location:	East Façade	Section Build:	A		
Sample:	EXT-13				
Element:	Transom window sash (Door D)				
Analysis:	() Manual cross-section/RLM () Binder characterization	(x) Embedded cross-section/RLM () Pigment analysis	(x) Ultraviolet fluorescence () Exposure window		
Sample Location:	Photomicrograph:

Chromachronology:					
<u>Campaign</u>	<u>Layer</u>	<u>Munsell Color</u>	<u>Color Name</u>	<u>Autofluorescence</u>	<u>Notes</u>
	Substrate: Wood				
	Finish	~2.5Y 7/2-8/2	Pale yellow	Yellowish white	
	Finish	~2.5Y 7/2	Grayish yellow	Yellow	
	Finish	2.5YR 3/4	Reddish brown	Little/None	
	Finish	2.5Y 9/2	Pale yellowish white	Light yellowish white	
	Finish	2.5Y 8/2	Pale yellow	Yellowish white	
	Finish	10YR 6/4	Light yellowish brown	Dull yellowish gray	
	Finish	10YR 4/4	Mod. yellowish brown	Grayish white	
	Finish	7.5R 3/4	Mod. reddish brown	Dull yellow brown	
	Finish		Grayish white	Gray-yel to Bluish white	Some phosphorescence; dirt layer

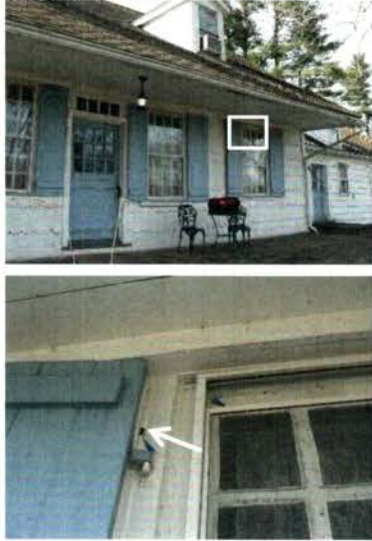
Location:	East Façade	Section Build:	A
Sample:	EXT-14		
Element:	Window trim (W114), North end of Section		
Analysis:	() Manual cross-section/RLM	(x)	Embedded cross-section/RLM (x)
	() Binder characterization	()	Pigment analysis () Ultraviolet fluorescence
			Exposure window

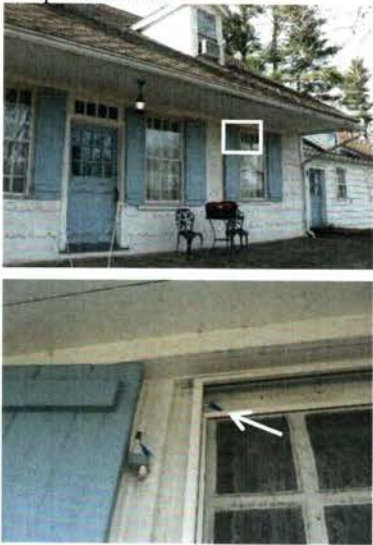
Location:	East Façade	Section Build:	A		
Sample:	EXT-15				
Element:	Window sash (W114), North end of Section				
Analysis:	() Manual cross-section/RLM () Binder characterization	(x) Embedded cross-section/RLM () Pigment analysis	(x) Ultraviolet fluorescence () Exposure window		
Sample Location:	Photomicrograph:

Chromachronology:					
<u>Campaign</u>	<u>Layer</u>	<u>Munsell Color</u>	<u>Color Name</u>	<u>Autofluorescence</u>	<u>Notes</u>
	Substrate: Wood				
	Finish	~2.5Y 8/2	Pale yellow/ white	Light yellowish white	
	Finish	~2.5Y 9/2	Yellowish white	Yellowish white	
	Finish	10YR 6/4	Light yellowish brown	Dull yellowish gray	
	Finish	10YR 4/4	Moderate yellow brown	Grayish white	
	Finish	7.5R 3/4	Mod. reddish brown	Dull yellow brown	
	Finish		Grayish white	Gray-yel to Bluish white	Some phosphorescence; dirt layer
	Finish		Grayish white	Gray-yel to Bluish white	
	Finish		Pale yellow	Yellow

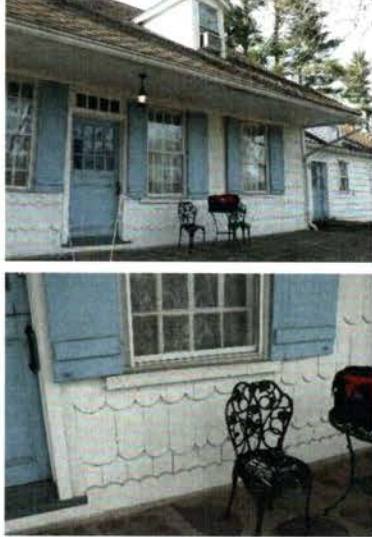
Location:	East Façade	Section Build:	A
Sample:	EXT-16		
Element:	Fish scale shingle, North end of Section		
Analysis:	<input type="checkbox"/> Manual cross-section/RLM	<input checked="" type="checkbox"/> Embedded cross-section/RLM	<input checked="" type="checkbox"/> Ultraviolet fluorescence
	<input type="checkbox"/> Binder characterization	<input type="checkbox"/> Pigment analysis	<input type="checkbox"/> Exposure window

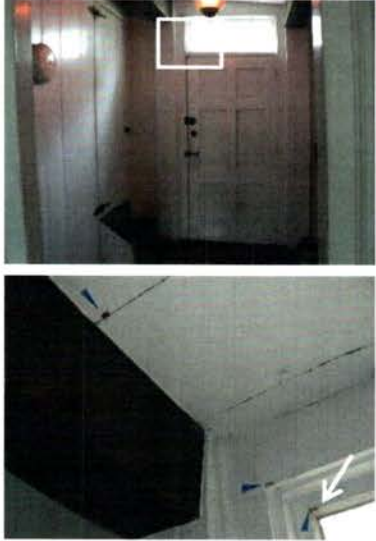
Room:	Foyer	Section Build:	A		
Sample:	101-02				
Element:	Transom sash (Door A)				
Analysis:	() Manual cross-section/RLM () Binder characterization	(x) ()	Embedded cross-section/RLM Pigment analysis (x) () Ultraviolet fluorescence Exposure window		
Sample Location:		Photomicrograph:

* 20 th c	Primer/Finish		Pale yellow	Yellow	*Missing earlier finishes
	Finish		Pale orange yellow	Yellowish white	
	Finish		Light orange yellow	Yellow	
	Finish		Pale yellow	Yellow	
	Finish		Light grayish yellow brown	Yellowish white	
	Finish		Grayish yellow	Little/None	
	Finish		Yellowish white	Little/None	
	Finish		Yellowish white	Little/None	
	Finish		Yellowish white	Little/None	
	Finish		Yellowish white	Little/None	
	Finish		Yellowish white	Little/None	
	Finish		Yellowish white	Little/None	
	Finish		Yellowish white	Little/None	
Observations:					
It is believed that this opening has been modified since original construction; the doorframe and transom window appear to have been replaced in the first half of the 20 th century.
