Historic Structures Report for **Symen Van Wickle House**

1289 Easton Avenue, Franklin Township, New Jersey

April 2019

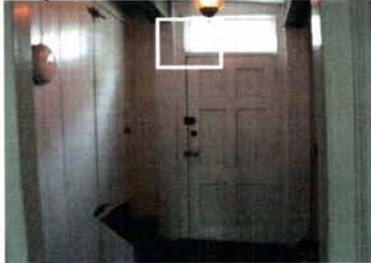
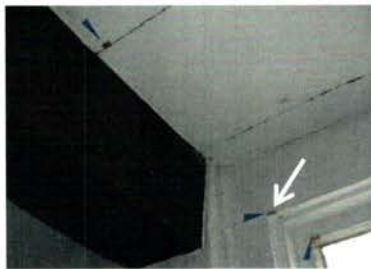
Room:	Foyer	Section Build:	A
Sample:	101-03		
Element:	Doorframe (Door A)		
Analysis:	() Manual cross-section/RLM () Binder characterization	(x) ()	Embedded cross-section/RLM Pigment analysis
		(x) ()	Ultraviolet fluorescence Exposure window

Campaign	Layer	Munsell Color	Color Name	Autofluorescence	Notes
	Substrate: Wood				
	Finish		Brown (translucent)	Bluish gray	Fragmentary evidence of varnish
* 20 th c.	Primer/Finish		Pale yellow	Yellow	*Missing earlier finishes
	Finish		Pale orange yellow	Yellowish white	
	Finish		Light orange yellow	Yellow	
	Finish		Pale yellow	Yellow	
	Finish		Light grayish yellow brown	Yellowish white	
	Finish		Grayish yellow	Little/None	
	Finish		Grayish yellow	Little/None	
	Finish		Yellowish white	Little/None	
	Finish		Yellowish white	Little/None	
	Finish		Yellowish white	Little/None	
	Finish		Yellowish white	Little/None	
	Finish		Yellowish white	Little/None	
	Patch/repair	-	-	-	Patching compound/repair material
	Finish		Yellowish white	Little/None

It is believed that this opening has been modified since original construction; the doorframe and transom window appear to have been replaced in the first half of the 20th century.

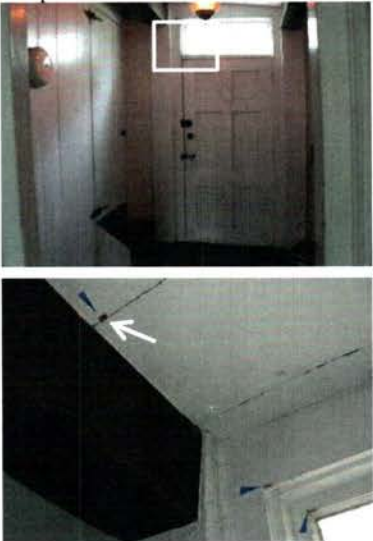
Room:	Foyer	Section Build:	A		
Sample:	101-04				
Element:	Ceiling (Door A)				
Analysis:	<input type="checkbox"/> Manual cross-section/RLM <input type="checkbox"/> Binder characterization	<input checked="" type="checkbox"/> Embedded cross-section/RLM <input type="checkbox"/> Pigment analysis	<input checked="" type="checkbox"/> Ultraviolet fluorescence <input type="checkbox"/> Exposure window		
Sample Location:		Photomicrograph:

*	Primer/Finish		Pale yellow	Yellow	*Missing earlier finishes
	Finish		Pale orange yellow	Yellowish white	
	Finish		Light orange yellow	Yellow	
	Finish		Pale yellow	Yellow	
	Finish		Light grayish yellow brown	Yellowish white	
	Finish		Grayish yellow brown	Little/None	
	Finish		Yellowish white	Little/None	
	Finish		Yellowish white	Little/None	
	Finish		Yellowish white	Little/None	
	Finish		Yellowish white	Little/None	
	Finish		Yellowish white	Little/None	
	Finish		Yellowish white	Little/None	
Observations:					
The ceiling was not painted until the first half of the twentieth century.

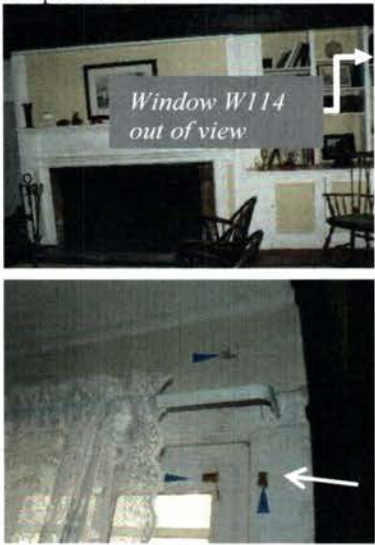
Room:	Living Room (103)	Section Build:	A		
Sample:	103-07				
Element:	Window frame (W114)				
Analysis:	<input type="checkbox"/> Manual cross-section/RLM <input type="checkbox"/> Binder characterization	<input checked="" type="checkbox"/> Embedded cross-section/RLM <input type="checkbox"/> Pigment analysis	<input checked="" type="checkbox"/> Ultraviolet fluorescence <input type="checkbox"/> Exposure window		
Sample Location:		Photomicrograph:

Chromachronology:					
Campaign	Layer	Munsell Color	Color Name	Autofluorescence	Notes
	Substrate: Wood				
	Finish 1	2.5YR 3/2	Reddish brown	None	
	Finish		Grayish greenish brown	Yellow	
	Finish		Grayish green	Yellow	
	Finish 2		Light grayish blue green?	Yellow	
	P/Finish		Pale yellow	Yellow	
	Finish 3		Pale yellow	Yellow	
	Finish 4		Yellowish white	Grayish white	
	Primer + Ground + Finish 5/Grain		Pale yellow Pale pinkish brown Brown	Yellow Grayish yellow Dull brown

Primer + Finish 6		Grayish yellow Grayish brown	Grayish yellow Grayish blue	
	Primer + Finish 7		Pale yellow Dark brown	Yellow None	
	Finish		Grayish white	Grayish white	
	Finish		Gray	Grayish white	
	Finish		Pale orange yellow	Little/None	
	Finish		Grayish white	Little/None	
	Finish		Light gray	Little/None	
	Finish		Pale yellow	Little/None	
	Finish		Light gray	Little/None	
	Finish		Light yellow	Little/None	
	Finish		Yellowish white	Little/None	
	Finish		Yellowish white	Little/None	
	Finish		Yellowish white	Little/None	
Observations:

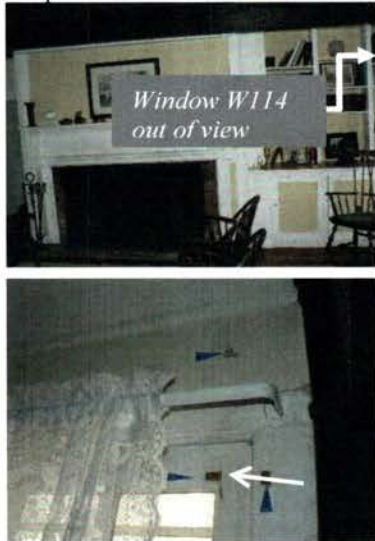
Room:	Living Room (103)	Section Build:	A	
Sample:	103-08			
Element:	Window sash (W114)			
Analysis:	<input type="checkbox"/> Manual cross-section/RLM	<input checked="" type="checkbox"/> Embedded cross-section/RLM	<input checked="" type="checkbox"/> Ultraviolet fluorescence	<input type="checkbox"/> Exposure window
	<input type="checkbox"/> Binder characterization	<input type="checkbox"/> Pigment analysis	<input type="checkbox"/>

Chromachronology:					
Campaign	Layer	Munsell Color	Color Name	Autofluorescence	Notes
	Substrate: Wood				
	Finish 1 ?	2.5Y 8/4	Pale yellow	Yellow	
	Finish(es)	-	-	-	Potentially missing a few finishes
	Finish		Grayish white	Grayish yellow white?	
	Finish		Pale yellow	Grayish white	
	Finish 5		Grayish yellow	Grayish yellow	
	Finish 6		Grayish yellow brown	Bluish gray	
	Primer? + Ground + Finish 7/Grain		Yellowish white Pinkish brown Dark brown	Grayish white Yellow None	
First half 20 th c.	Primer + Finish		Pale yellow Pale yellow	Yellow Grayish white	
	Finish		Pale orange yellow	Yellow	
	Finish		Grayish white	Grayish white	
	Finish		Gray	Grayish white	
	Finish		Pale (orange) yellow	Little/None	
	Finish		Pale yellow	Little/None	
	Finish		Pale yellow	Little/None	
	Finish		Light gray	Little/None	
	Finish		Light yellow	Little/None	
	Finish		Yellowish white	Little/None	
	Finish		Yellowish white	Little/None	
	Finish		Yellowish white	Little/None

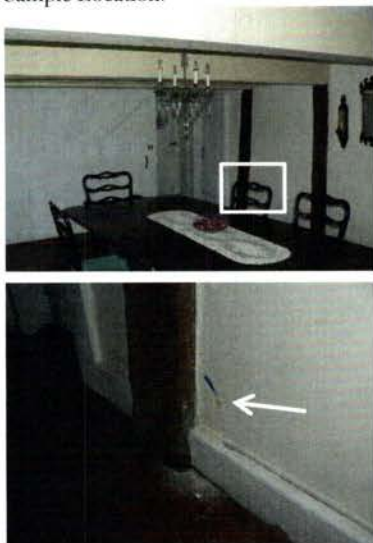
Room:	Dining Room (107)	Section Build:	B		
Sample:	107-03				
Element:	West Wall				
Analysis:	<input type="checkbox"/> Manual cross-section/RLM <input type="checkbox"/> Binder characterization	<input checked="" type="checkbox"/> Embedded cross-section/RLM <input type="checkbox"/> Pigment analysis	<input checked="" type="checkbox"/> Ultraviolet fluorescence <input type="checkbox"/> Exposure window		
Sample Location:		Photomicrograph:

Chromachronology:					
Campaign	Layer	Munsell Color	Color Name	Autofluorescence	Notes
	Substrate: Wood				
	Finish		Yellowish white/white	Grayish white	Whitewash
	Repair		-	-	Repair/Patch
	P + Finish		Pale/grayish yellow	Little/None	
	Finish		Pale yellow	Little/None	
	Finish		Grayish white	Little/None	
	Finish		Grayish white	Little/None	
	Finish		Yellowish white	Little/None	
Observations:

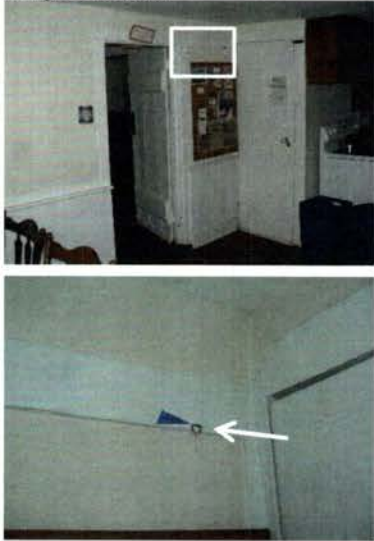
Room:	Kitchen (108)	Section Build:	C		
Sample:	108-01				
Element:	Doorframe top rail (Doorway to Dining Room)				
Analysis:	<input type="checkbox"/> Manual cross-section/RLM <input type="checkbox"/> Binder characterization	<input checked="" type="checkbox"/> Embedded cross-section/RLM <input type="checkbox"/> Pigment analysis	<input checked="" type="checkbox"/> Ultraviolet fluorescence <input type="checkbox"/> Exposure window		
Sample Location:	Photomicrograph:

Chromachronology:					
<u>Campaign</u>	<u>Layer</u>	<u>Munsell Color</u>	<u>Color Name</u>	<u>Autofluorescence</u>	<u>Notes</u>
	Substrate: Wood				
	Finish	N4.25/	Dark gray	Little/None	
	Finish		Blackish brown	None	
	Finish		Dark reddish brown	Little/None	
	Finish		Dark reddish brown	Little/None	
	Finish		Grayish reddish brown	Dull grayish yellow	
	Finish		Grayish reddish brown	Dull brown	
	Finish		Yellowish white	Grayish white

Finish		Grayish blue	Grayish white	
	Finish		Pale grayish green	Yellow	
	Finish		Pale yellow	Dull gray	
	Finish		Pale yellow	Grayish white	<
	Finish		Pale grayish yellow	Yellow	
	Finish		Pale yellow	Dull gray	
	Finish		Light blue	Grayish white	
	Finish		Orange yellow	Little/None	
	Finish		Orange yellow red	Little/None	
	Finish		Pale yellow	Little/None	
	Finish		Pale yellow	Little/None	
	Finish		Pale yellow	Little/None	
	Finish		Pale yellow	Little/None	
	Finish		Pale yellow	Little/None	
	Finish		Pale yellow	Little/None	
	Finish		Pale yellow	Little/None	
	Finish		Yellowish white	Little/None	
	Finish		Yellowish white	Little/None	
	Finish		Yellowish white	Little/None	
	Finish		Yellowish white	Little/None	
Observations:					
19 th century build, could be Victorian colors

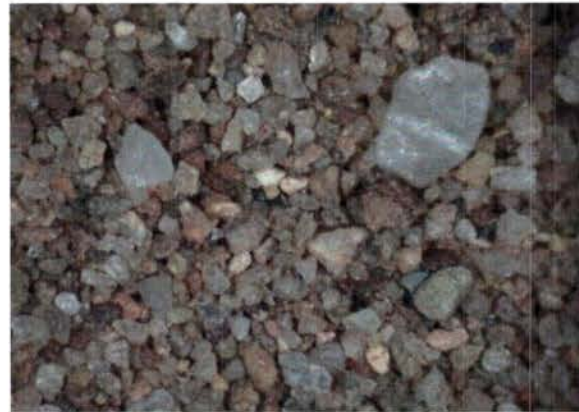
Photomicrograph of sands extracted from 18th century mortar.

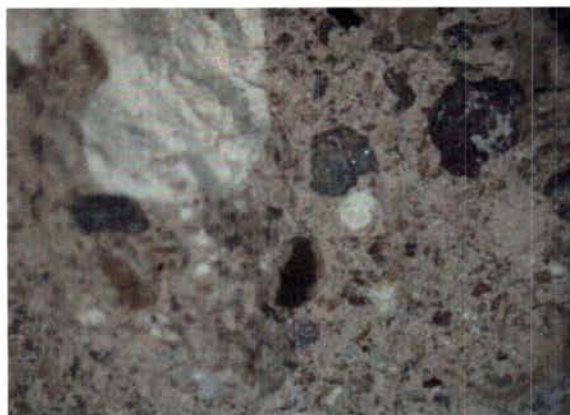
Photomicrograph of 19th century mortar.

- Comparative analysis: Comparatively, the 19th century stone mortar displays evidence of nodules/blebs of lime which are larger and a sand which is more coarsely-textured than the 18th century stone mortar – characteristics which suggest the mortars may date to different campaigns.

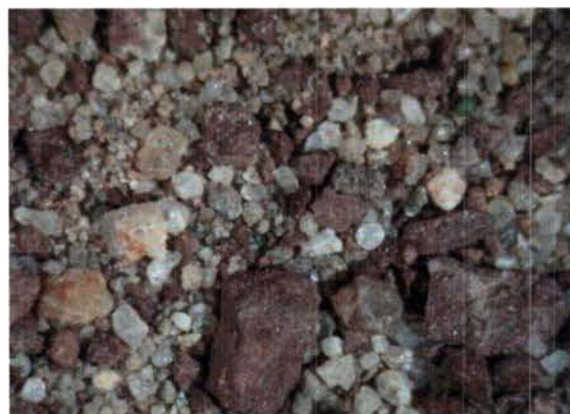
Photomicrograph of sands extracted from 19th century mortar.

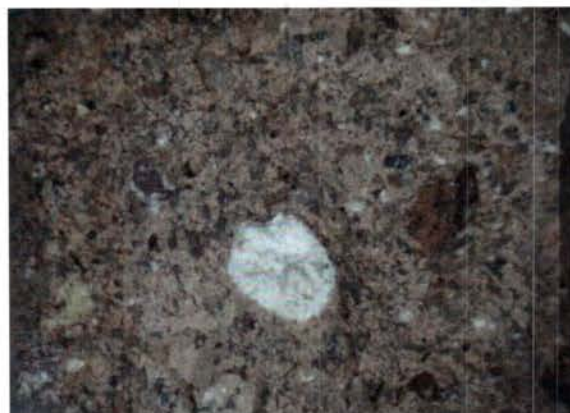
18th century stone mortar – reddish brown sand suspended within a light reddish brown matrix, with lime nodules/blebs visible to the naked eye. Photomicrograph, 10x magnification in color-balanced light.

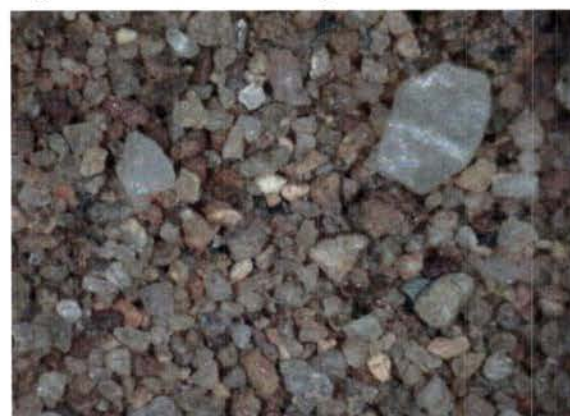
Sands extracted from 18th century stone mortar. Photomicrograph, 10x magnification in color-balanced light.

This is a reddish brown sand which is based primarily on a combination of quartz and feldspar, with some accessory minerals and stone fragments. Grain shape is predominantly rounded to subrounded, but some subangular grains are present as well. Clarity ranges from translucent to opaque.

8	16	30	50	100	200	<200
Sands	%	1.44	2.24	8.43	45.33	34.41	6.63	0.24

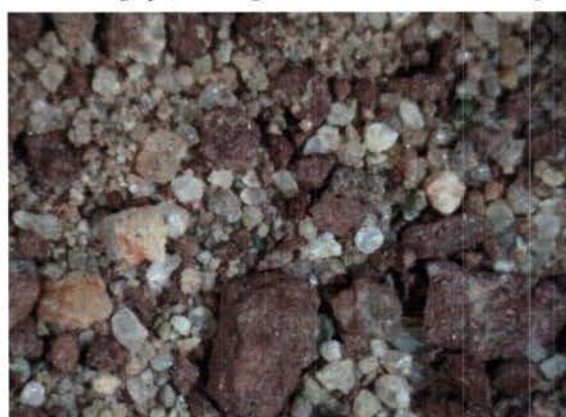
Sands extracted from 19th century stone mortar. Photomicrograph, 10x magnification in color-balanced light.

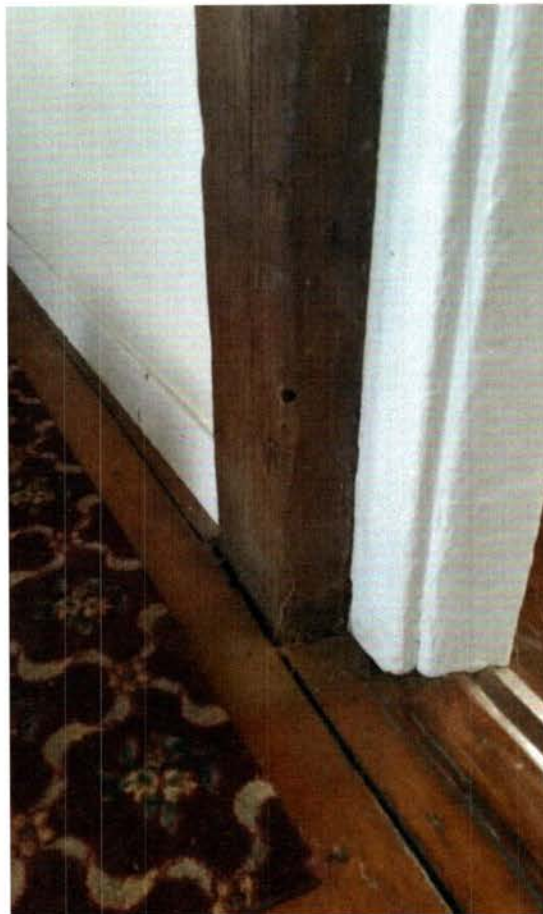
Plate 3.1: Sample #1 Field Photo.

Sample #1: Addition, first floor, Room 107, 1st post, west wall. 112 rings. In the field this sample appeared to have a waney edge but not in the lab. Dated 4 out of 4 rows, confidence level .62, giving a starting date of 1564 and a final ring date of 1676 (Figure 3.1).

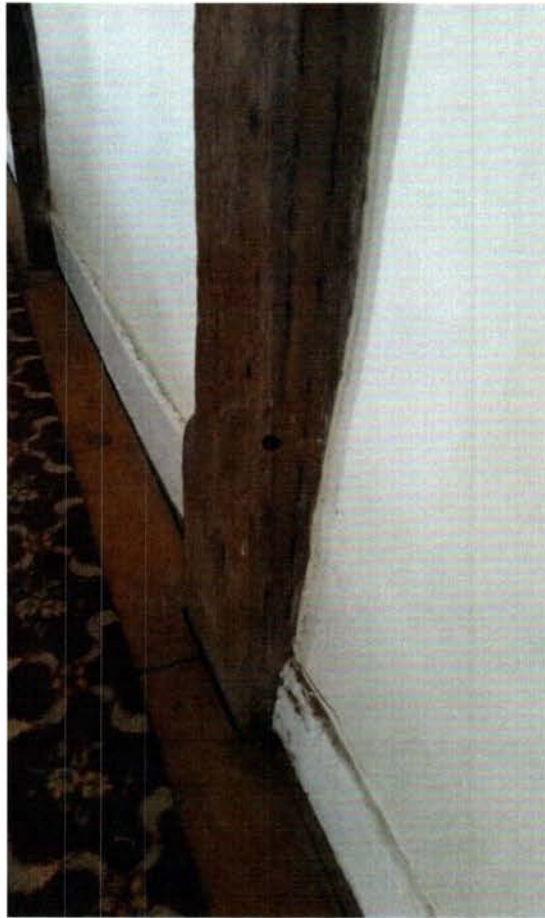
Plate 3.2: Sample #2 Field Photo.

Sample #2: Addition, first floor, Room 107, 2nd post, west wall. 104 rings. In the field this sample appeared to have a waney edge but not in the lab. Dated 3 out of 4 rows, confidence level .60, giving a starting date of 1612 and a final ring date of 1716 (Figure 3.2).

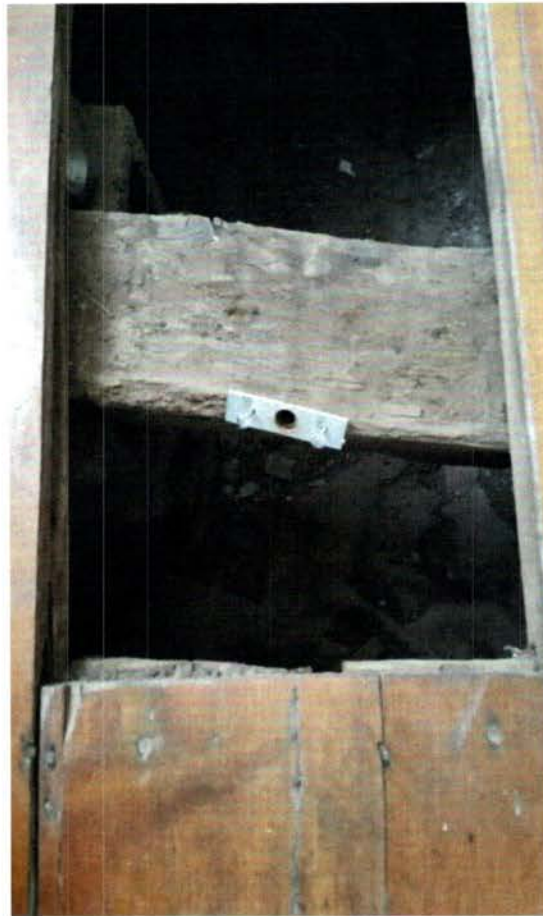
Plate 3.3: Sample #5 field photo.

Sample #5: Addition, first floor, Room 107, floor joist. 61 rings. In the field this sample appeared to have a waney edge but not in the lab. The sample was too short to date but suggests a starting date of 1676 and a final ring date of 1737 (Figure 3.3).

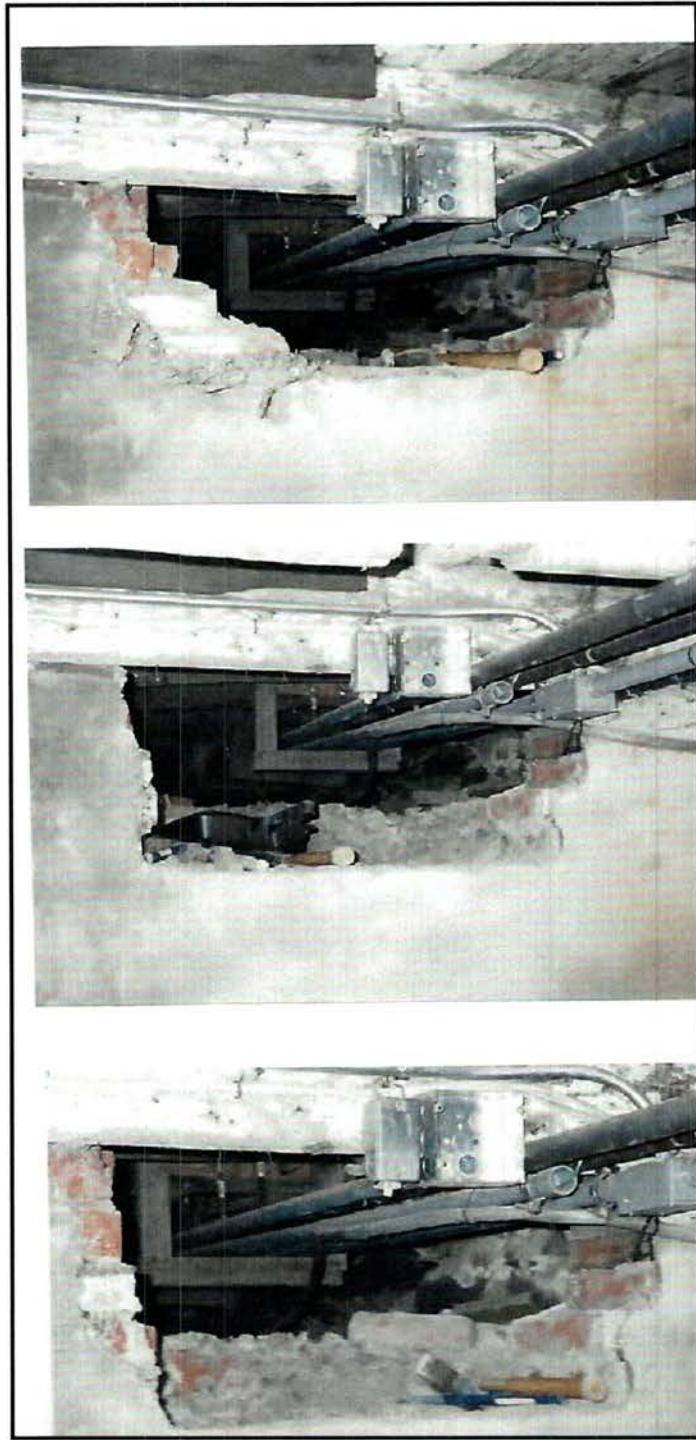
Plate 4.1: A sequence of photos showing the work done to enlarge the entrance into the crawlspace under the western addition of the house. View south.

A photo album of undated and unlabeled photos accompanies the diary. They show the hole being broken through the west wall of the cellar to create an entrance (Plates 4.1). Other images show the crawlspace before excavation (Plates 4.2 and 4.3). Many of the photographs show pieces of masking tape with an alphanumeric code written in Sharpie indicating a rough gridding out of the cellar beneath the wing.

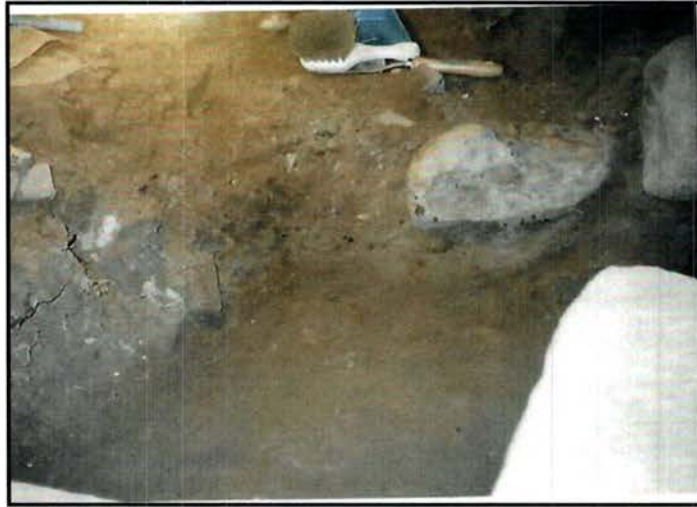
Plate 4.2: Undated photo showing one of the dig locations within the crawl space.

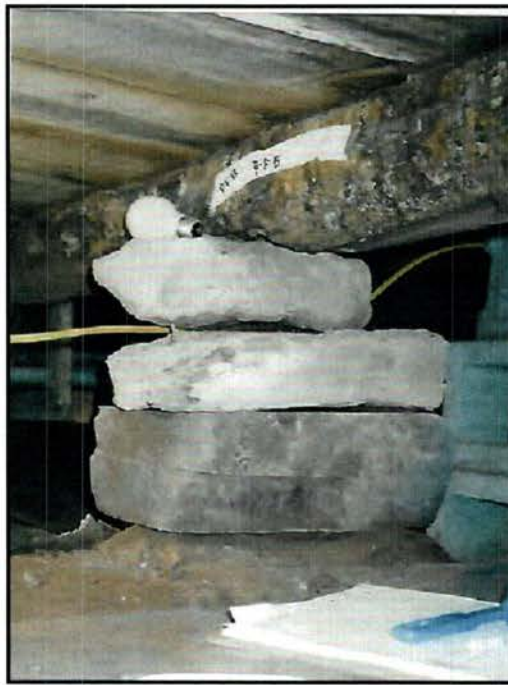
Plate 4.3: Undated photo showing a pier and floor joist within the crawl space. Note the masking tape label on the timber.

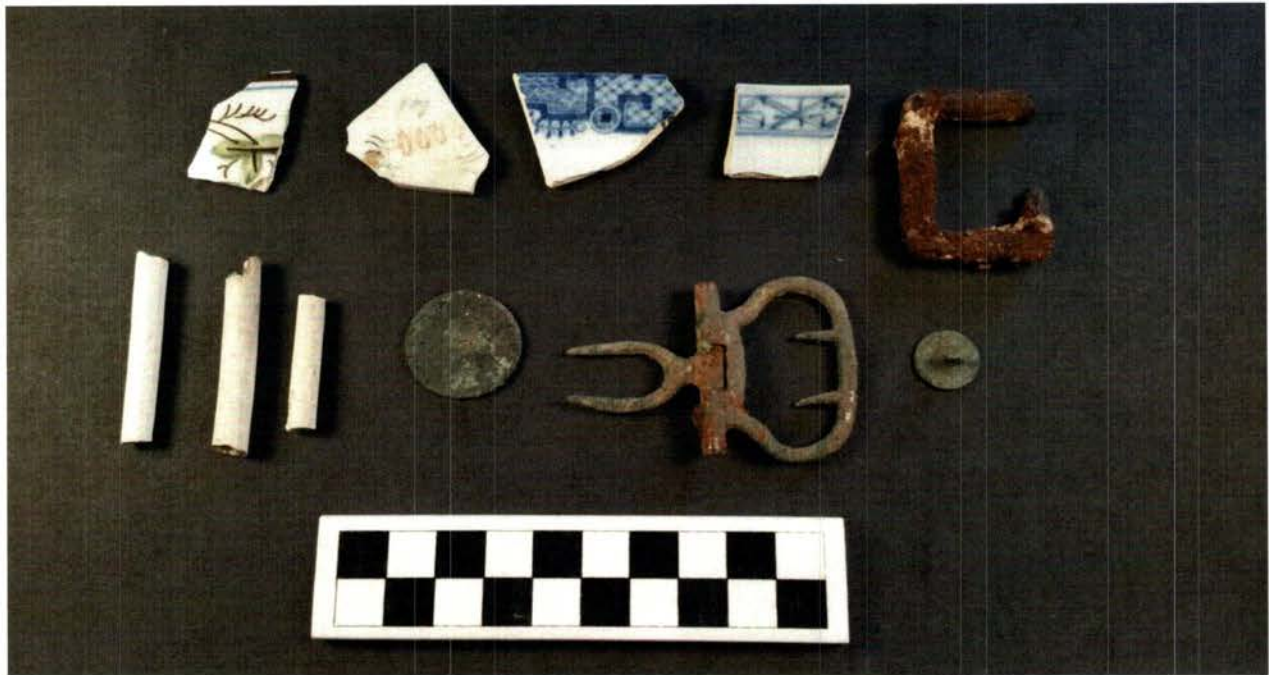
Plate 4.4: Select artifacts from Bag 2, Day 2. Including, from left to right and top to bottom, two fragments of hand-painted pearlware, a transfer-printed pearlware fragment, a porcelain fragment, a buckle, three pipe stems, an unidentified button, a shoe buckle hasp, and a second button. Centimeter scale.

Seven buttons were recovered, six copper alloy and one wooden (see Plate 4.4). They all appear to date from the late 18th or 19th centuries. One has a partial inscription IL on the rear. None are decorated. Fragments of an iron buckle and the hasp of a brass buckle, likely dating from the 18th century, were also recovered (see Plate 4.4).

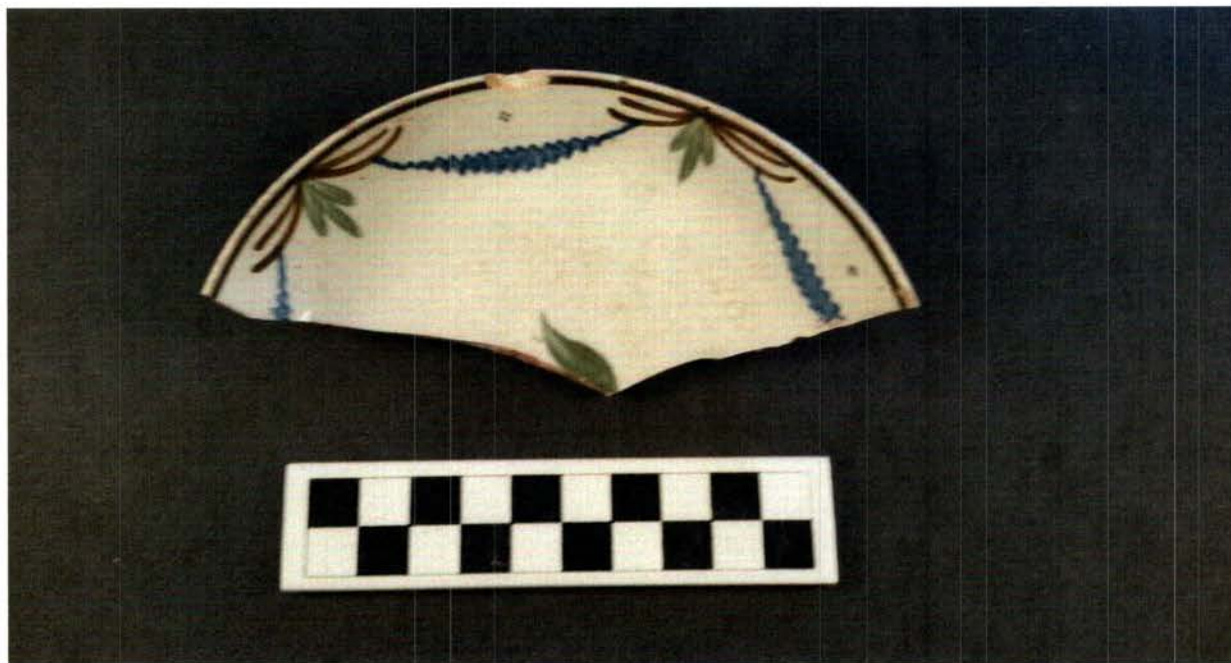
Plate 4.5: A fragment of hand-painted pearlware, likely dating from the late 18th or very early 19th centuries. Bag 13, Centimeter scale.

Ceramics made up 73 percentage of the assemblage with 213 artifacts. The number of ceramics relative to other artifact types may be more reflective of collector behavior than it is of the actual quantities of artifacts originally present on the site. Types represented included: creamware, pearlware (Plate 4.5), whiteware (Plates 4.6 and 4.7), porcelain, stoneware (Plate 4.8) and redware (Plate 4.9). Plain creamware plates were also present. Pearlware vessels included blue shell edged plates (1775-1840), hand-painted pearlware bowls (1775-1840), and transfer printed pearlware and whiteware (c. 1820+). The transfer prints included several fragments of an Abbey Pattern vessel and others showing a patriotic motif that includes images of George Washington and arched ribbons with the names of the states (see Plates 4.6 and 4.7).

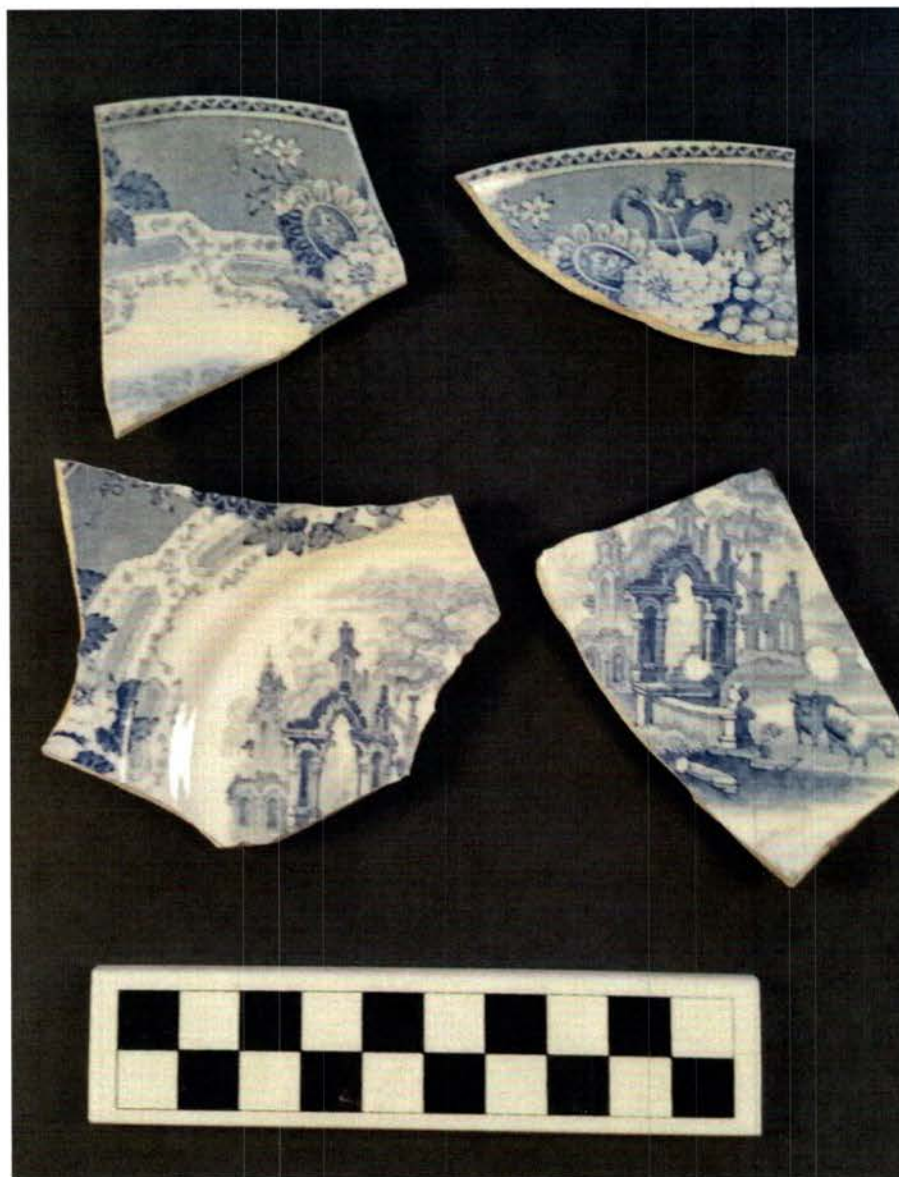
Plate 4.6: Fragments of Abbey pattern transfer-printed whiteware, dating from the mid 19th century. Bag 15, Centimeter scale.

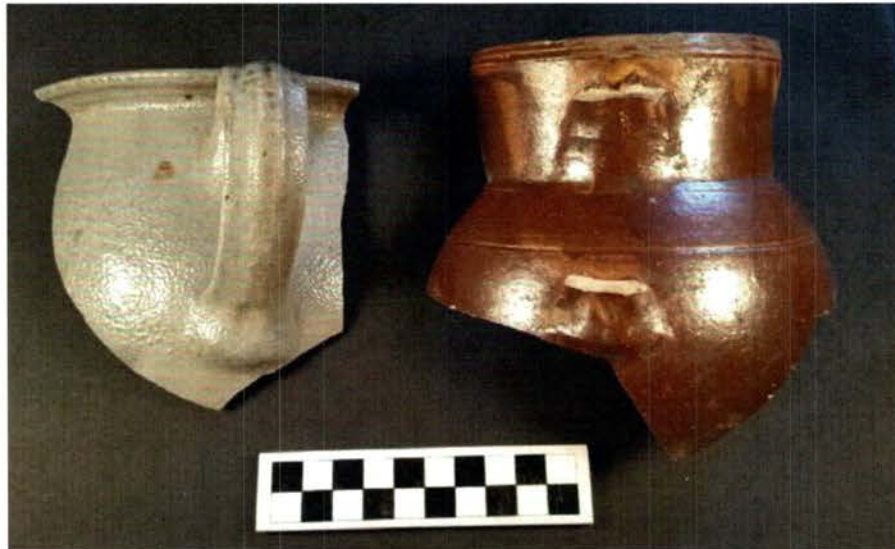
Plate 4.8: Fragments of a gray salt glazed stoneware chamber pot, and a brown stoneware pitcher. Bag 32, Centimeter scale.

Stoneware fragments included a gray salt glazed stoneware chamber pot, and a brown British stoneware jug (see Plate 4.5). Fragments of at least three redware utility or pie plates were present with simple slip trailed decoration on a clear lead glaze as was a milk pan with a brown manganese glaze (see Plate 4.6). All of these items likely date from the 19th century.

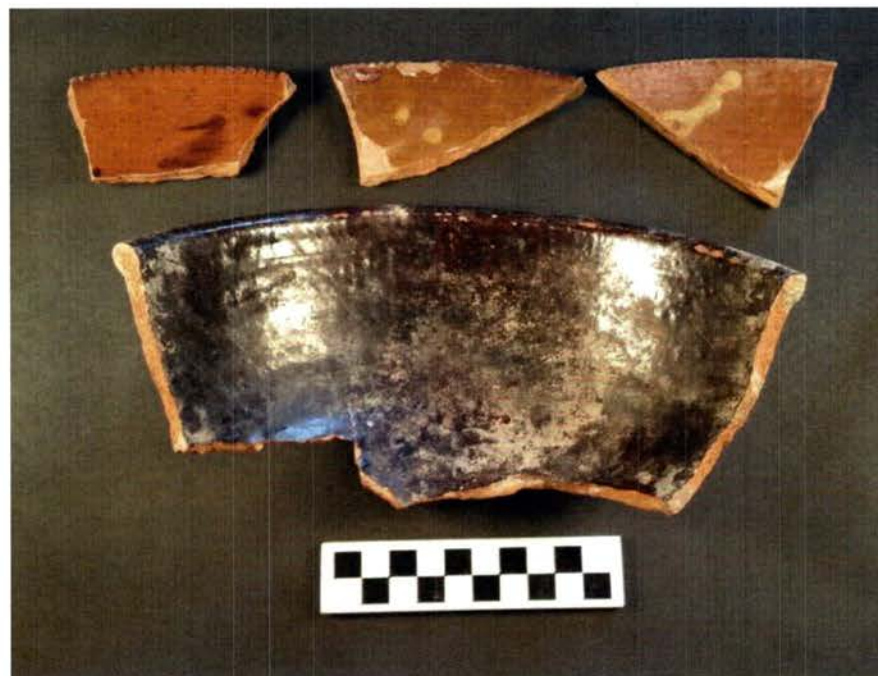
Plate 4.9: Fragments of three redware plates, the middle and right examples show slip trailed decoration, and a redware milk pan with brown manganese glaze. Bag 30, Centimeter scale.

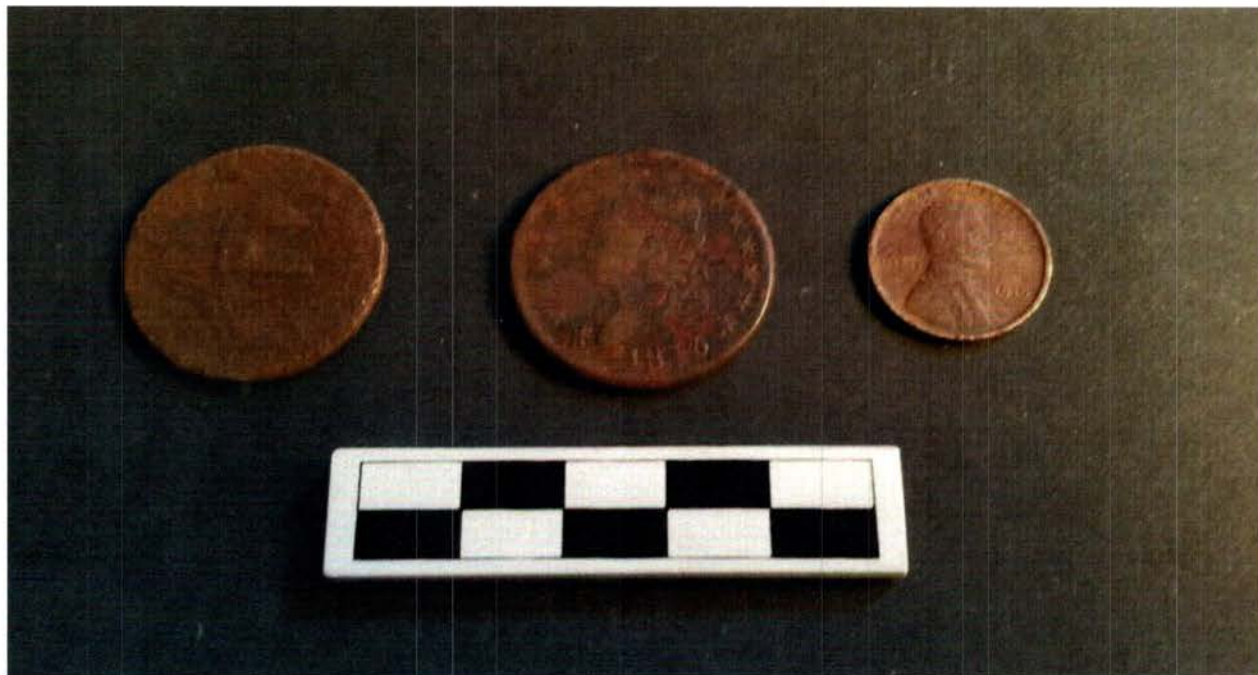
Plate 4.10: Three of the coins recovered from the Van Wickle house, from left to right, a 1787 New Jersey Copper, an 1813 Liberty Head large cent, and a 1919 Lincoln cent. Centimeter scale.

Five coins are present in the collection. They include a 1786 New Jersey copper one-cent piece, with head facing right, an 1813 Liberty head large cent, a 1919 Lincoln cent, a 1910 dime, a heavily worn Buffalo nickel (1913-1938) (Plate 4.10). The most noteworthy of the coins is the New Jersey copper. These coppers were minted in Rahway, Elizabethtown, and Morristown. Three million were minted in 1786 and 1787 (Yeomans 2012:68). They were the first American coin to bear the inscription *E Pluribus Unum*. They, and other copper coins issued by the states under the Articles of Confederation, circulated widely in the northeastern colonies and are commonly found on historic sites. However, questions about the weight and composition of the state coppers began to cause concern. New Jersey Coppers were better than most and were allowed to circulate at 15 per shilling in 1787. However, in 1789 a Copper Panic led to such a decline in value that the coppers ceased to circulate (Mossman 1993:265).

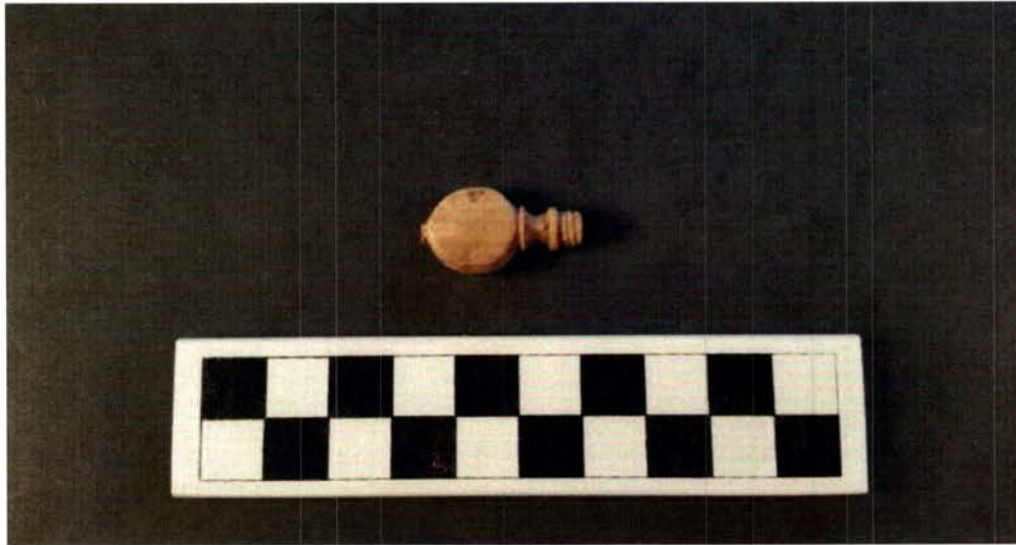
Plate 4.11: Fragments of a bone or ivory tuning peg from a violin. An unusual artifact, it may date from the 18th or 19th centuries. Bag 9, Centimeter scale.

Personal Items included two clay marbles, likely dating from the late 19th century. A lens from a set of eyeglasses, One especially interesting find is an ivory or bone tuning peg from a violin/fiddle or other stringed instrument.

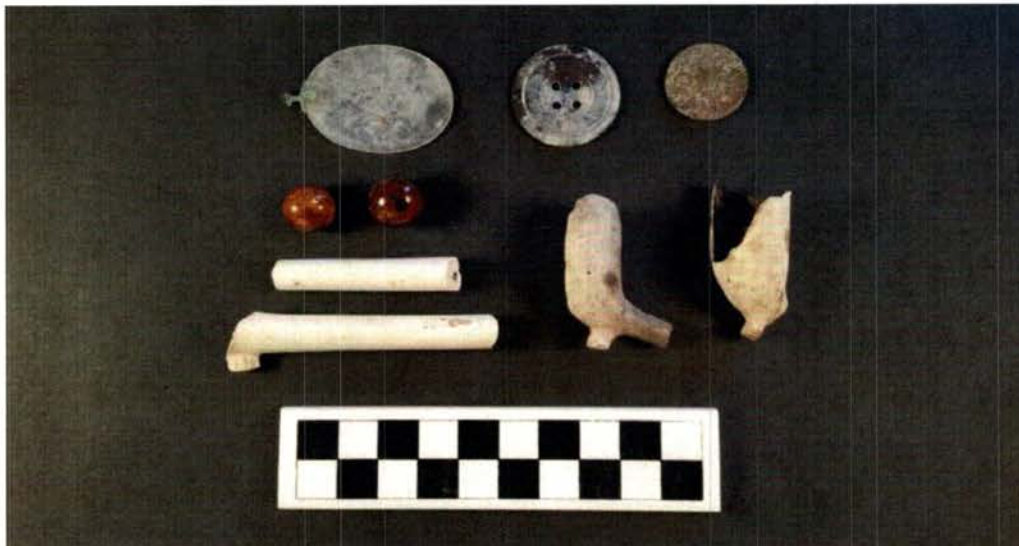
Plate 4.12: A fragmentary set of eyeglasses, two buttons, two beads, and four tobacco pipe fragments. Bag 6, Centimeter scale.
