*Historic Structures Report*

# **VAN LIEW-SUYDAM HOUSE**

Franklin Township, New Jersey

June 15, 2002

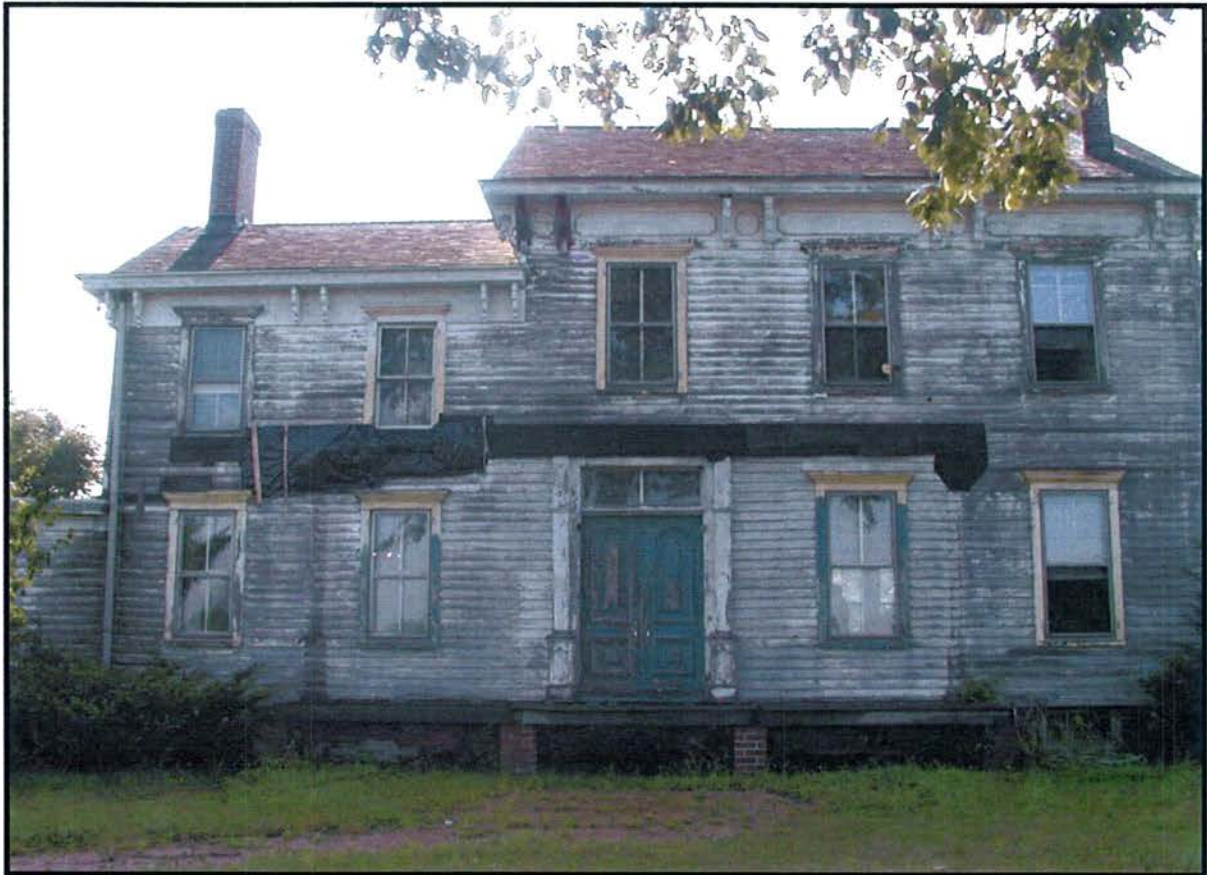
West facade view, showing area covered by former porch.

- Repoint all deteriorated joints in the house foundation.
- Reconstruct/restore the decorative Victorian porch (including doorway components and glazing) on the west side of the house, using salvaged components where possible, and in-kind replicas of wood components where there are missing pieces.
- Replace all flat or low-sloped roofs with EPDM systems.

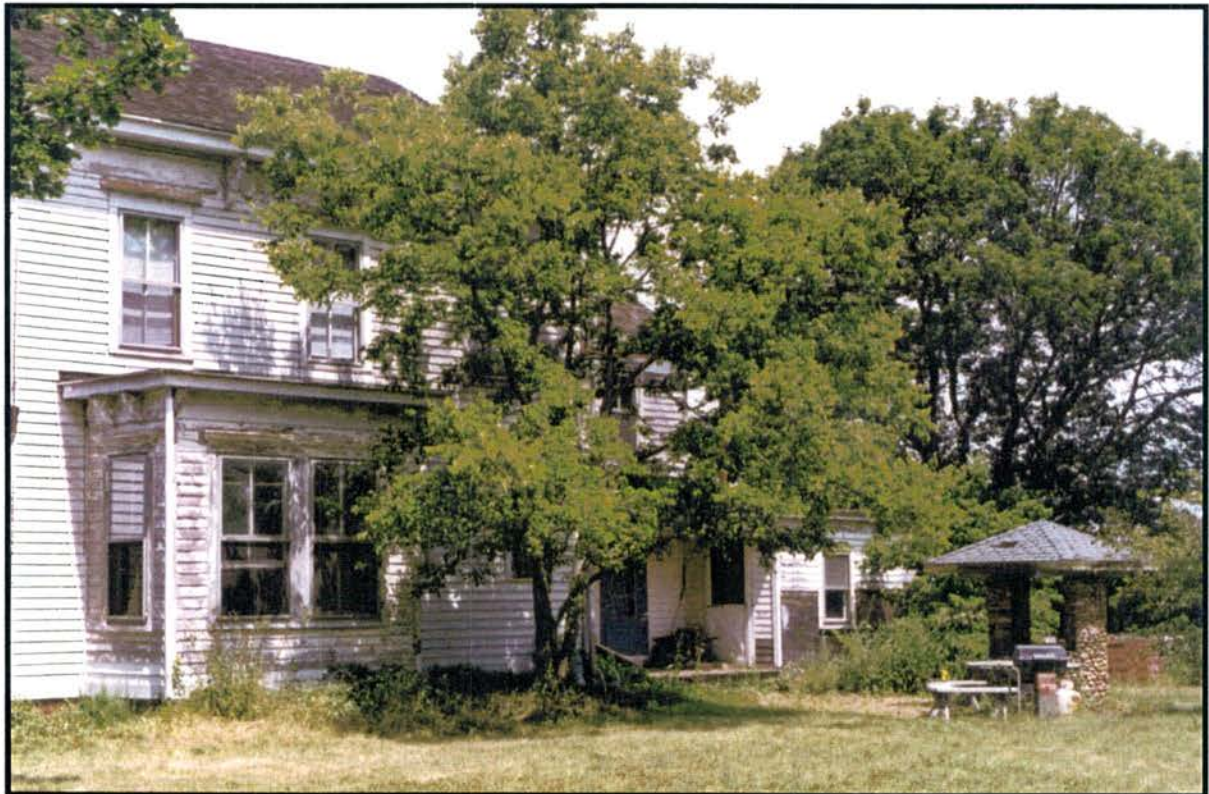
Southeast view of house and grounds, showing location of covered well.

- Rehabilitate gazebo, well and other outbuildings near the house for possible interpretive use.
- Develop a comprehensive landscape and planting plan for the site, using the services of professional landscape architects.

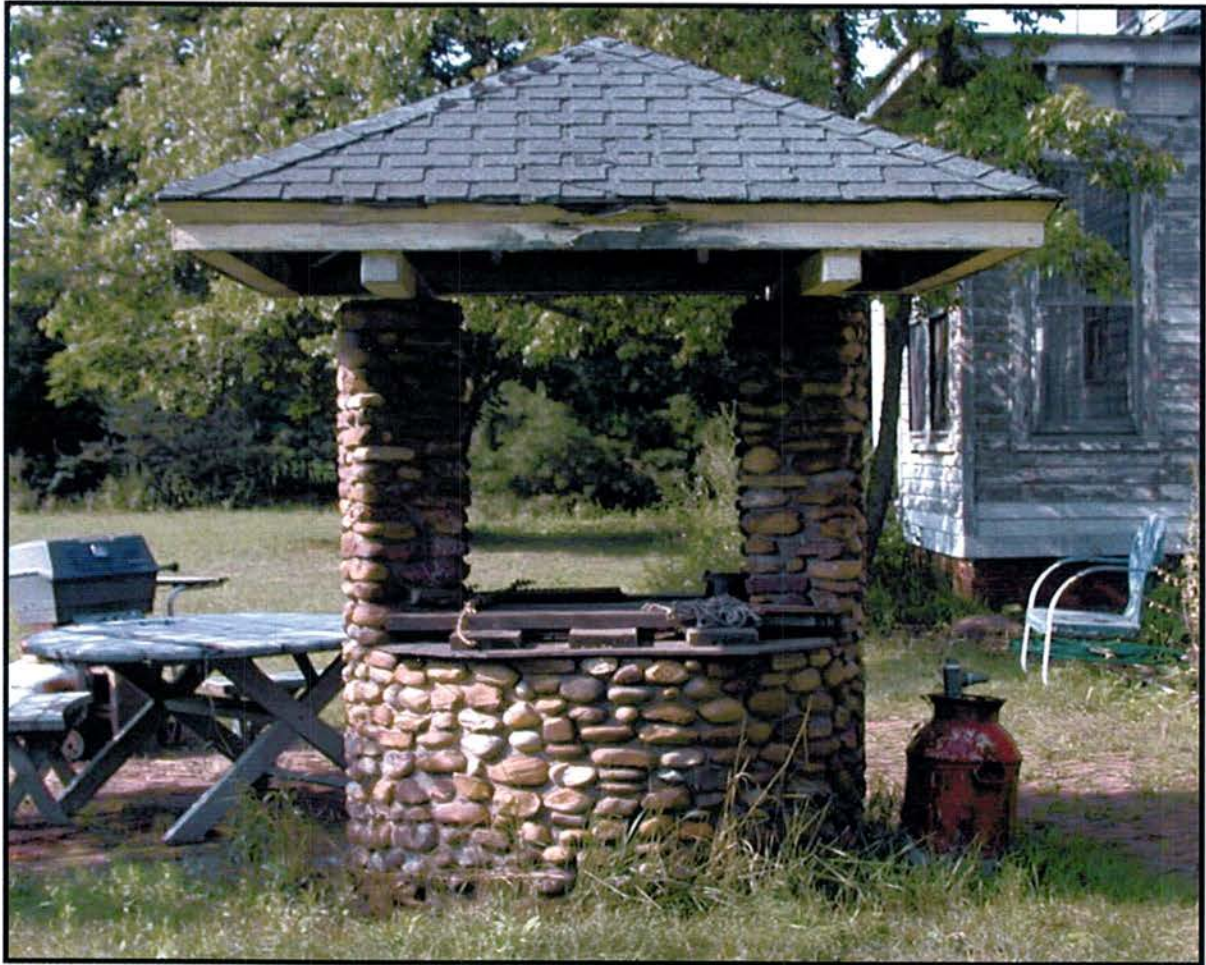
Close-up view of covered well.

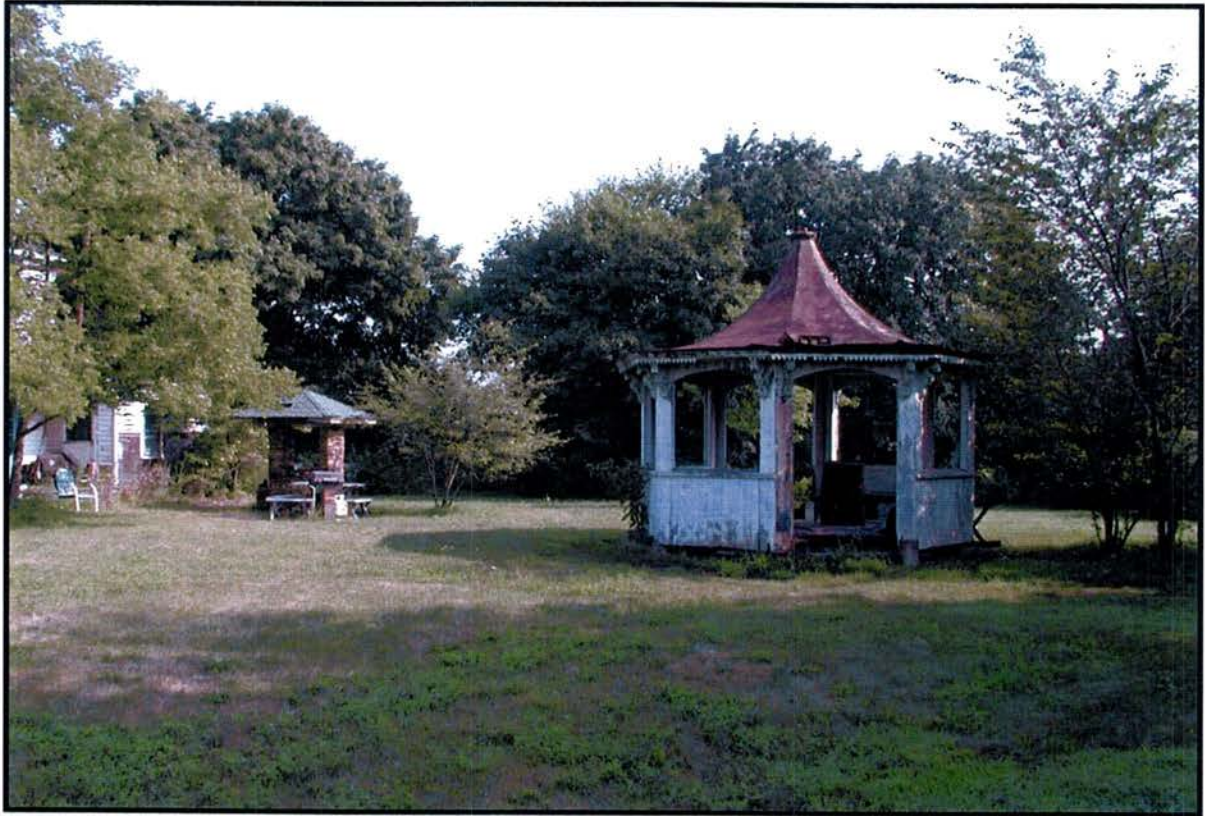
The Victorian gazebo on the property was salvaged by David Brook from a nearby house under demolition and moved to the site.

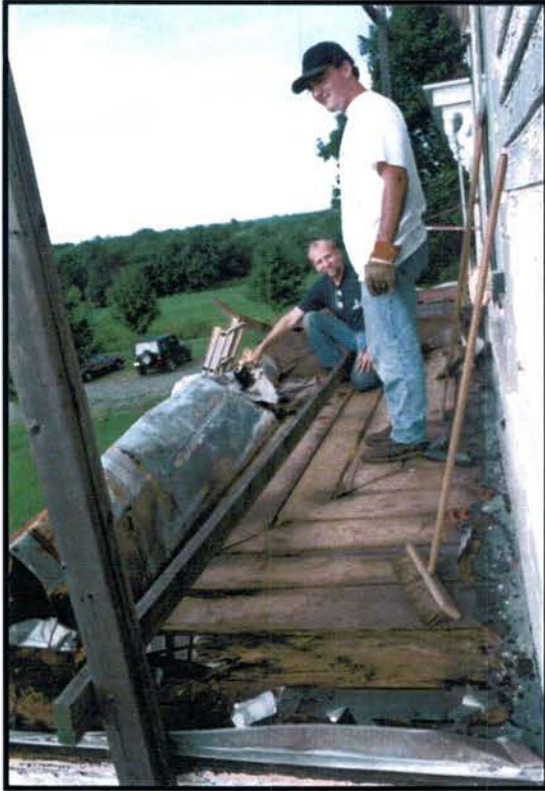
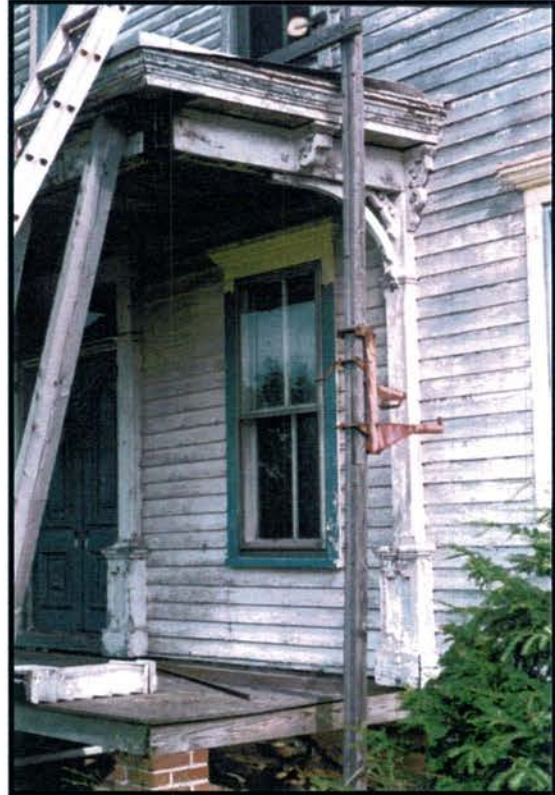
Two photos showing the process of removing the Victorian porch on the west side of the building. The roof, left, was constructed of planks covered with metal sheeting. Wooden components, right, were disassembled, catalogued and saved for the reconstruction.

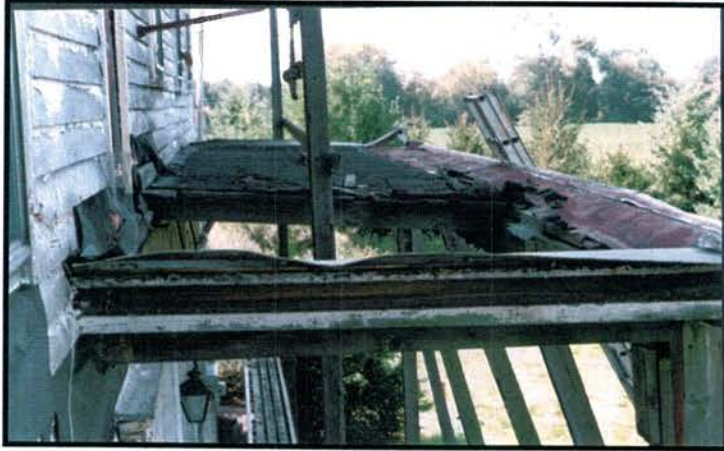
Above left: the collapsed roof of the porch and framing members. Note the metal at the right.

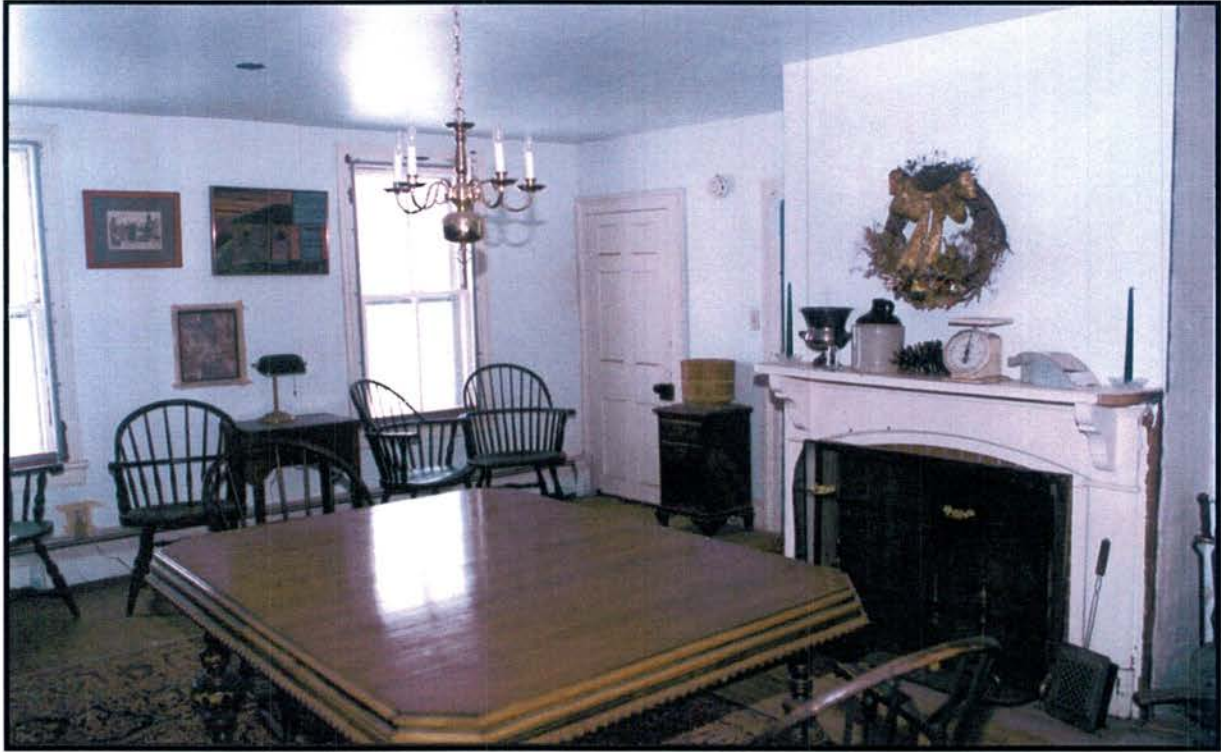
Dining Room, Room 101. This room is part of the older, north wing of the house. Its mantel was replaced following a rebuilding of the fireplace during the 1990s.

- Restore Room 101, Dining Room, with new paint finishes to match early color scheme. Furnish the room for classroom use and install new lighting. Replace new doors with four panel to match c. 1875 doors.

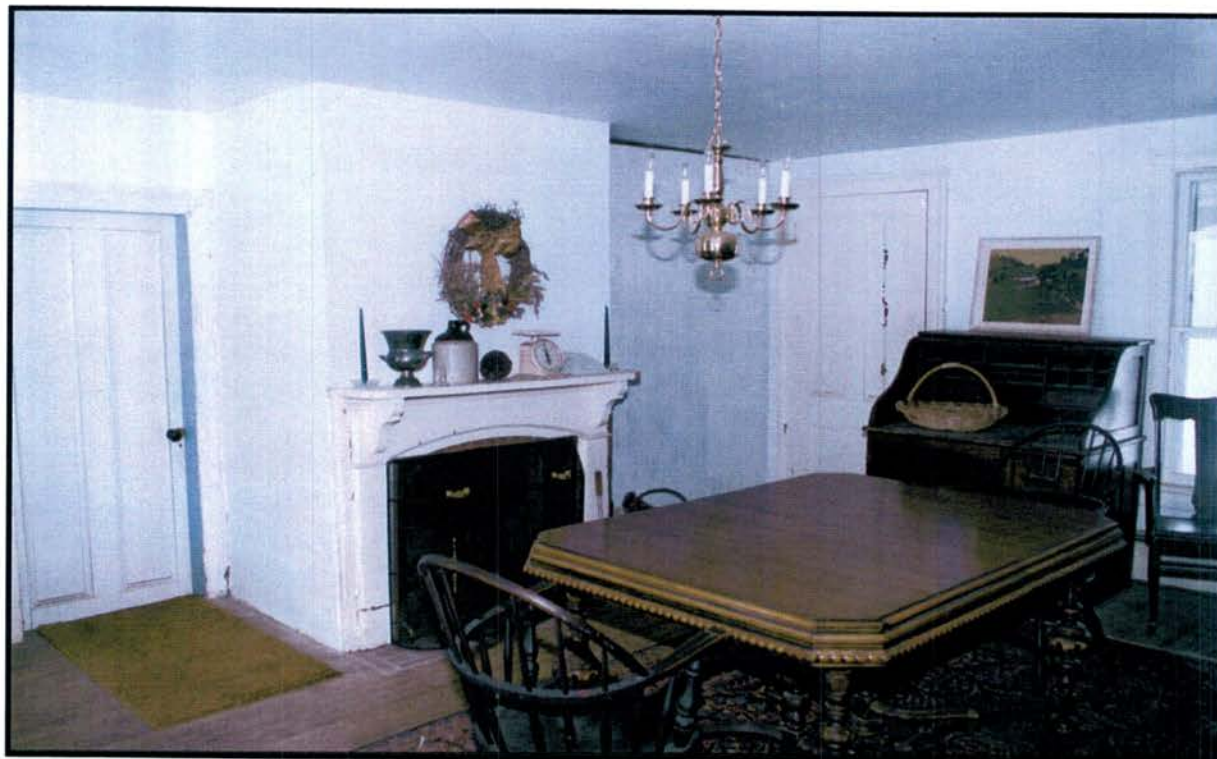
Dining room looking northeast toward door to back porch. The wooden mantelpiece may be from the early 19th century, but the fireplace has been enlarged and its position moved forward.

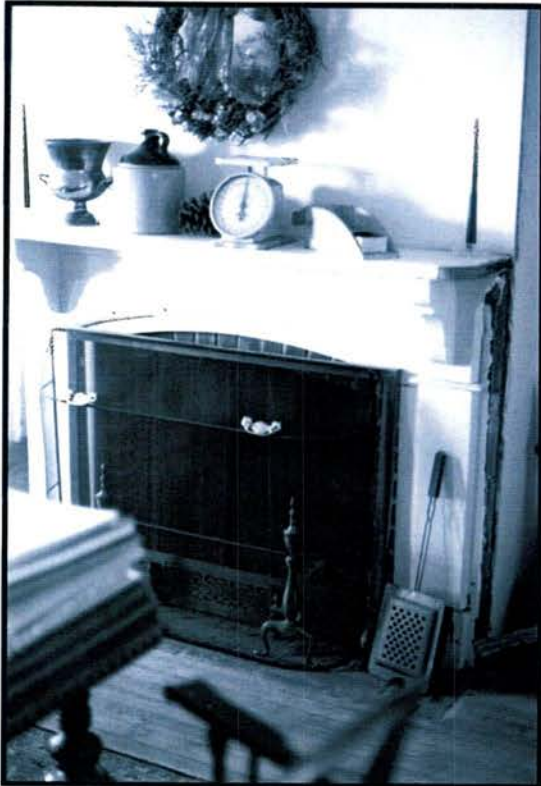
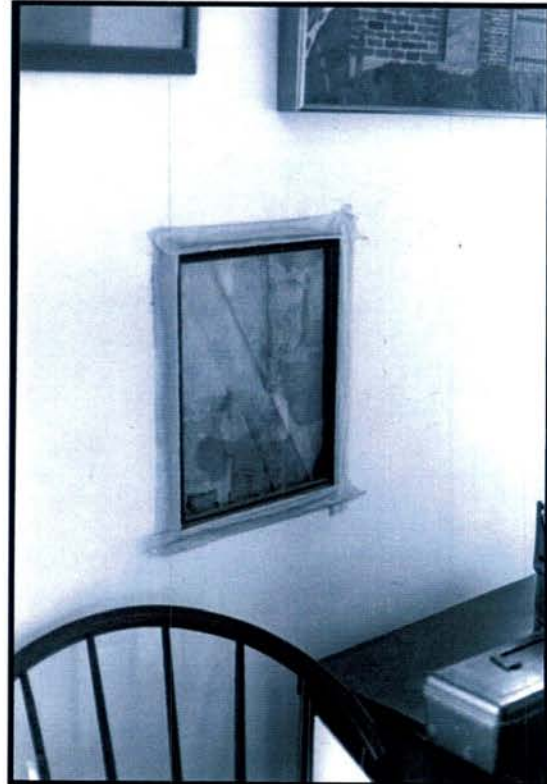
Left: close up of dining room fireplace. Right: a portion of the braced timber framing and brick nogging has been left exposed under the gypsum board walls.

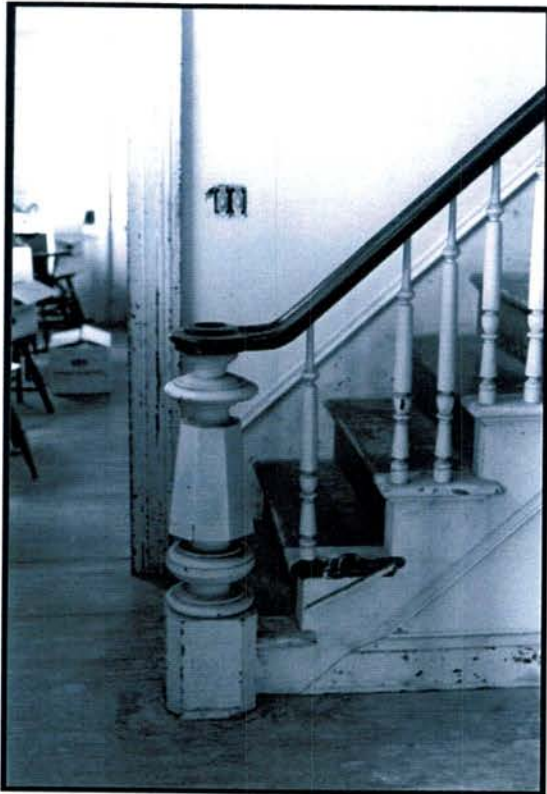
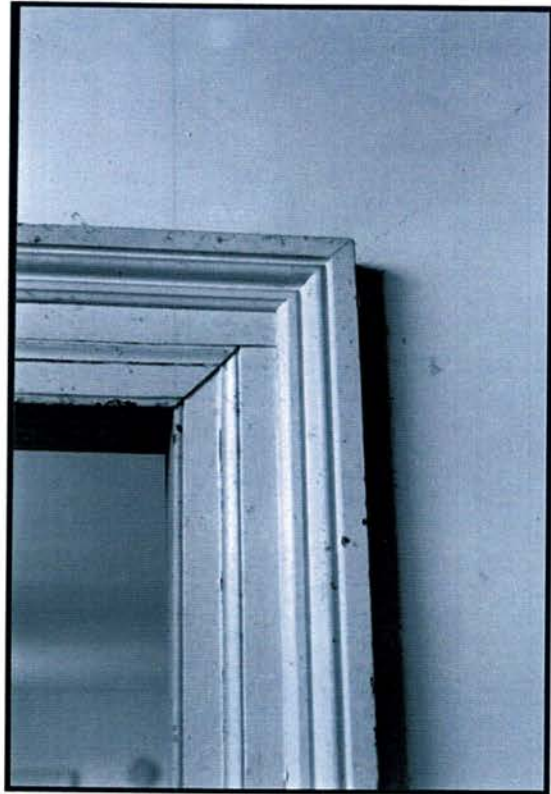
Two details of stair hall, Room 102. The newel and balustrade are typical of Victorian staircases in the New York area. Door casings also mark the building as a later 19th century product.

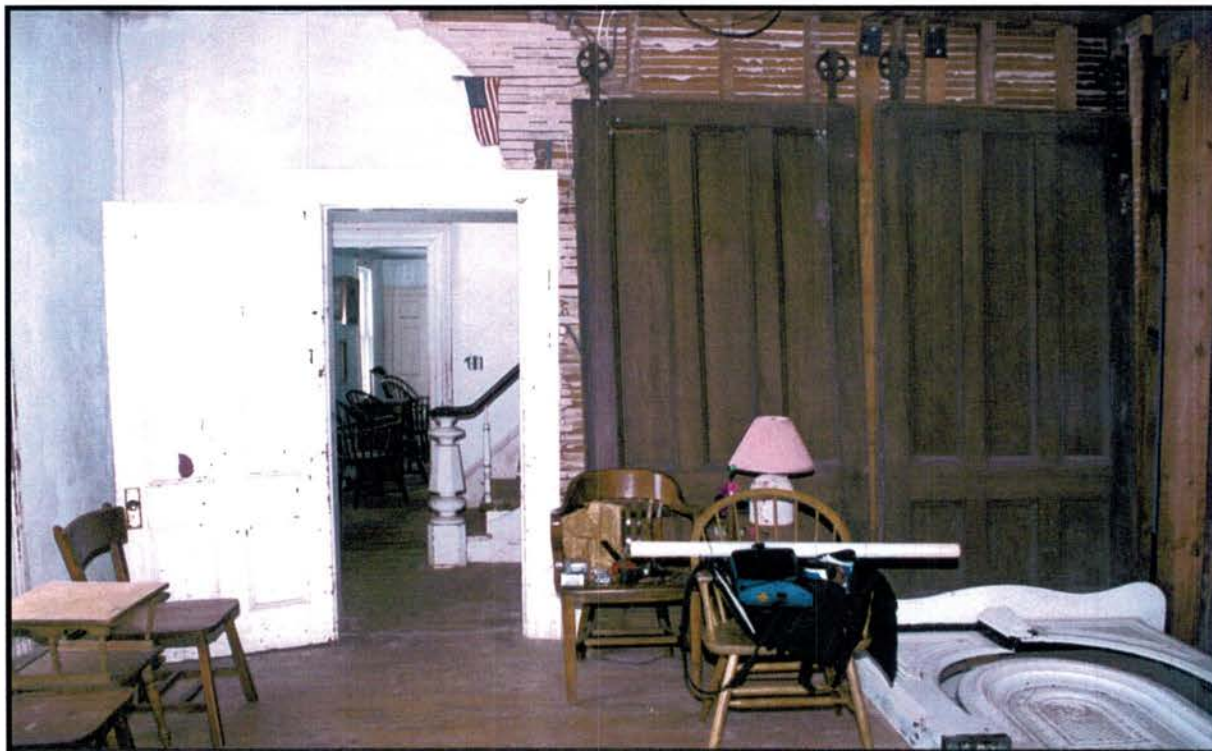
View of the large front parlor, looking north toward the stair hall. The two wooden doors at right were salvaged from a building of similar vintage for re-use here. The mantelpiece on the floor is from the 1875 build and will be restored to its location on the south wall of this room.

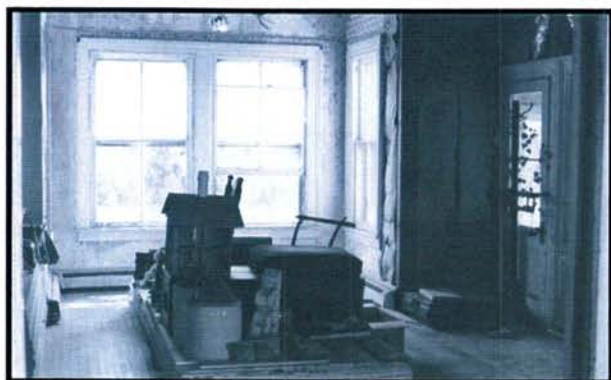
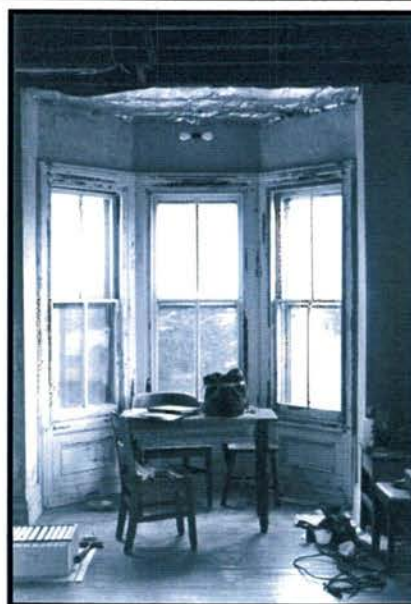
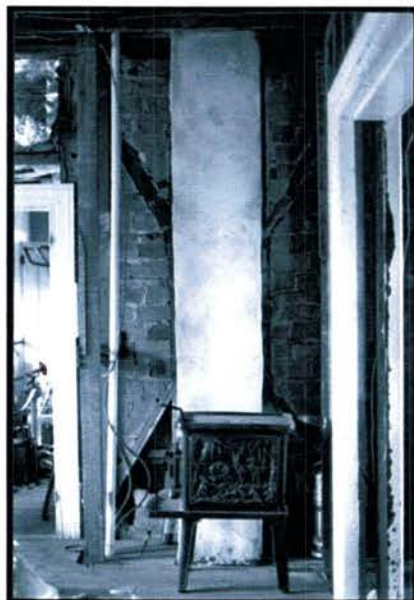
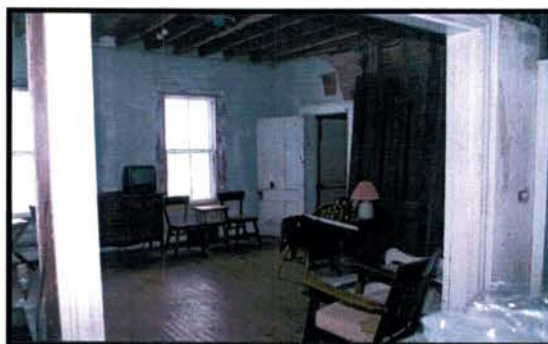
Four views of the front and rear parlors, showing the partially-stripped plaster walls and the process of renovation undertaken during the 1990s.

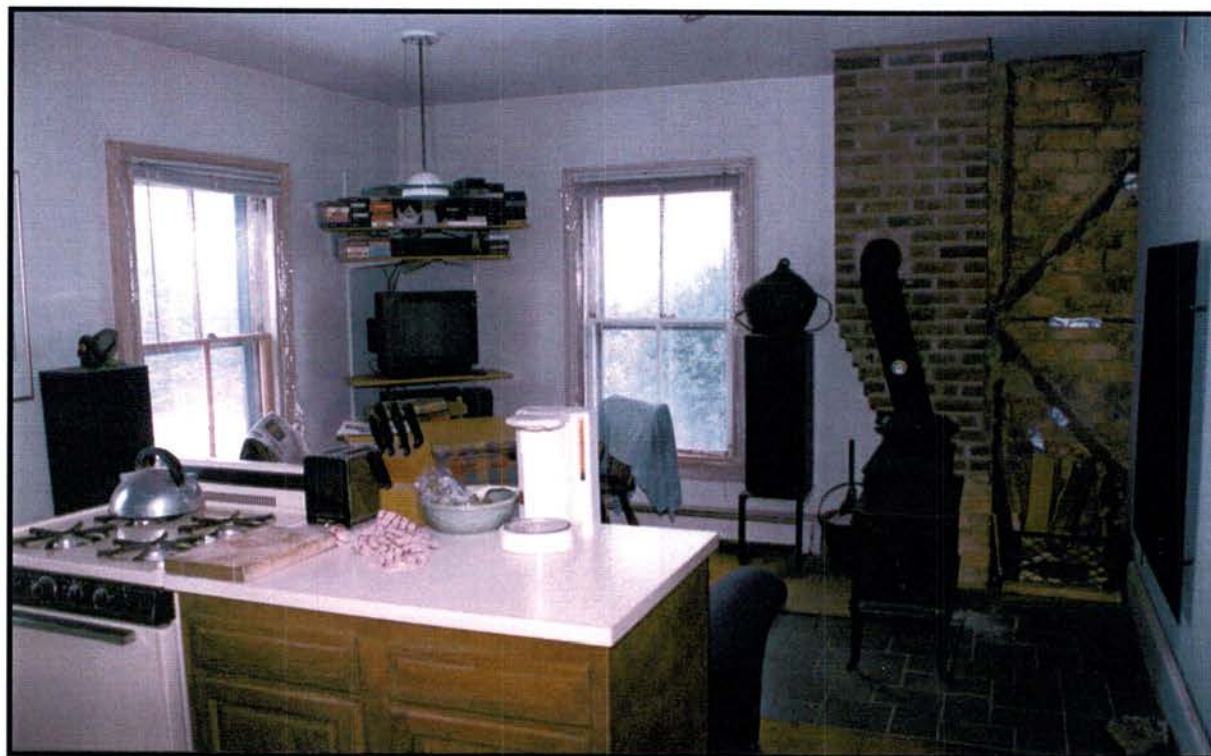
Caretaker's apartment, Room 205, looking south from kitchen to stove and rebuilt chimney at right. The walls and ceiling are finished in gypsum board. The 19th century window sashes have been retained in the modernized room.

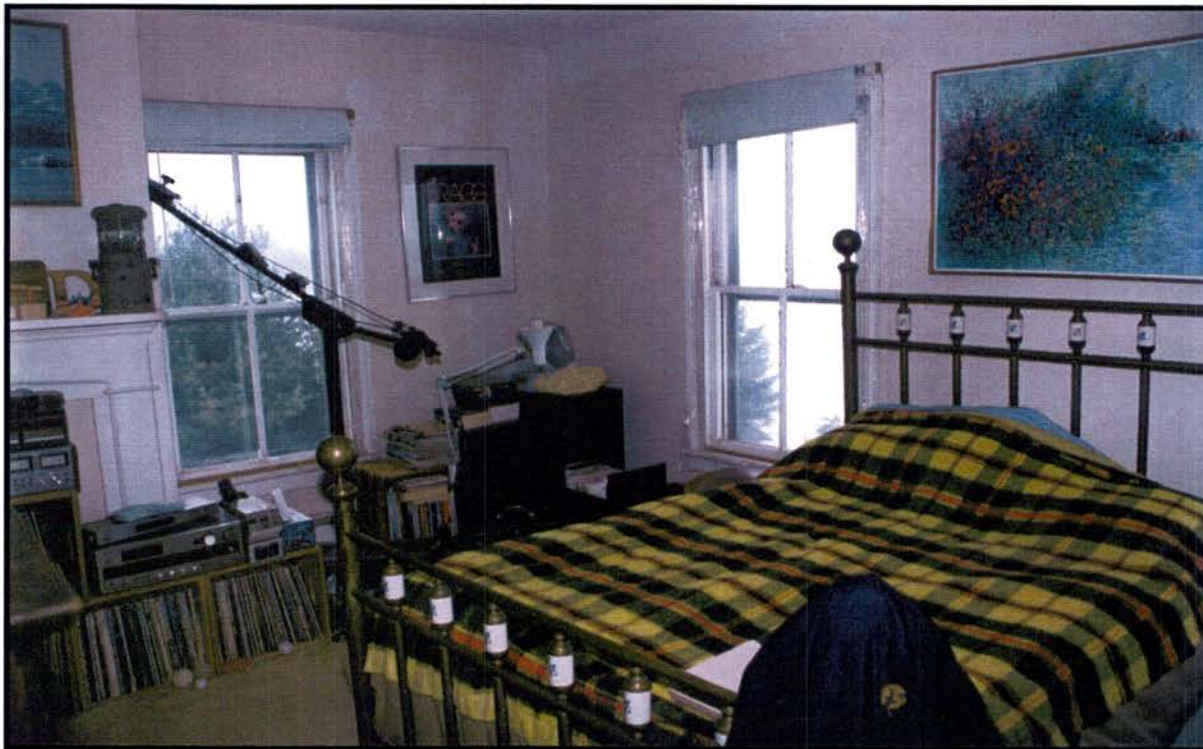
Caretaker's bedroom, Room 207, looking southwest. The early mantelpiece on the left opens to a non-functioning chimney stack. Like the apartment next door, the room has been renovated to serve its current purpose and needs little in the way of upgrades.

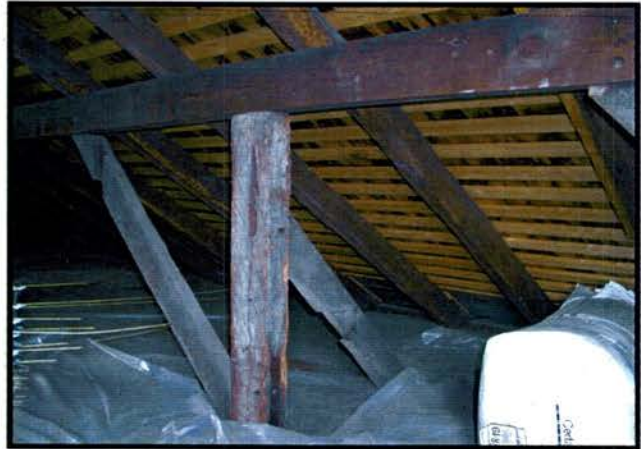
Right: Attic framing of south wing.  
Note the knee truss supporting the  
rafters at approximately mid span.

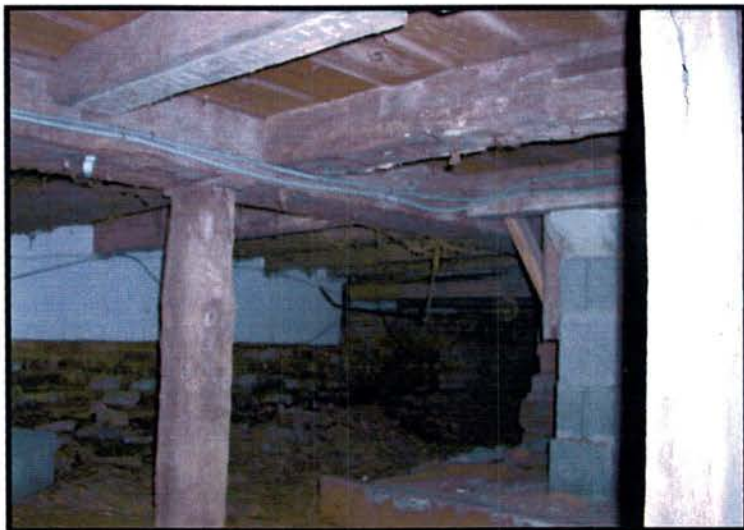
Above left: framing members in crawl space under older south wing. There is evidence here of hand-hewn construction and early framing techniques common to the 18th century.
