Historic Structures Report
Wyckoff-Garretson House

Franklin Township, New Jersey

Volume II: Illustrations & Appendices

Mark Alan Hewitt, AIA
Architect

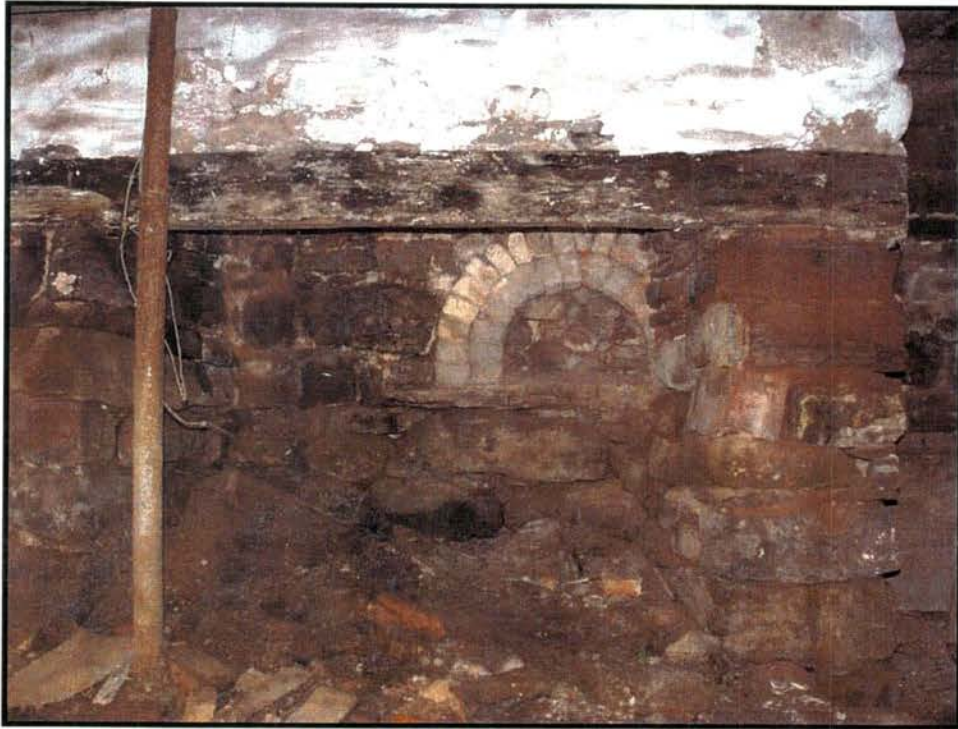
Plate 1. View looking southwest showing the side walls, wood lintel and chimney massing for the fireplace in the basement of the southern section of the house; the blocked brick-arched opening in the rear of the fireplace gave access to the bake oven (Photographer: Vincent Maresca, November 2000) [HRI neg. # 00050/D1:9].

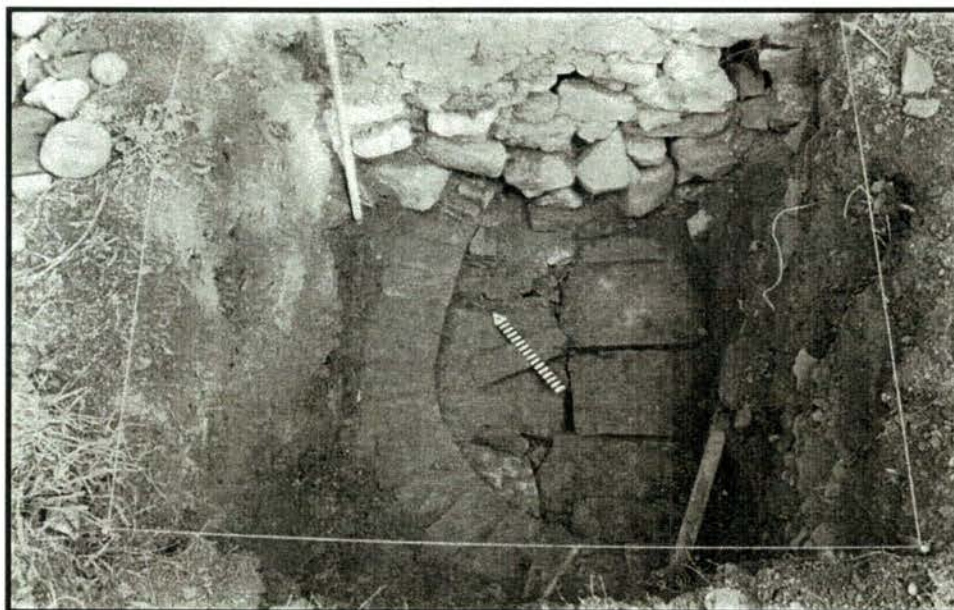
Plate 2. View of Excavation Unit 3 looking northeast showing the shale and brick base for the 18th-century bake oven set in the back of the fireplace in the basement of the southern section of the house; note the crude stone in-filling of the bake oven opening within the main foundation for the south wall of the house; scale in feet (Photographer: Vincent Maresca, November 2000) [HRI neg. # 00050/3:7].

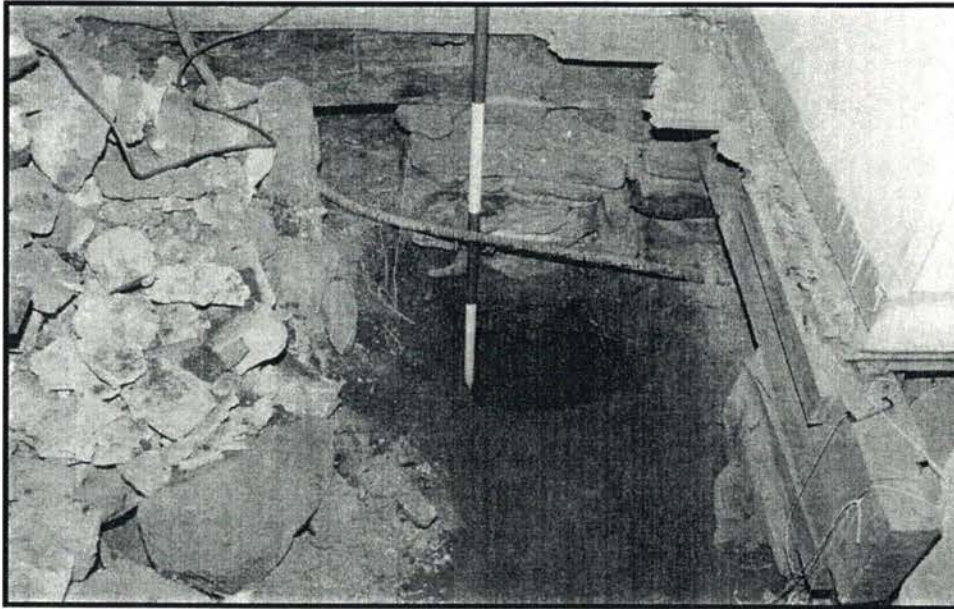
Plate 3. View of Excavation Unit 4 looking southeast showing the re-excavation of a portion of Grubb Unit #6; the stone foundation for the partition wall in the northern section of the house is visible behind the range pole; scale in feet (Photographer: Vincent Maresca, November 2000) [HRI neg. # 00050/3:8].

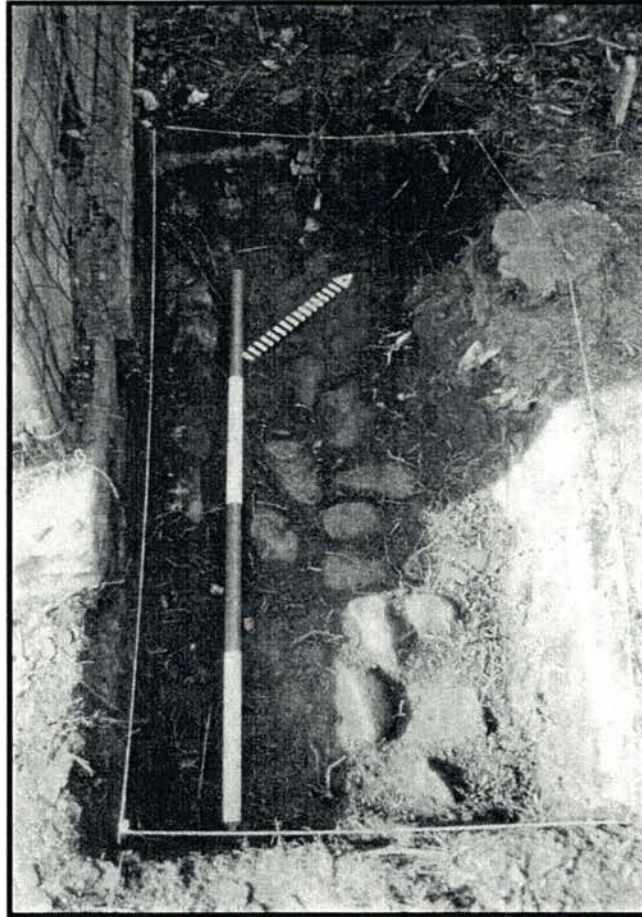
Plate 4. View of Excavation Unit 2 looking northwest showing the late 19th/early 20th-century crude stone paving adjacent to northeast corner of house; scale in feet (Photographer: Vincent Maresca, October 2000) [HRI neg. # 00050/3:7].

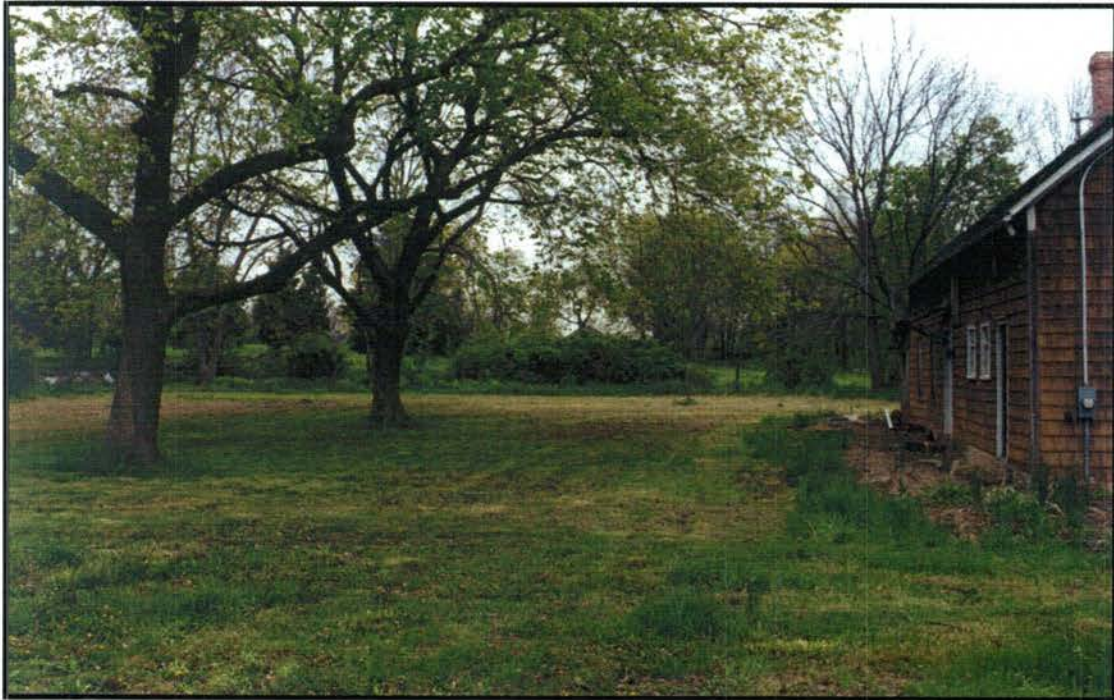
Lawn on the west side of the house; view looking north toward historic hedgerow marking the edge of a field. The two maple trees should be protected.

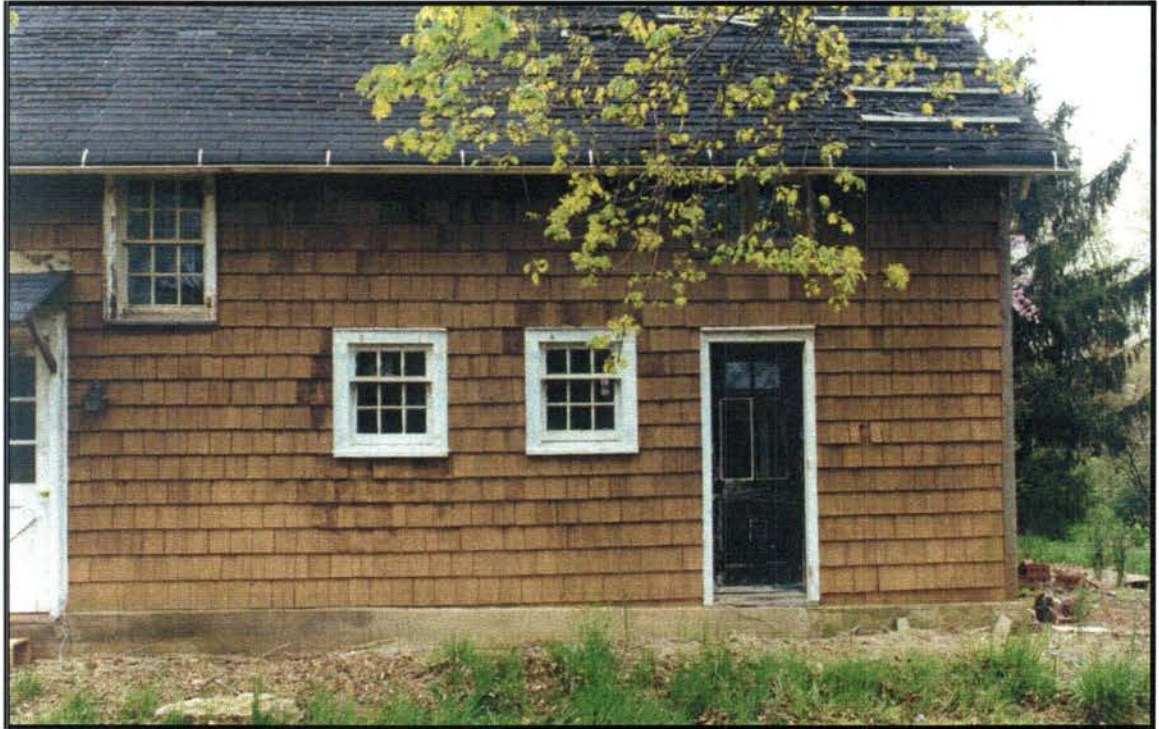
Perspective-corrected image of southern half of west facade, showing the portion of the house constructed by John Wyckoff. All of the openings have been changed since the early 19th century.

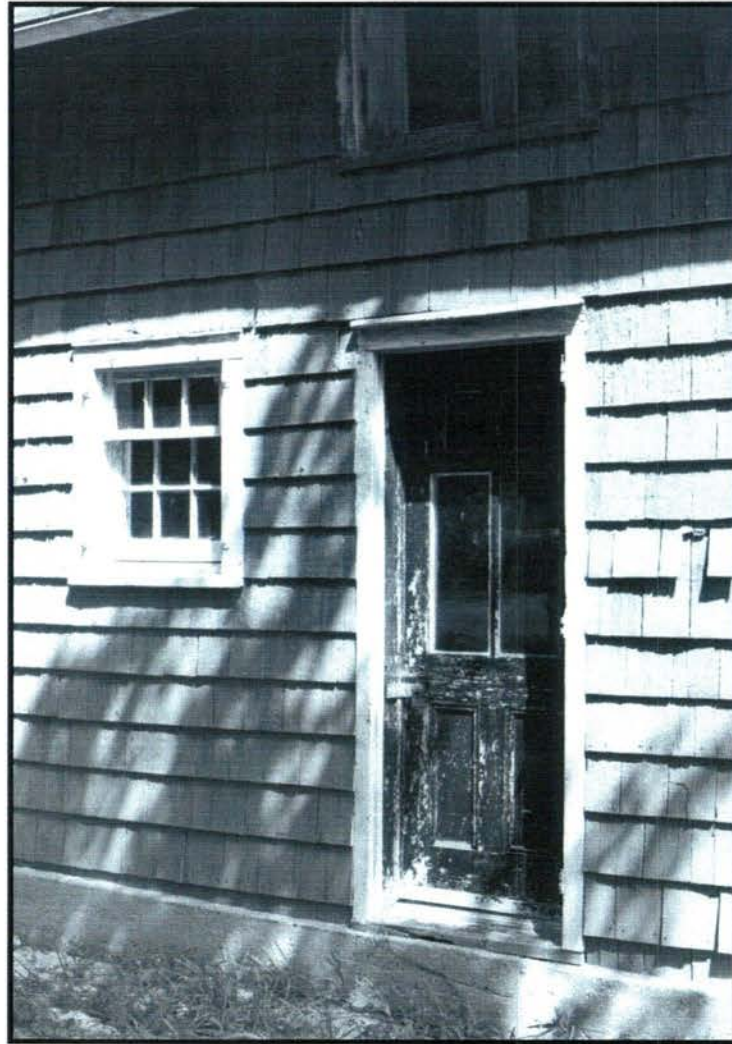
West facade, Door No. 11 and Window No. 1. In the original building, the door was a window and the window a closed wall.

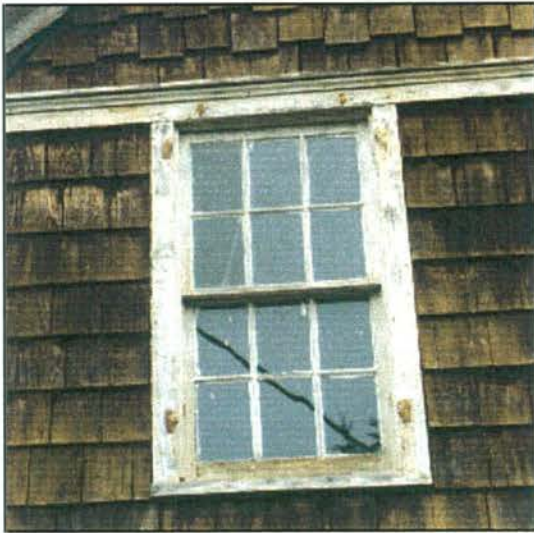
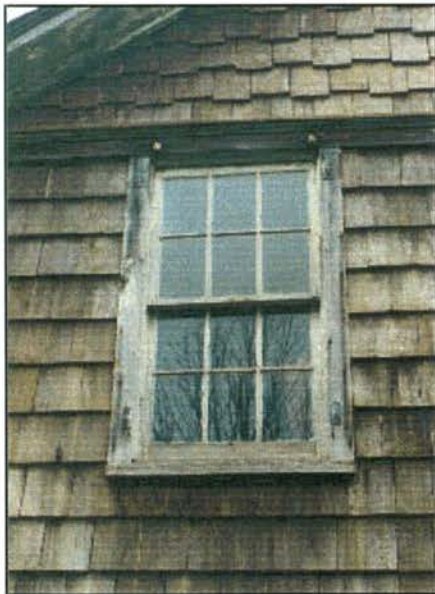
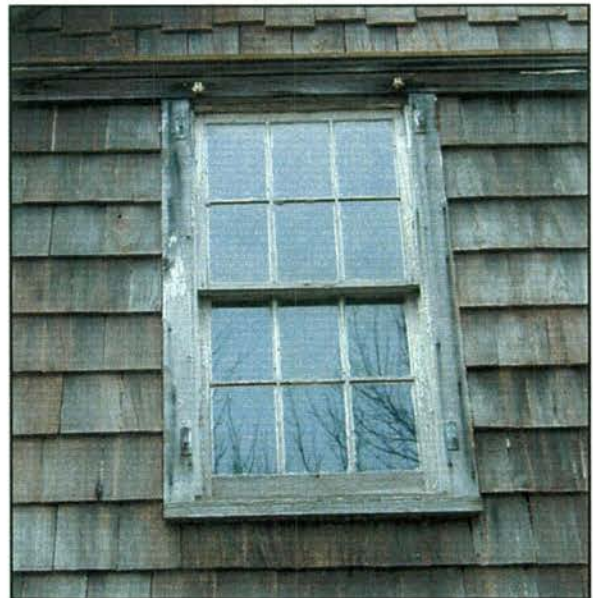
Second story windows on the north and south gable ends. Left: Window No. 24 on the south end, first build. Bottom: two views of Window No. 18 on the north gable. These sash were originally 2 over 2, but were later modified to 6 over 6.

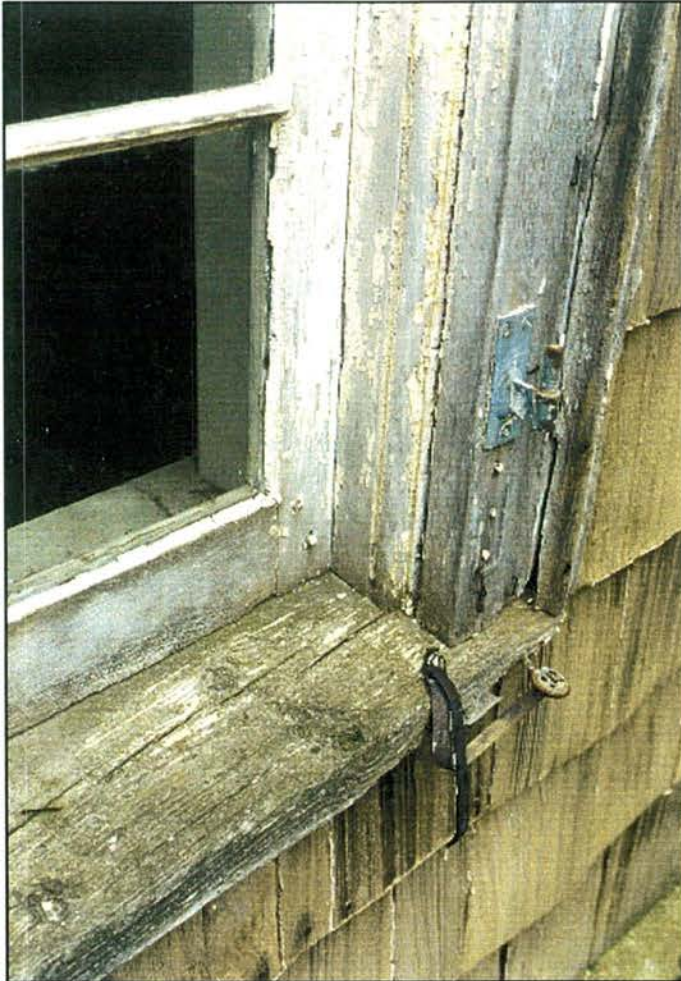
Detail photo of typical casing and sill from the first floor 9 over 6 windows of the east facade. Here the casing appears to date from the early 19th century. Though the windows have not been painted for years, much of the wood may be conserved using consolidants or epoxy patches.

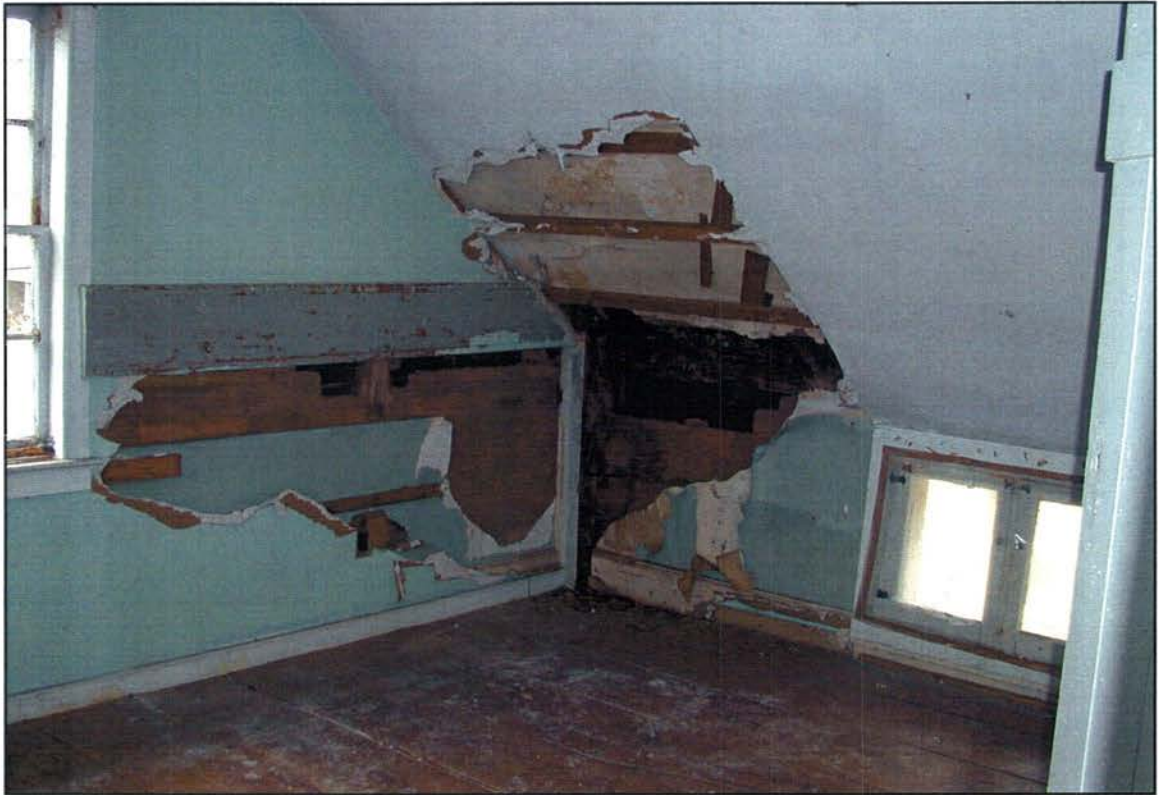
Room 200, Bedroom No. 1 on the southwest side of the first build. The probe has exposed the unusual gunstock post and English style corner joint. The unusual element is the middle tie beam, now cut by the window at the left, that seems unnecessary from a structural point of view.

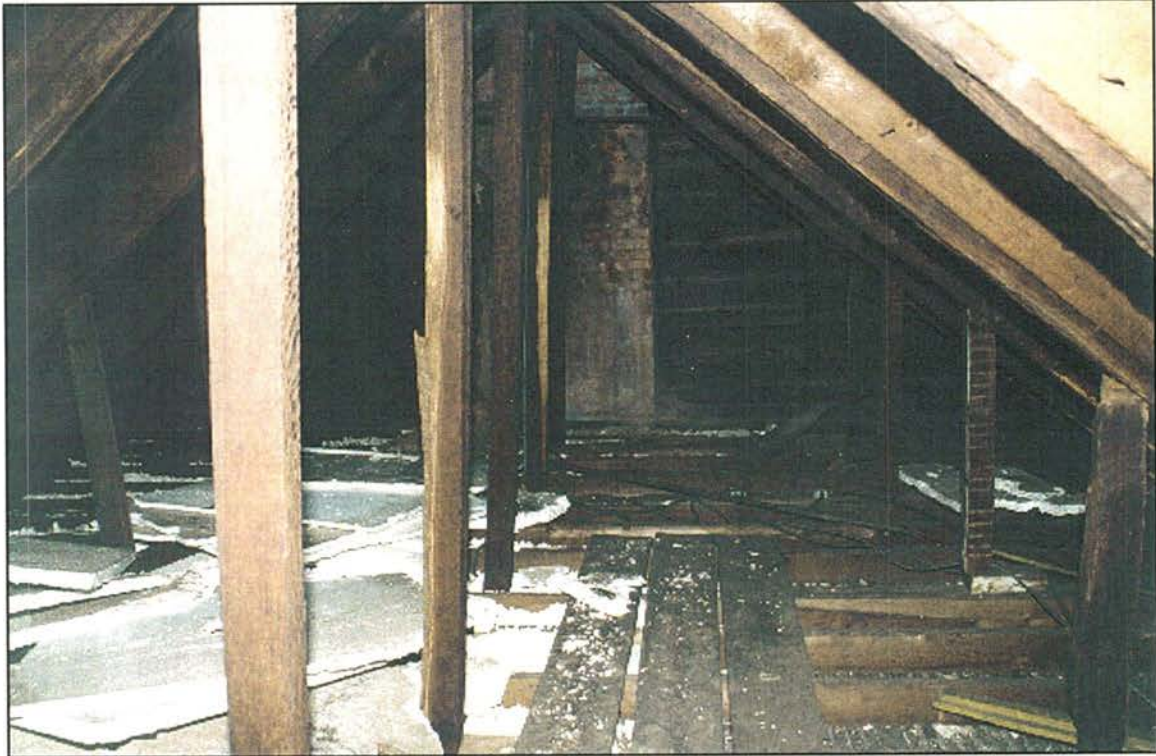
Room 301, view of the attic looking south, toward the oldest chimney and rafters of the first build. Note the vertical struts at every bent, and the intermediate roof framing (2x6) between each main rafter. Many of the rafters are also sistered with modern 2x6's.
